Assessment of Wooden Beams from Historical Buildings Using Ultrasonic Transmission Tomography

The main goal of this study was non-destructive evaluation of wooden elements using ultrasonic waves. The inspection was carried out on wooden beams from a historical object. Elastic wave signals were processed by ultrasonic transmission tomography to obtain imaging of the internal structure of tested elements without disturbing their state and integrity. The focus was on the influence of wood anisotropy on the propagation of ultrasonic waves. A novel method of determining the position of the cross-section pith was proposed. The study presented that the proposed imaging approach was capable to assess the technical condition of historic wooden beams by determining the degree of wood damage and the location of discontinuities, scratches or fibrosis in the tested cross-section.

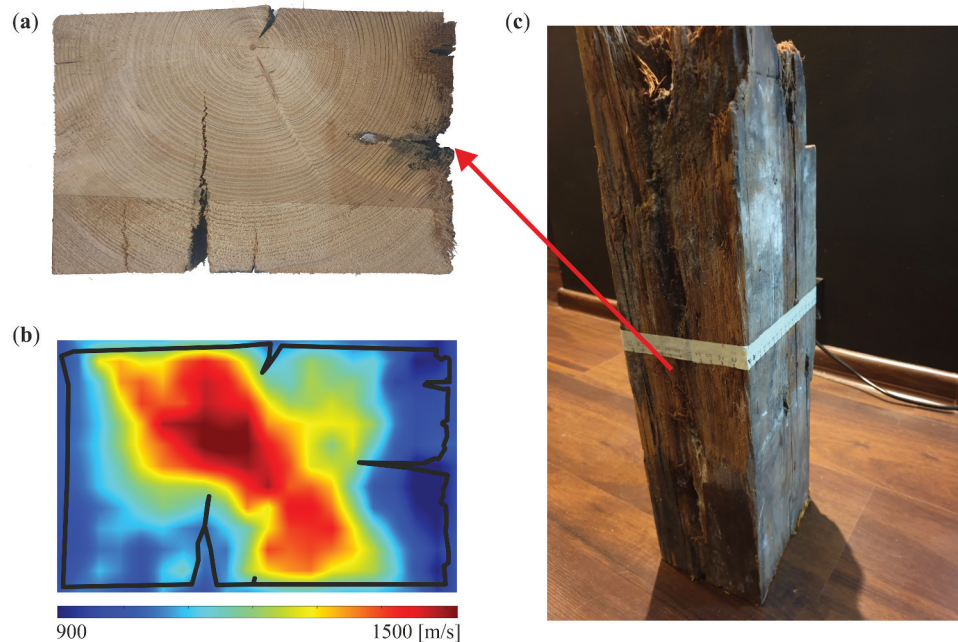
Beam #2 was taken from the historical roof framework. One of its sides included major wood fibrosis (see Figure 9a). The remaining three contained cracks. The ultrasonic tomography image clearly indicates the places where the beam is damaged (Figure 9b). The edge with the wood fibrosis showed the reduced wave transfer velocity. A similar effect was observed in the places where the cracks were located. Furthermore, an increased velocity may be spotted at the location of the pith, similar to the reference beam (#1). The wave propagation velocity varied between 632.7 m/s and 1442.3 m/s. The difference between the minimum and maximum velocity was, therefore, greater than in the reference beam (#1) and equal to 809.6 m/s. The average velocity of wave propagation was 1093.3 m/s, the standard deviation was 137 m/s. Both of these values are smaller than in the undamaged beam. The coefficient of variation was equal to 12.5% and it was at the same value as for reference beam #1. However, it should be noted that the pith of the undamaged beam is outside the cross-section, while in beam #2, the pith is within the tested cross-section.

Figure 9. Results obtained for beam #2: (a) top view of the beam, (a) ultrasonic tomography image, (c) side view of the beam.

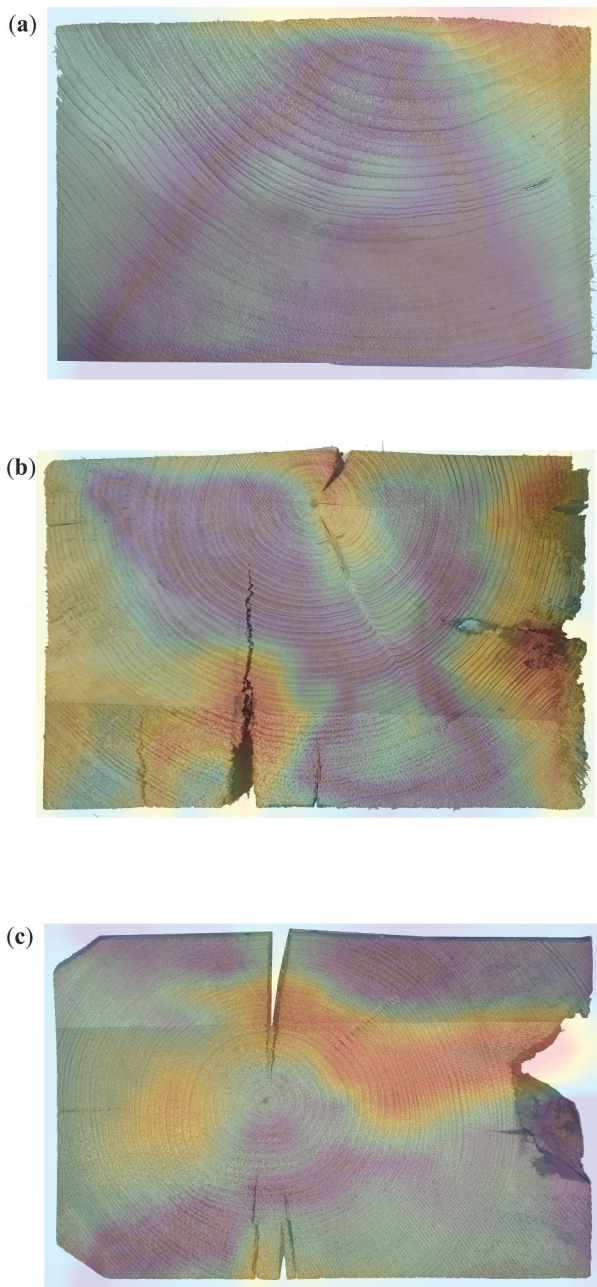
propagation velocity due to discontinuities, voids, scratches or fibrosis are visible on these maps. The final ultrasound tomography maps with a visible beam cross-section are shown in Figure 14.

Figure 14. Final ultrasonic tomography maps imposed on cross-sections of tested beams.
