Assessment of Wooden Beams from Historical Buildings Using Ultrasonic Transmission Tomography

Monika Zielińska

^a and Magdalena Rucka

^b

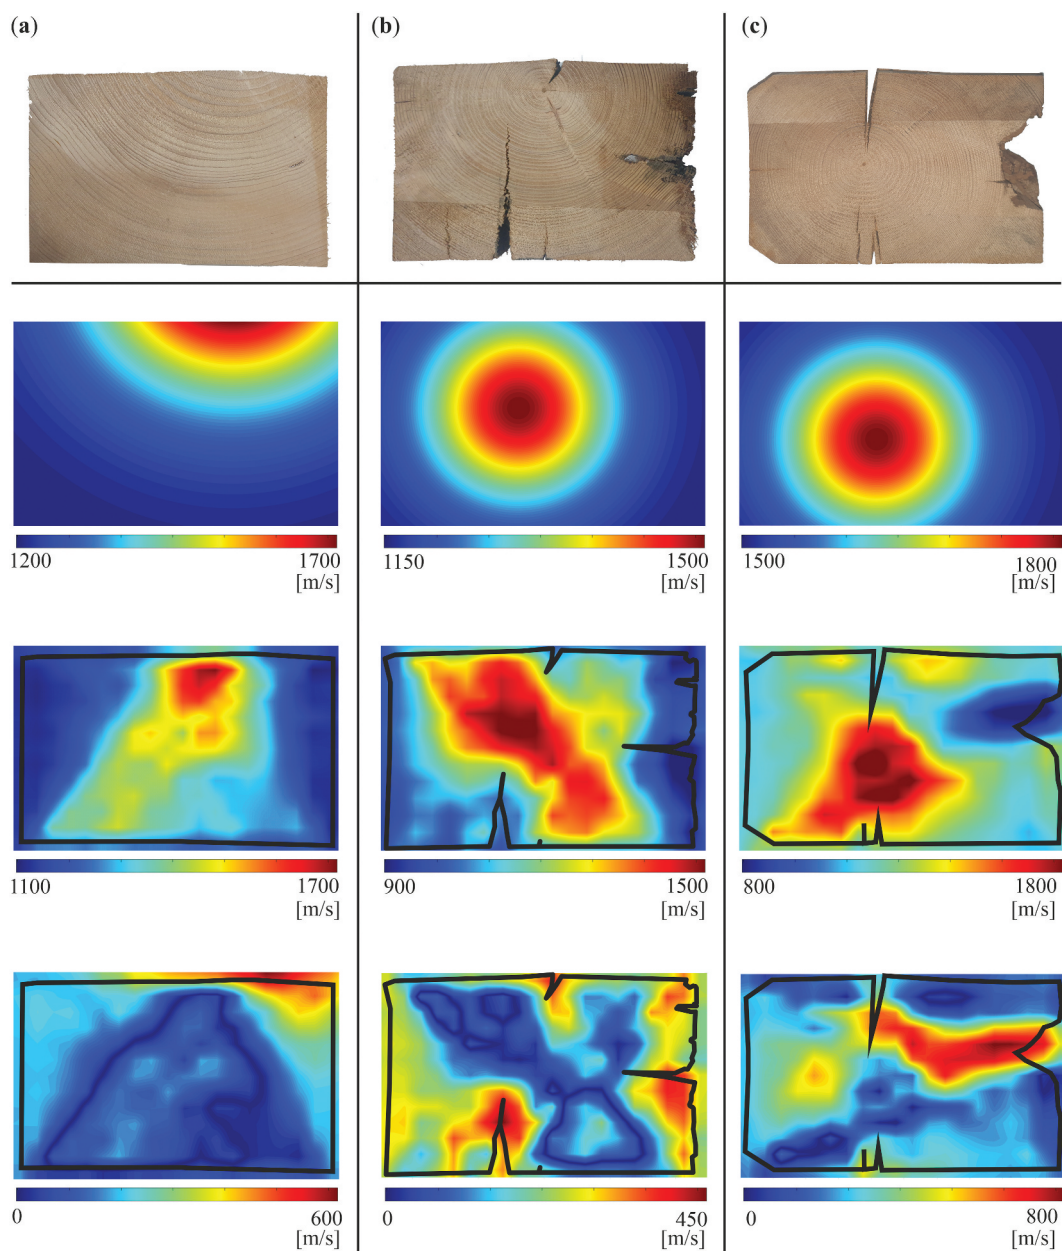
Idealized maps of wave propagation velocity in the wooden element were created after determining the pith location (Figure 13, second row). The highest speed was identified at the designated pith and was equal to the maximum value in the preliminary topographic map (Figures 8–10). It was different for

Figure 13. Ultrasound tomography maps: cross-sections (first row), idealized models, taking into account the location of the pith (second row), initial tomographic maps from Figures 8–10 (third row), the difference between the idealized maps and the initial maps (fourth row).

each of the three samples and was 1637 m/s, 1442.3 and 1842.5 m/s respectively for samples # 1- # 3. The velocity decreased circularly and uniformly for each direction of the outer edges of the beams. The third row in Figure 13 summarizes the initial tomographic maps. The final result is the maps shown in the fourth row. They are the difference between idealized and initial maps. Due to the subtraction of the idealized model indicating the location of the pith, only places showing a decrease in wave

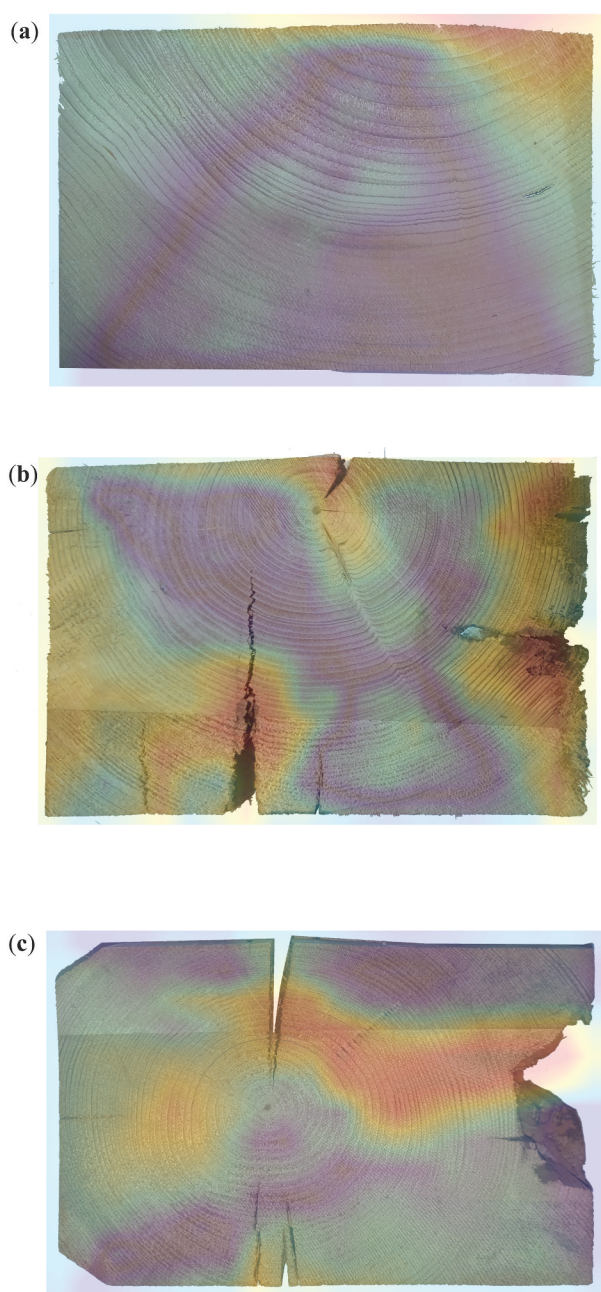
propagation velocity due to discontinuities, voids, scratches or fibrosis are visible on these maps. The final ultrasound tomography maps with a visible beam cross-section are shown in Figure 14.

Figure 14. Final ultrasonic tomography maps imposed on cross-sections of tested beams.
