Emergency condition of the ceramic facade of a residential building

Abstract

Keywords: elevation, ceramic cladding, emergency condition, renovation, repair works

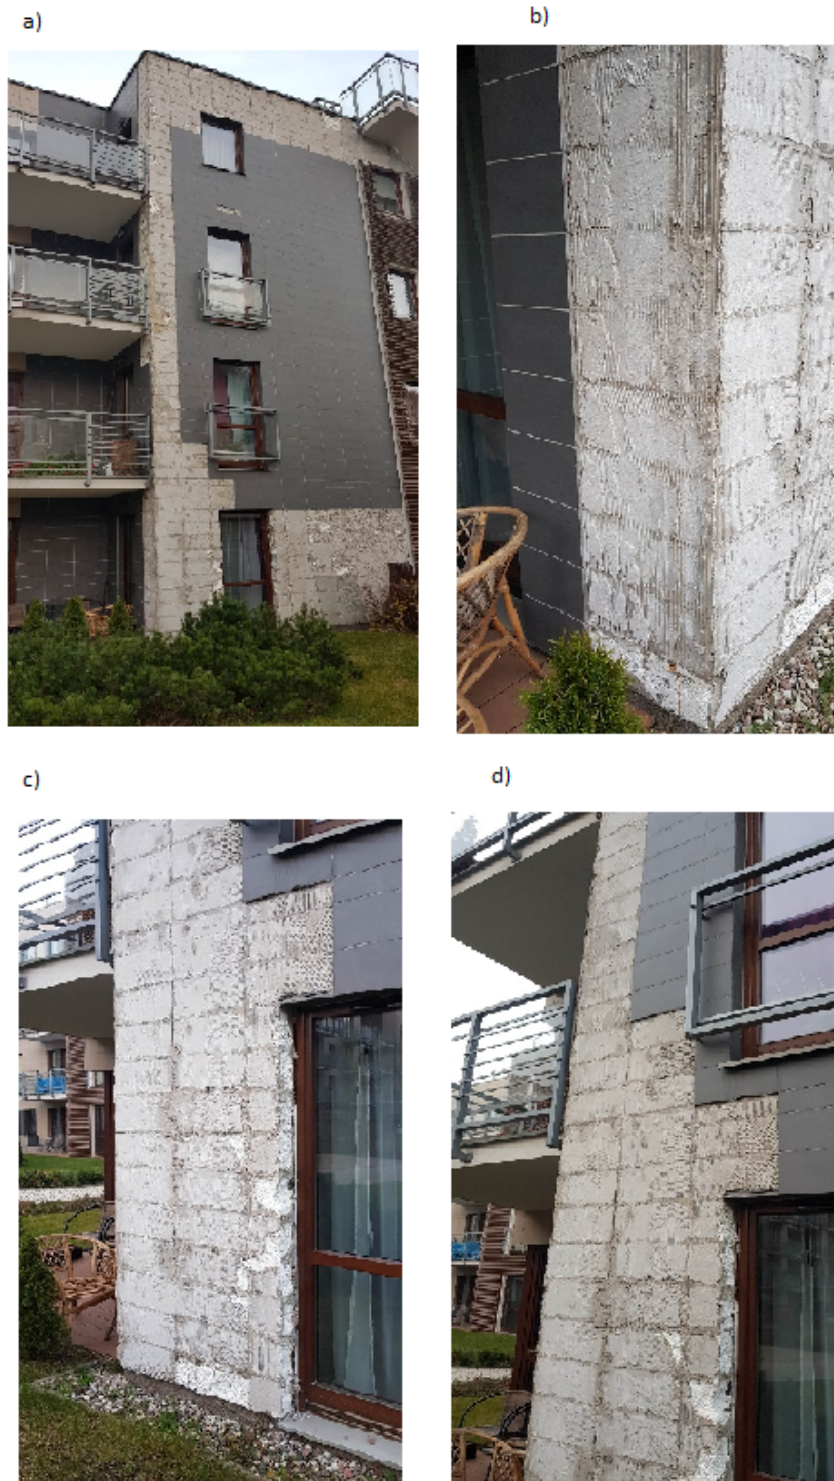
Figure 1. Damaged ceramic cladding a), b), c) and d) of the building facade

On the façade fragments made of ceramic tiles, extensive blooms were visible, occurring at the joints between individual ceramic tiles. About 50% of the façade surface made with the use of ceramic cladding had damage in the form of its detachment from the substrate, i.e. from the adhesive layer, made on a heat-insulating material such as polystyrene. These damages occur over the entire height of the building, at the height of 4 above-ground storeys (Fig. 1).

In the case of damage to the ceramic cladding of the building façade, it was most likely a consequence of using too little water added to the adhesive, which resulted in its drying too quickly instead of the spread of bonding over time. Carrying out cladding works in the period when the wind was probably periodically blowing, which resulted in exceeding the so-called open time and resulted in the glue drying out, and consequently accelerated setting start contributed to the tiles being scorched by the glue layer. Likewise, the probable performance of works in the period of periodic increased insolation had a negative effect on the adhesion of the adhesive to the substrate and to the tiles. In addition, the implementation of the cladding fragments on the thickened adhesive layer led to excessive shrinkage and loss of adhesion. Leaks in the attic's plinth also contributed to the degradation of the cladding.

Local efflorescence on the ceramic cladding of the building façade resulted from the occurrence of local leaks in the attic roofing, which could result in the penetration of rainwater into the façade finishing layers, which by gravitation resulted in leaching of calcium compounds. In addition, the locally increased diffusion of water vapor transported to the outside leaches calcium compounds from cement mortars, and the limited transport surface, which is a grout, also made as cement-based mortar, contributes to the formation of efflorescence [20].

- disassembly of the damaged ceramic cladding on the entire surface of all facades of the building,
- re-profiling the substrate: gluing an additional layer of facade mesh in places of damage, additional pinning of the thermal insulation material (polystyrene), making a new layer of glue on the entire surface,
- reconstruction of all facades of the building using the facade plaster,
- checking the tightness of flashings and flashing, especially in the area of parapets, taking into account the possibility of their complete replacement.

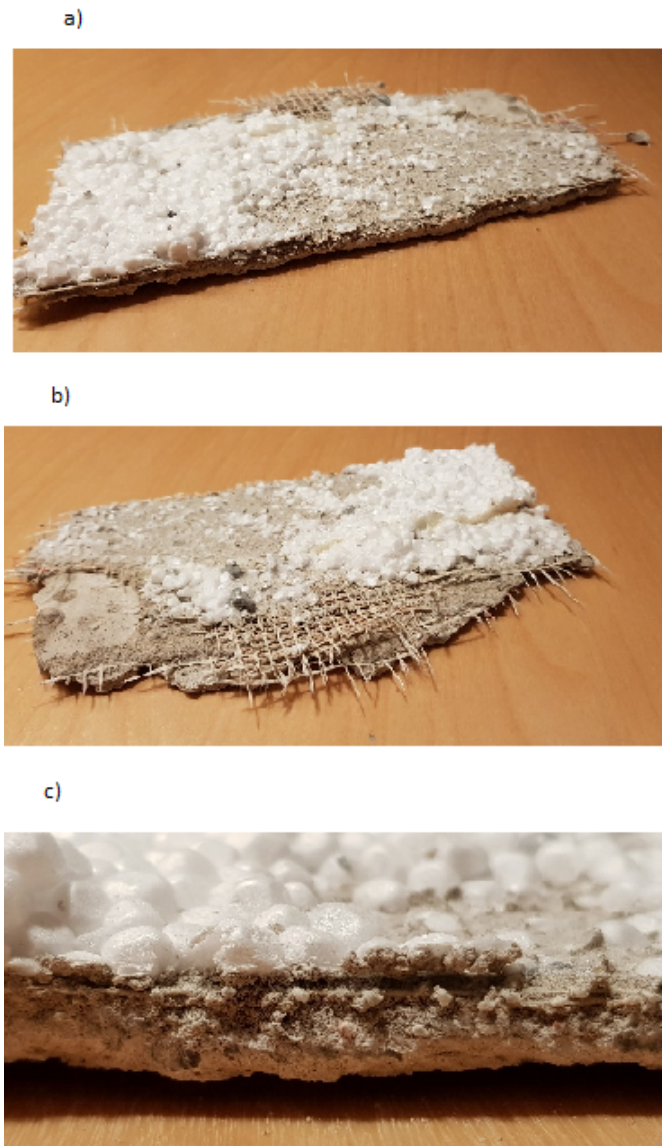
Figure 2. Details of thermal insulation (substrate) a), b) and c) for the ceramic cladding of the building facade

- the pins should be fixed in the first layer of the facade mesh and then covered with the second (top) layer of the mesh with glue - in the outcrops, the use of a double facade mesh and fixing the pins according to the technological requirements (+) was found. The thickness of the glue allows the facade mesh to be fully covered (Fig. 2),

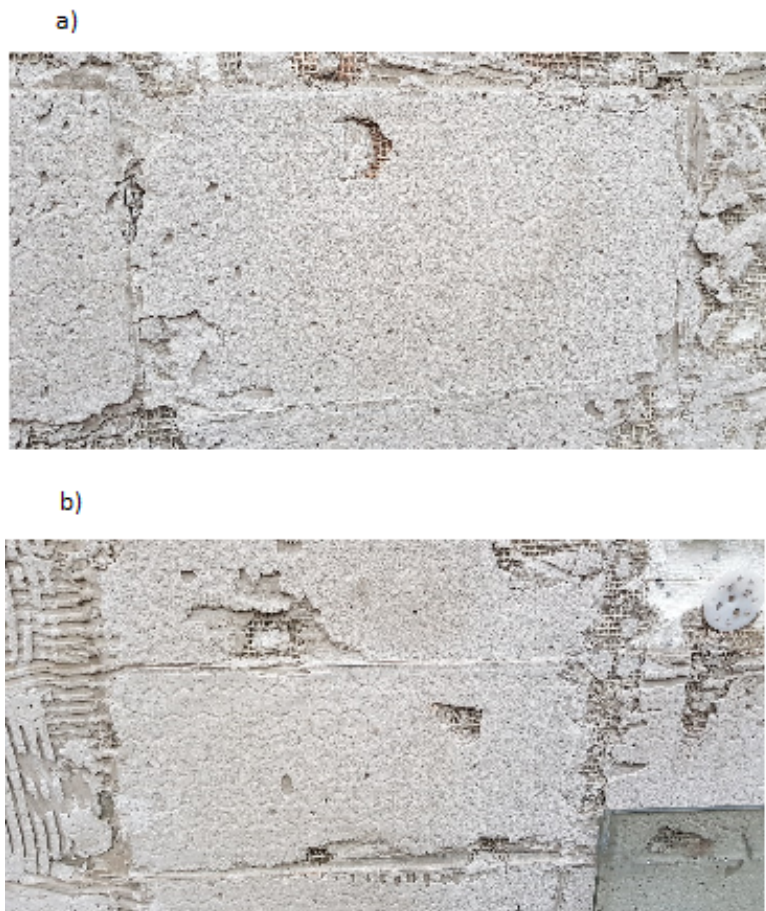
Figure 3. Mechanism a), b) (method of detaching) the ceramic cladding of the building facade
