Demolition of the cereal elevator building located in the conservation protection zone in the aspect of technical, functional-utility and economic conditions

Abstract

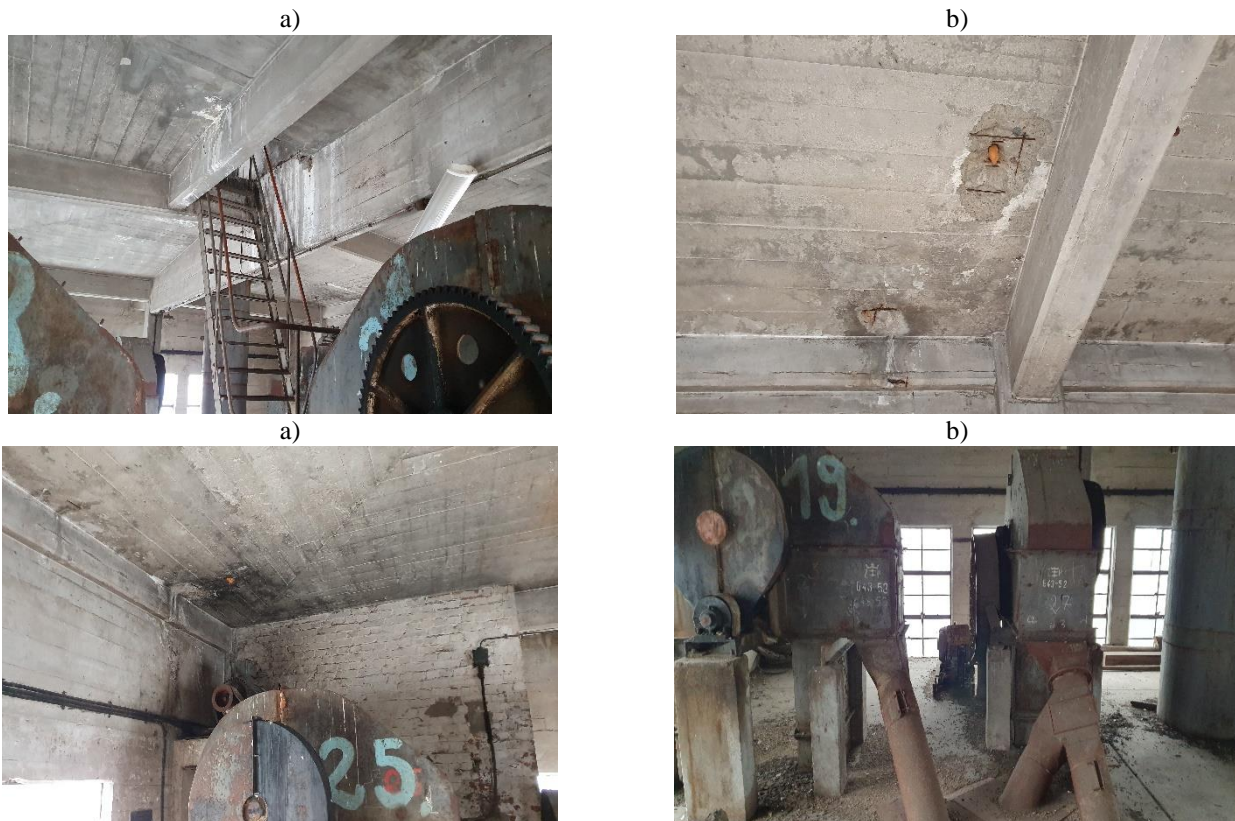
In the rooms on the +10 level, mechanical damage to the ceiling above this level was visible. Elements of devices used for transporting loose materials were also visible (Photo 3).

Photo 3: Grain Elevator building - level +10: a) mechanical damage to structural elements, b) defective and incomplete equipment for transporting loose materials

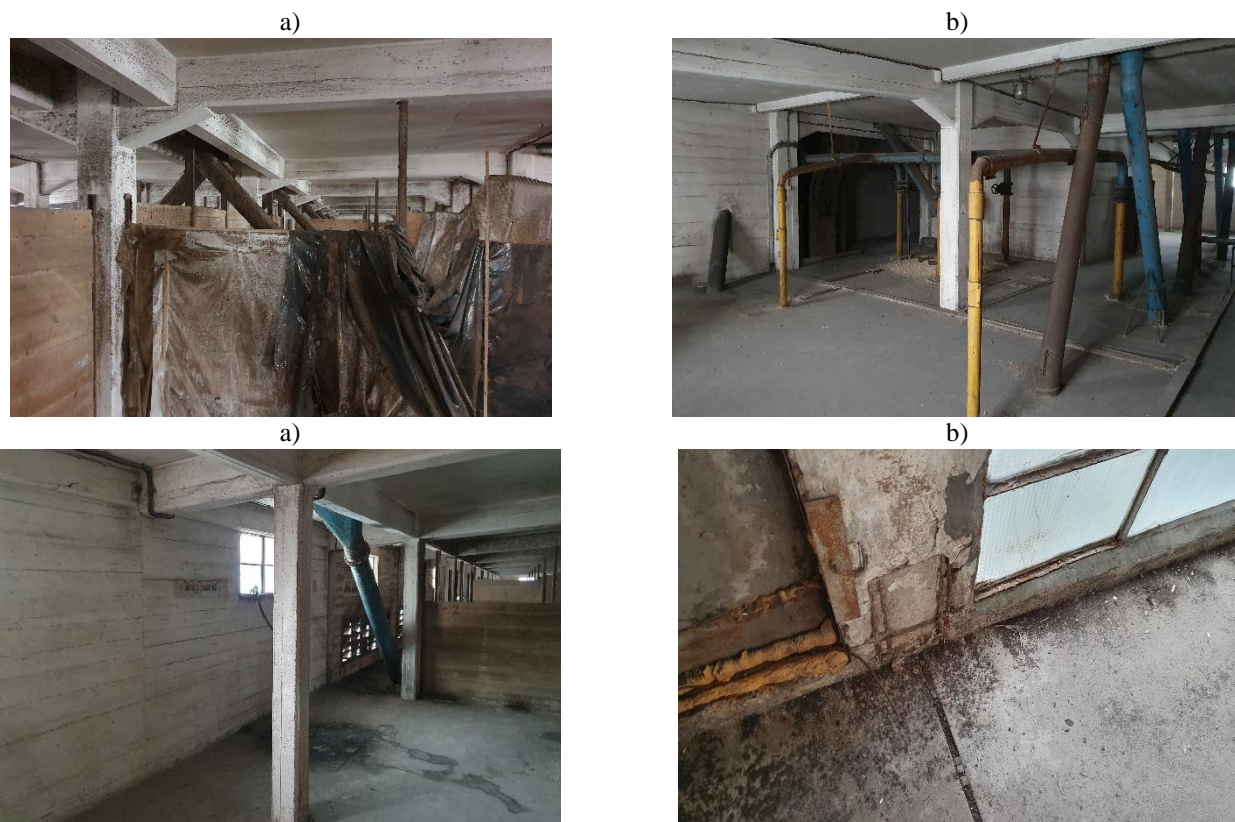
The rooms on the +7 level, as well as the higher rooms: +8, +9, and the lower ones: +6, +5, +4, +3, +2 and +1 floors had sections for storing materials separated by wooden partitions loose. In the rooms, inoperative devices for transporting the stored materials were visible. Traces of freezing of external walls were visible in the floor zone. Loss of concrete cover was visible on some of the pillars between the windows (reinforced concrete columns) (Photo 4).

Photo 4: Grain Elevator building - level +7: a), b), c) division of the usable area with wooden partitions, d) falling off the concrete cover in the floor zone
