Demolition of the cereal elevator building located in the conservation protection zone in the aspect of technical, functional-utility and economic conditions

Maciej NIEDOSTATKIEWICZ^{*1}, Tomasz MAJEWSKI²

¹ Department of Engineering Structures, Faculty of Civil and Environmental Engineering, Gdańsk University of Technology, Gdańsk, Poland

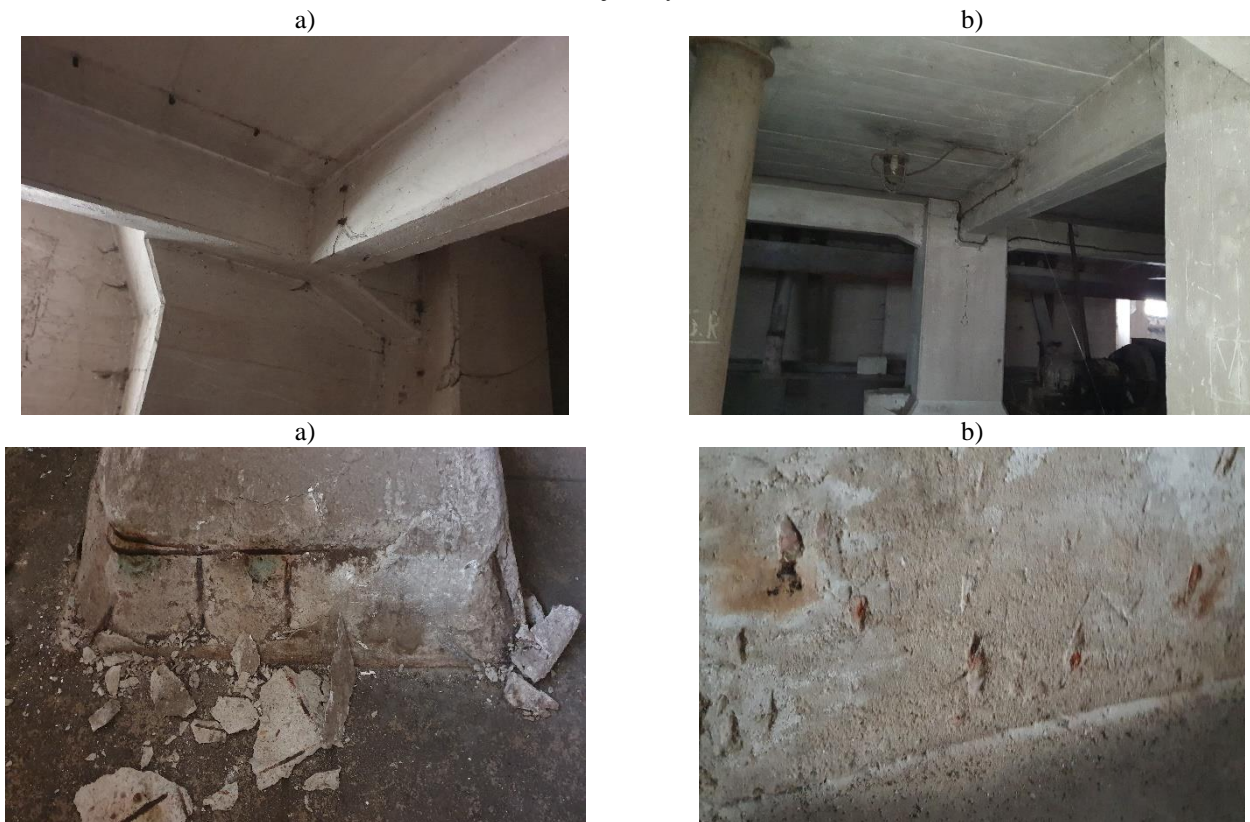
The reinforced concrete elements in level -1 had mechanical damage visible on the ceiling, walls and internal columns. Most of the internal columns showed very intense damage to the concrete cover of the bars, its falling off and dampness. Traces of freezing and dampness on the outer walls were visible in the floor zone. The floor in the underground level had extensive cracks and chipping (Photo 6).

Photo 6: Grain Elevator building - level -1: a) mechanical damage to structural elements, floor zone: c) concrete cover falls off the column heads at the level of the foundation slab, d) moisture in the outer wall
