# Bunker demolition located in a conservation protection zone in the light of technical, national defense, functional-utility and economic conditions

Maciej NIEDOSTATKIEWICZ<sup>\*1</sup>, Tomasz MAJEWSKI<sup>2</sup>

<sup>1</sup> Department of Engineering Structures, Faculty of Civil and Environmental Engineering, Gdańsk University of Technology, Gdańsk, Poland

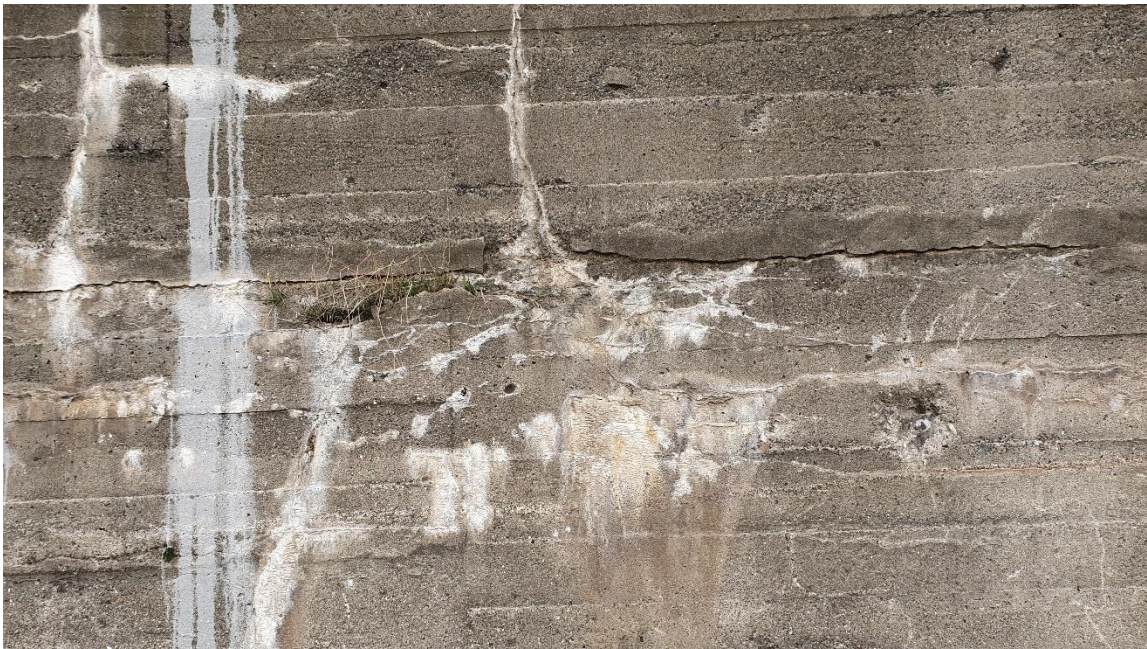
A single-storey annex adjoined the external gable wall on the left (Photo 1b). The condition of the left gable wall was similar to the condition of the front wall in terms of the extent of damage - there were numerous places (cracks and cracks) from which calcium carbonates were leached, especially intensive in the upper part of the wall (Photo 2).

Photo 2: Examples of calcium carbonate leaks on the south-west elevation (external gable (transverse) wall from the land side (left)) of the Bunker building

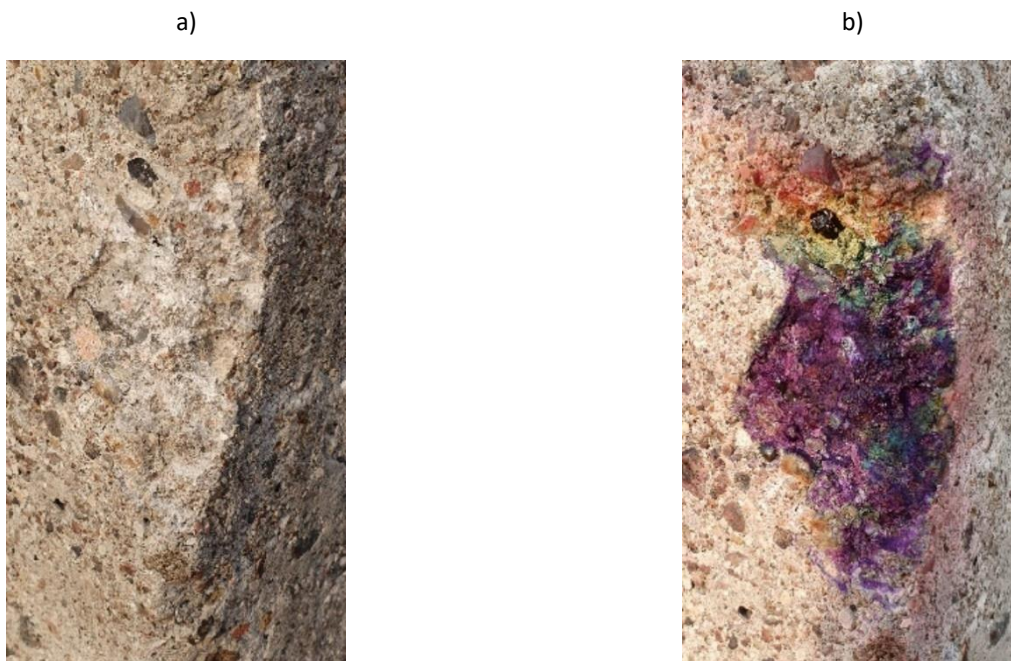
On the walls of Bunker, based on chemical tests, high carbonation of concrete, i.e. low pH value ( $\sim 10$  pH) was found (Photo 4). This means that the concrete cover has lost its natural ability to protect the reinforcement against corrosion, which results in the acceleration of the destruction of the concrete structure on the one hand, and on the other hand, it means that the process of corrosion of the reinforcement bars is active and progressing, which was confirmed by brown-rust tarnish on the concrete surface. Photo 5 shows the study of the degree of concrete carbonation on the external wall in the place of a wet crack.

Photo 4: Discoloration of concrete after the Rainbow Test in the place of forging the concrete cover to a depth of 2 cm in the corner of the left annex - view of the test site: a) before, b) after the test: purple-green coloration indicates advanced carbonation of the concrete cover and its reduced capacity to protect the armament
