Aleksander Piwek*

Chapel at St. Joseph's Church in Gdańsk

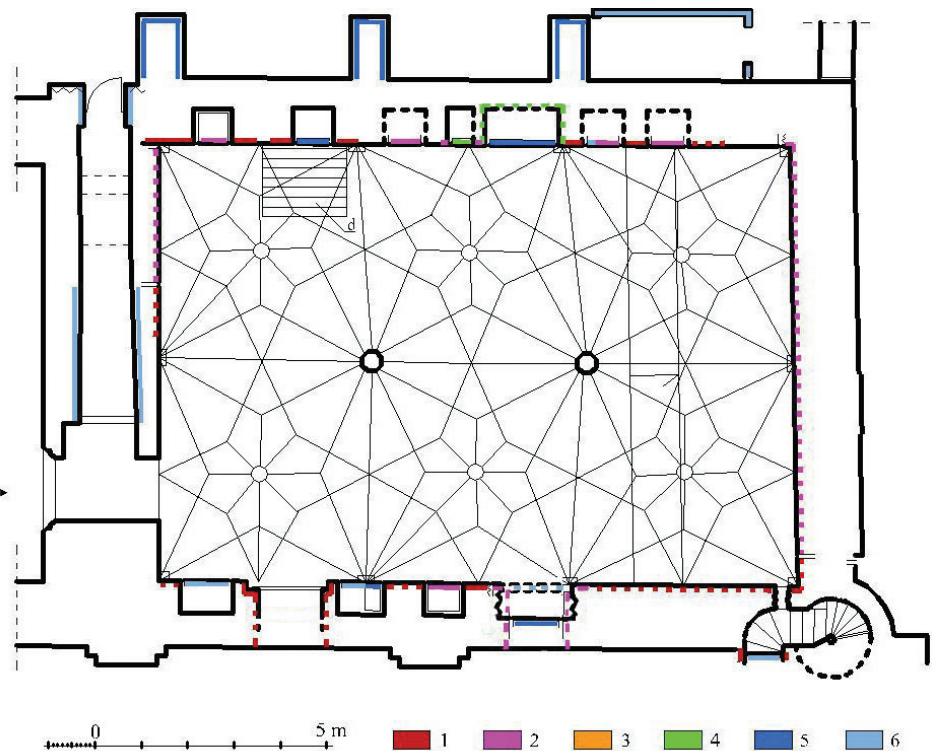
Fig. 2. Stratification of the walls of the chapel at St. Joseph's Church in Gdańsk on the ground floor (below the windows) and in the basement.

The letter "d" indicates the extent of the wooden trapdoor, different from the stone floor of the chapel.

Markings: 1 – late 15th century,
2 – 17th century,
3 – 18th century,
4 – after 1840, 5 – 1901–1920,
6 – 1945–2019
(elaborated by A. Piwek)

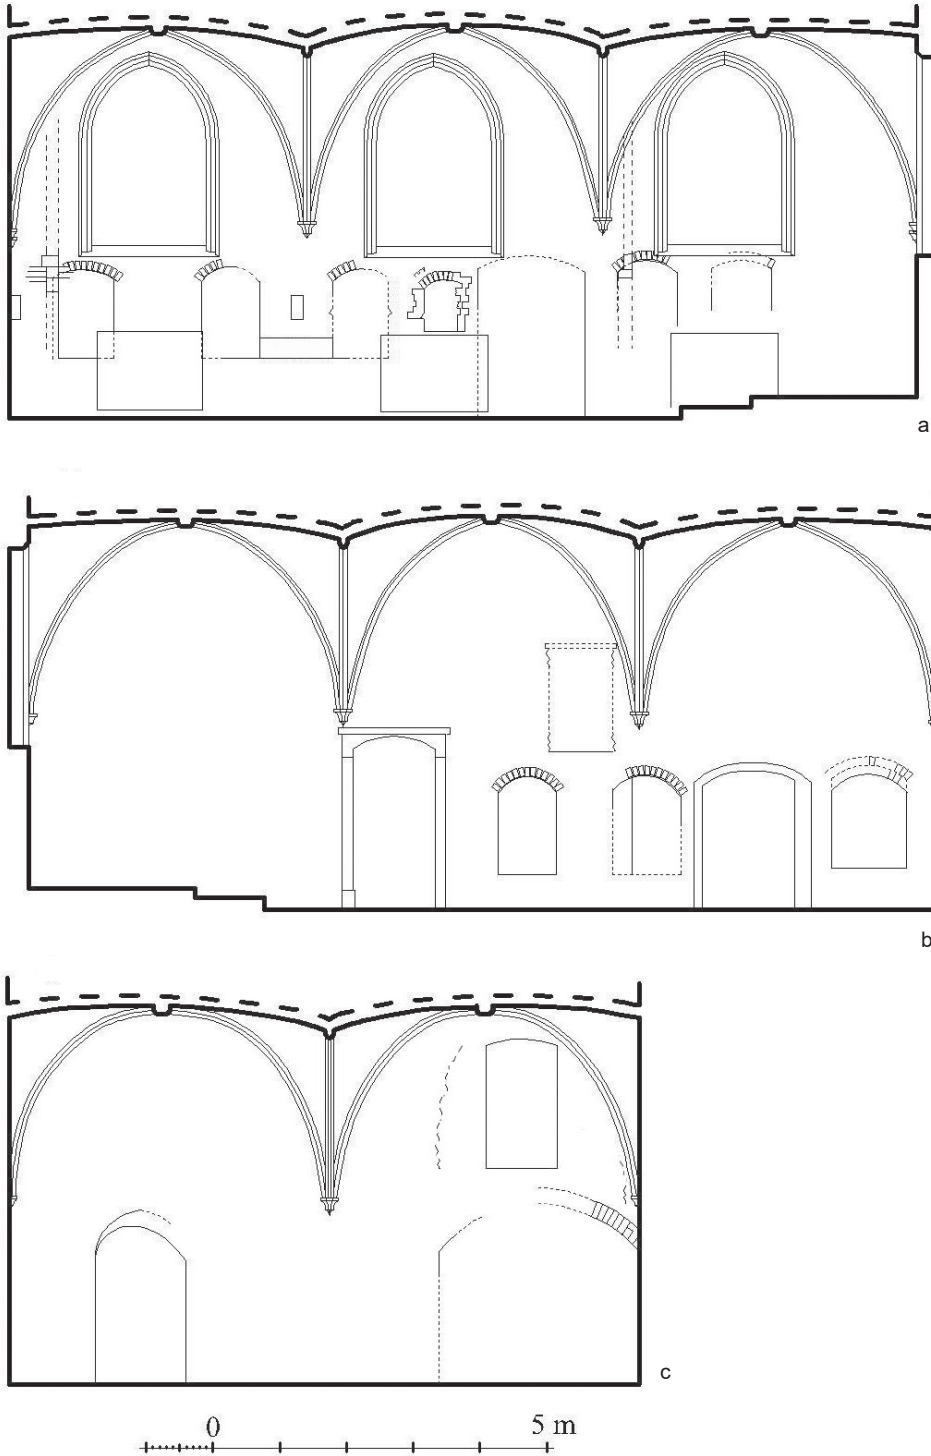
Fig. 3. View of the surface of the internal walls of the chapel at St. Joseph's Church in Gdańsk with marked traces of reconstructions: a) northern, b) southern, c) western (elaborated by A. Piwek)

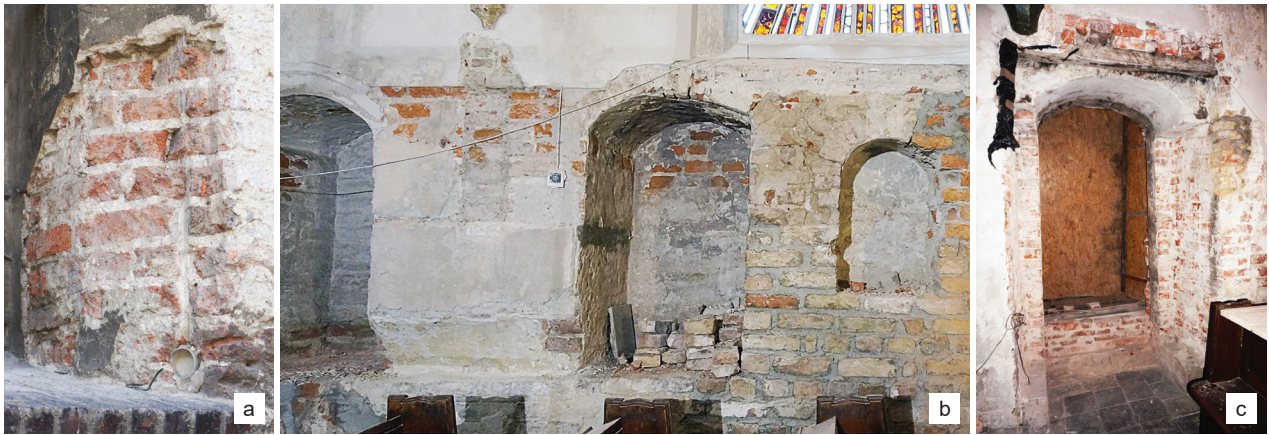
Fig. 4. Discoveries in the northern wall of the chapel at St. Joseph's Church in Gdańsk:

- a) a fragment of the first window from the west, b) three recesses; between two of them (on the left) there is a quarter circular indentation in the wall, c) a recess in the south wall, in the 2nd half of the 17th century, which was a passage to the chancel (photo by A. Piwek)

Further traces on the wall are spatially related to the interior of the chapel. These include the quarter circular niche found (Fig. 4b) between the bricked up recesses of the second and third (from the west wall). It runs horizontally through their bases and is 30 cm high. It penetrates into the wall from 9.5 cm (on the eastern side) to 14.5 cm (on the western side). As it is close to the trapdoor covering the exit to the underground, it is most likely associated with it. Further traces include two rectangular niches filled with bricks probably dating from the 1st quarter of the 17th century. They are 20 cm wide, 59 cm high, and start at 885 cm and 1,340 cm from the present eastern wall at a height of 146 cm above the floor. They were created in the Middle Ages and are only associated with the north wall³. The last traces include two vertical strips 20 cm wide of machine-made bricks, narrowing the second and seventh recesses to the west. These covered the vertical channels forged in the wall (to a depth of about 20 cm). Soot marks were found on their surfaces. They are therefore associated with the addition of furnaces to the wall in the early 20th century.

On its surface, three pairs of vertical grouts were found, connected by segmental arches (Fig. 4c). In terms of shape, they were similar to those recesses in the north wall, which were classified as type one. There were not very large differences between them in terms of dimensions: spacing, base height (167–176 cm), cap height (here 167–176 cm) and depth (70 cm). One reason for this state of affairs may be the priority of the commencement of the construction (perhaps the completion) of the large chapel (the present chancel) in the Middle Ages. The masonry of the recesses varied. The first to the east contained uniform brick material throughout its depth, probably dating from the 17th century. The interior of the second to the east, along a length of 29 cm, had an early 20th century solid brick infill. It was created to vent smoke through a vertical channel (40 × 90 cm) forged in the wall. The bricks obscuring its section from above contained traces of soot. The third recess, near the west wall, was walled up with a thin wall of machine-made bricks after 1945.

The last trace on the south wall is near the third vault bracket from the east (Fig. 4b). Vertical ripped grouts were found at 797 and 893 cm from the east wall. They started at a height of 236 cm from the floor. From above, they ended with a horizontally placed beam 8 cm high. Traces of its setting were found 390 cm from the floor. The re-building thus delineated contained 6.5–7 cm bricks on mortar containing clay. It was associated with the entrance to the level of the pulpit set on the chancel side. The stairs leading up to it had to be adjacent to the wall in order to cause as little disturbance as possible to the faithful gathered inside the chapel. The opening must have been forged before 1678, when the associated pulpit was destroyed.

At a distance of 200 cm from the floor, the base of a segmental arch was exposed, which “blended” into the north wall (Fig. 4c). Based on its curvature (the highest point was 150 cm from the north wall), it appears that the arch was 300 cm long. Below it, the wall contains bricks measuring: 29.5–29.9 × 13.5–14–15.5 × 7–7.5–8–8.5, 10c = 89 cm. The arch should be associated with a medieval recess. It is highly likely that its background had a passage. The bricked up recesses are associated with the removal of the medieval matroneum, which presumably took place in the 1st quarter of the 17th century. Above the described arch, two vertical grouts were found. They were found at 123 and 244 cm from the north wall⁵. They started at 325 cm from the floor level and ended at 508 cm to connect with the segmental arch. Within the area thus delineated were machine-made bricks measuring 25 × 12.2–12.2 × 6.7–6.8 cm, 10c = 81 cm. These form the masonry of the Gothic entrance made in the 20th century. Further analysis revealed that from this entrance (floor level), it was possible to access the now collapsed, one-flight stairs (Fig. 5). These were adjacent to the west wall. They were covered by a brick arch with a hacked-off corner, descending towards the south. An examination of the passage in the west wall to the adjoining room revealed a fragment of the Gothic arch on the north side. It therefore belonged to the original layout of the chapel. Its present irregular coping is the result of 17th–18th century alterations.

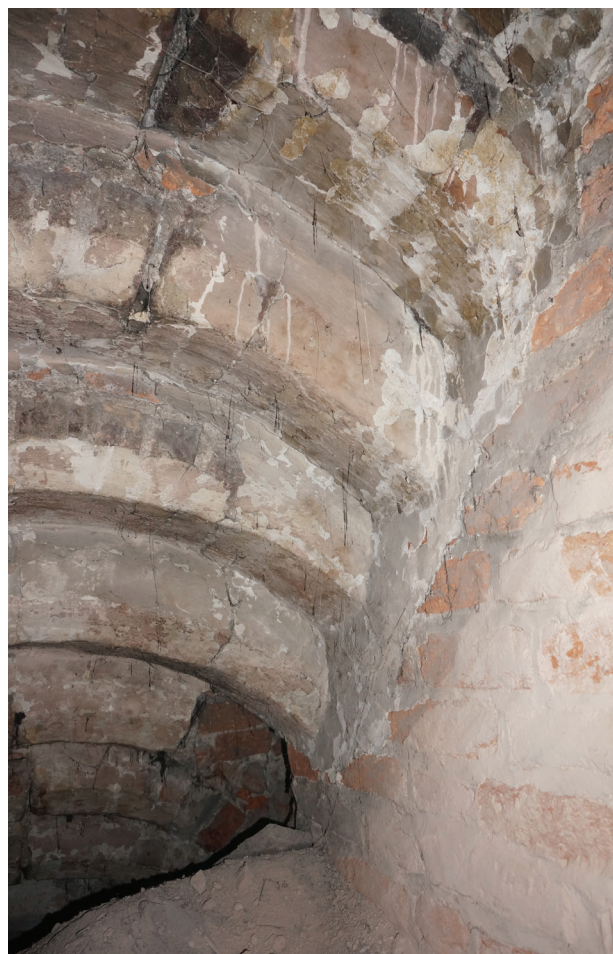
Fig. 5. A section of a partially buried descent from the level of the former matroneum to the ground floor of the chapel at St. Joseph's Church in Gdańsk (photo by A. Piwek)

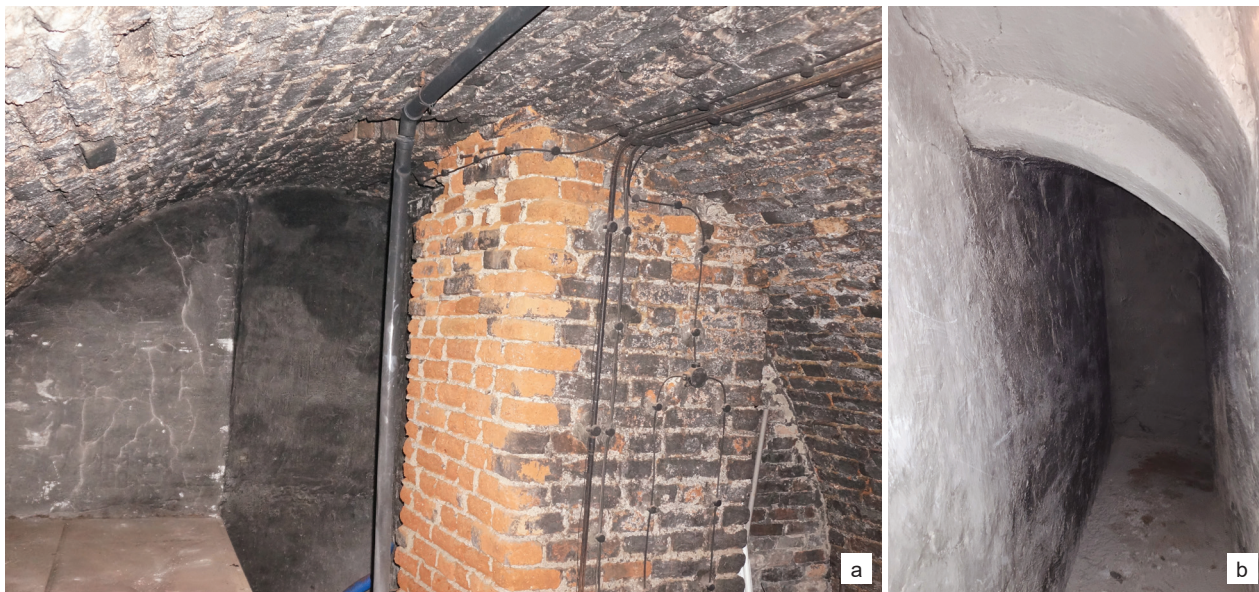
Fig. 6. Underground parts connected with the chapel at St. Joseph's Church in Gdańsk:
 a) a view of the interior of the crypt under the eastern part of the chapel towards the south,
 b) a fragment of the present corridor connecting the former crypt with the chancel (photo by A. Piwek)

of the brick covering were half covered by a bricked-up wall narrowing the passageway to 48–60 cm (Fig. 6b). It was probably made in the 20th century.

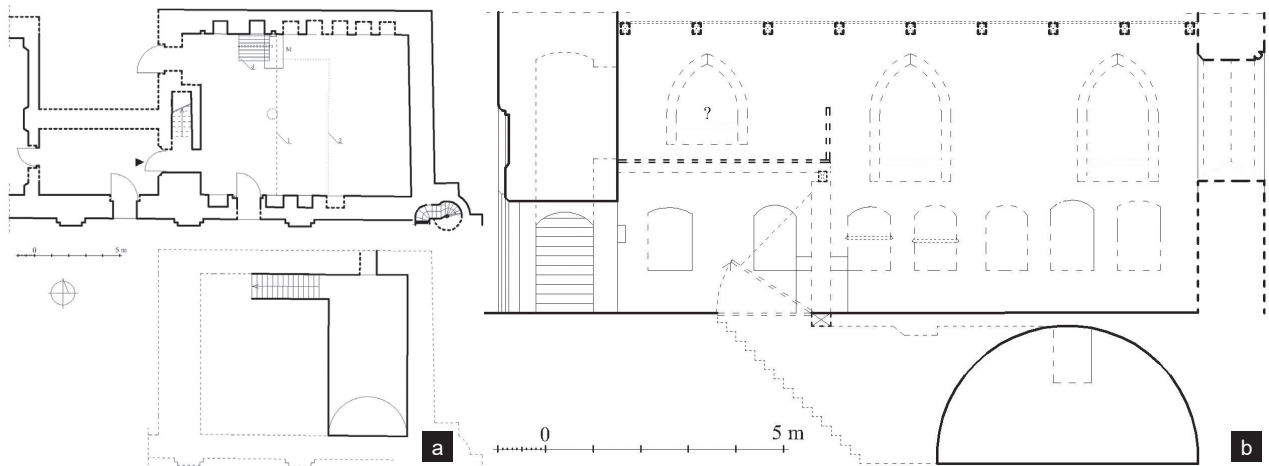
Fig. 7. Reconstruction of the chapel at St. Joseph's Church in Gdańsk and the crypt located under its eastern part from phase 1 (late 15th century):
a) plan, b) longitudinal section with view on the north wall,

1 – presumed range of the Gothic matroneum, 2 – the range of the crypt and the descent to its interior,
M – hypothetical location of the mechanism enabling the opening of the trapdoor covering the descent to the crypt, d – trapdoor
(elaborated by A. Piwek)

used as a library and storage for precious devotional objects. The north wall contained seven recesses along its entire length (Fig. 7b). The opposite wall of the small chapel probably had four recesses (the first one on the east side is presumed), but, as analysis [4, p. 5] has shown they could only have started at a length of about 3.5 m from the then east wall. The west wall was devoid of similar recesses. Instead, it contained one-flight stairs enclosed by a vaulted brick flight of segmental arches with chamfering. They led to the matroneum in the sacred interior¹². The matroneum was supported by a single pillar, the axes of which were about 4.5 m from the longitudinal walls and about 4.2 m from the west wall. Below the matroneum, in the northern part of this wall, there was a 3 m long recess surmounted by a segmental arch. The aforementioned passage to the utility courtyard was probably inside it.

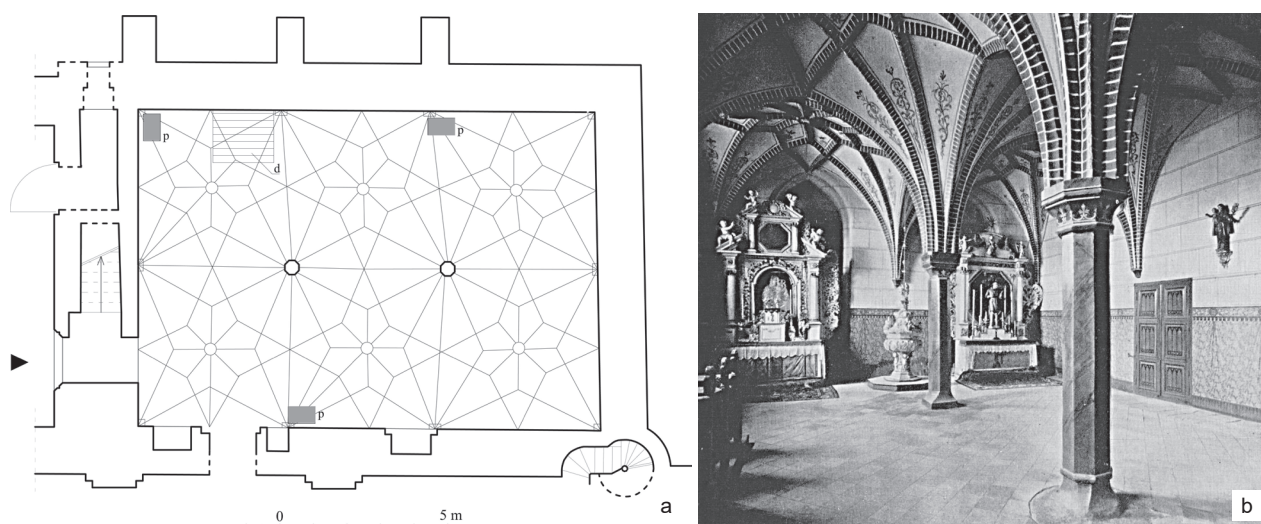
Fig. 8. The chapel at St. Joseph's Church in Gdańsk in the early 20th century:
 a) reconstruction of the plan from 1904 (p – location of furnaces) (elaborated by A. Piwek),
 b) view of the interior towards the south-east, circa 1920 (source: [14, p. 127])

deepened by 1 metre. The lowered level of the floor there made it necessary to add new steps to the old ones (leading to the ground floor level), maintaining the previous direction. On the pillars of the chapel, six vaulted areas were created, each with an extended star-shaped plan. It was probably at this time that cracks appeared in the west wall, below the north-west vault. Some of these were re-built to stabilise them. The cupboard recess in the north wall was removed. The south aisle was converted into a two-door cupboard, after a slight demoulding of the side walls and partial bricking up. The old entrance at the west wall was activated. Probably at that time, the windows were widened and glyphs were created by hacking off sections of the wall. The north wall of the chapel was reinforced (if not in 1916) with three buttresses. In 1904, furnace heating was established in the interior [13] (Fig. 8a).
