# Renovation works in buildings in the area of former defensive fortifications

Maciej NIEDOSTATKIEWICZ<sup>\*1</sup>, Tomasz MAJEWSKI<sup>2</sup>, Adam BARYŁKA

<sup>1</sup> Department of Engineering Structures, Faculty of Civil and Environmental Engineering, Gdańsk University of Technology, Gdańsk, Poland

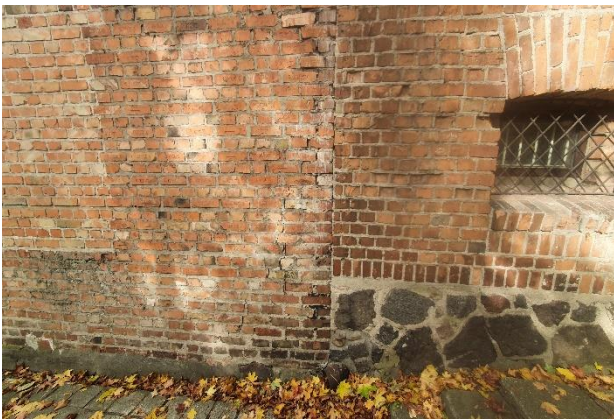
**Photo. 2:** No masonry bond at the junction of the former office spaces (A) with the former staff apartment (B), part of which are the rooms of the Southern Guardhouse

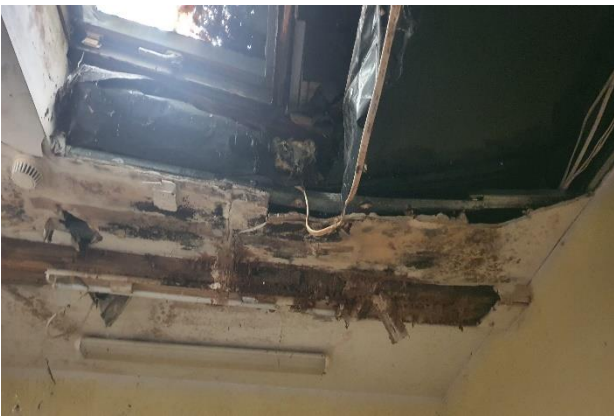
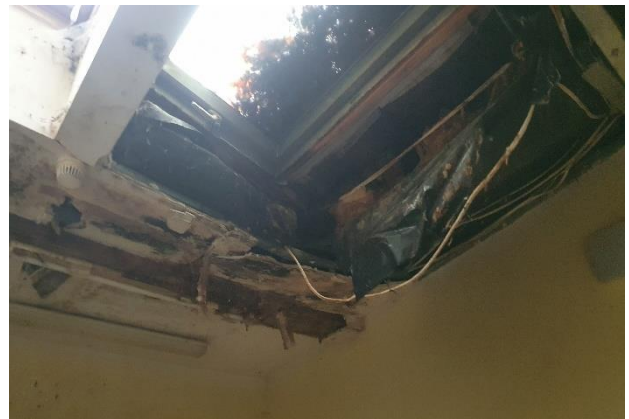
In the summer, in the room of the former office premises (A) adjacent to the defensive embankment, a random event occurred involving the collapse of a fragment of the roof structure (Photo 5). The roof, made as a ceiling on wooden beams with mineral wool insulation, has collapsed. Damage to the roof caused the ingress of rainwater into the interior of the rooms, contributing to the dampness of the walls and floor.

During the inspection, a local collapse of the flat roof structure (roof collapse) was found, made as a ceiling on wooden beams with mineral wool insulation. The direct cause of the damage to the roof structure was the breaking of the beams caused by biological corrosion of the wood, its rotting, probably the result of long-term dampness of the wood and the fungus and mold. It is worth noting that the roof damage occurred in the place where snow bags formed in winter, i.e. the wet wooden beams, weakened by biological corrosion, were subjected to an increased load from the weight of the snow. With the passage of time and the progress of corrosion, the wooden beams weakened so much that during the next winter, after snowfall, their bearing capacity was exhausted and the roof collapsed.

A visual assessment of the wood in the area of the damaged flat roof, in the zone of rooms adjacent to the top of the defensive rampart, clearly allowed to classify the wood as wet.

It was also very important that the roof surface had undulations, i.e. on fragments of the slope there were depressions in which the roofing could be felt. This is a characteristic symptom for wooden roof trusses with wooden elements damaged by biological corrosion. Depressions (sinks) were particularly perceptible in the zones in front of the skylights, where there were no fenders (baskets), i.e. in places where there were water pools. In the case of leaks in the roofing felt, these places are particularly exposed to moisture, and the depressions of the pavement indicated that such damage occurred in these places.

**Photo. 5:** Zapadnięty dach w części nad dawnymi pomieszczeniami biurowymi (A) Collapsed roof in part above former office spaces (A)

- perform temporary protection of the damaged flat roof as a matter of urgency:
  - ❖ in the space of the collapsed ceiling, place wooden square timber vertically, which will ultimately serve as a supporting structure for the roof over the damaged fragment of the roof,

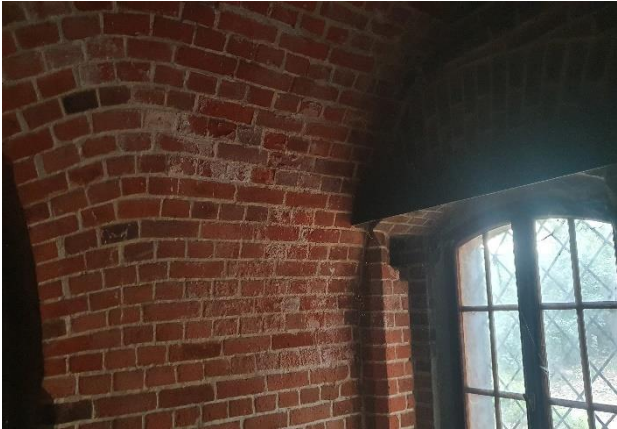
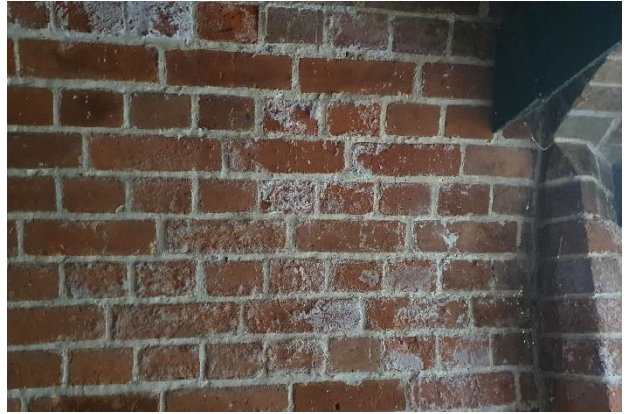
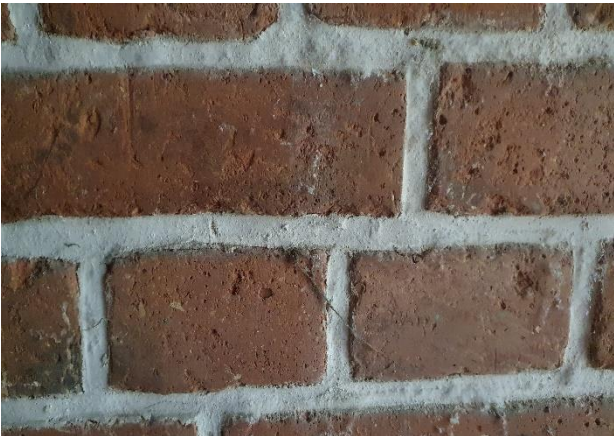
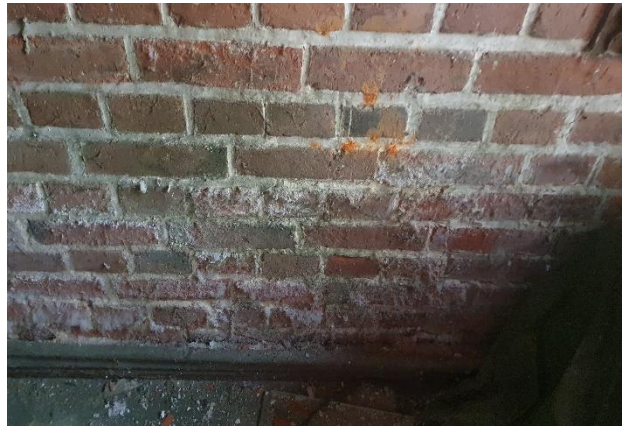
In the rooms of the former service apartment (B), local traces of dampness were visible, both in the floor area and at the height of the wall. In the historical part of the South Guardhouse, cracks and scratches in the plaster on the fillings under the brick arches were visible. Salination was visible on the surface of the walls inside the rooms of the Southern Guardhouse (Photo 6a and 6b), particularly intense on the surface of bricks, on fragments of walls that were subjected to renovation works in the past period. The porous lime-sand mortar was replaced with a sealed cement or cement-lime mortar (Photo 6c and Photo 6d).

In the rooms of the Southern Guardhouse, on the walls, especially in the floor zone, salt efflorescence and brick discoloration were visible on the surface of the brick wall - this situation was caused by the capillary rise of moisture resulting from the lack or technically inefficient anti-moisture insulation of the vertical and horizontal parts of the walls sunk in the ground. Similar faults and damages also occurred locally on keystones and runoffs of brick vaults and were a consequence of moisture seepage from the roof side as a result of local leaks in the roofing as well as due to the lack of proper thermal insulation of the roof over part (B) of the Building Complex. .

Extensive discoloration occurred on the old fragments of the wall made of old bricks (historical fragments of the wall), the joints of which had previously been cleaned and filled with modern mortar (as part of renovation works carried out in recent years) and on the wall made of new brick laid on modern mortar. It should be noted here that the number of redevelopments with modern bricks along with filling with modern mortar was negligible.

Increased humidity and the presence of salt in the air were manifested by bright efflorescence, discoloration and salt crystallization on the surface of the wall. According to the authors, such a mechanism of brick wall destruction also occurs in the rooms of the Southern Guardhouse.

**Photo. 6:** Salting the walls inside the rooms of the former service apartment (B)

- ❖ reconstruction of the anti-moisture insulation of the vertical and horizontal parts of the walls sunk into the ground,
  - ❖ revitalization of the flat roof by insulating it and adapting it to the current requirements in the field of thermal protection,

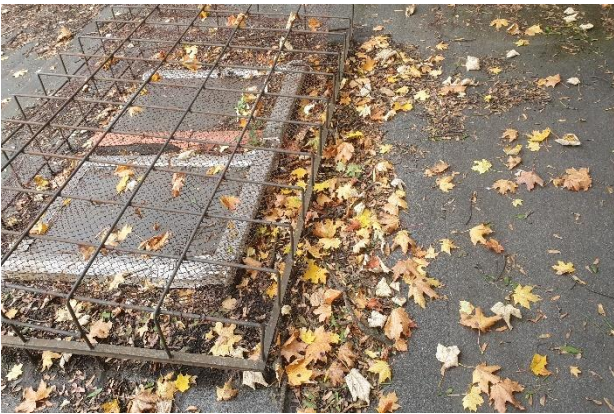
The damaged roof in the area of the former office spaces (A) (Photo 7) had additional lighting in the form of roof skylights (Photo 8). In front of the skylights, there were no fenders (so-called kozubków), as a consequence of which pools of water formed at the windows, the lack of baskets hindered the flow of rainwater.

Photo. 8: No bumpers (bumpers) in front of the windows next to the windows on the roof above the former office spaces (A)

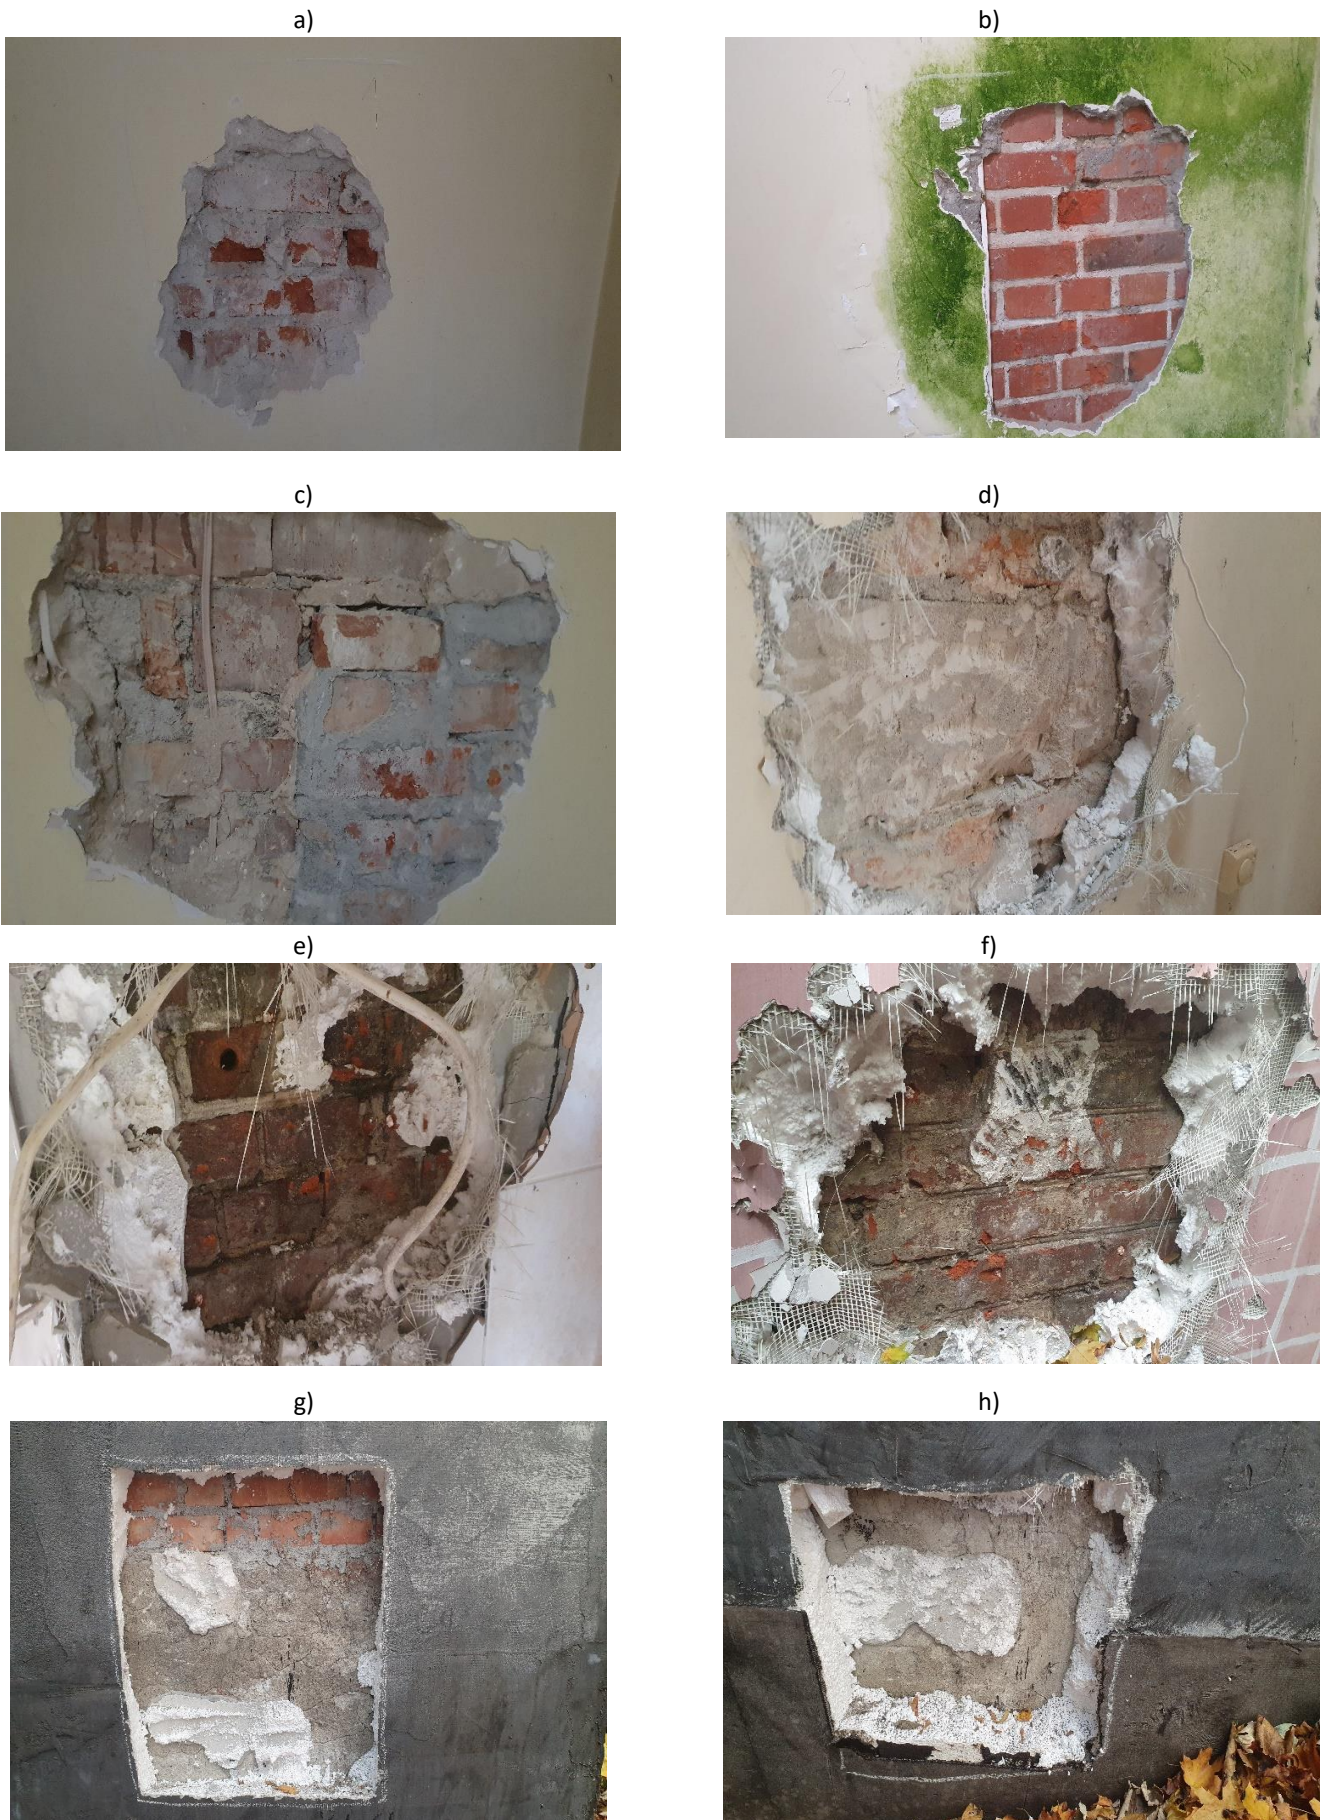
- inner outcrop (inside the building) O1: contemporary brick wall + cement-lime plaster from the inside (Photo 9a),
- inner outcrop (inside the building) O2: contemporary brick wall + cement-lime plaster from the inside (Photo 9b),

- inner outcrop (inside the building) O3: local redevelopment of a modern brick wall with a fragment of a modern wall built later (with high probability in the place of a bricked-up window opening) + cement-lime plaster from the inside (Photo 9c),

- inner outcrop (inside the building) O4: contemporary fragment - brick wall with redevelopment made of cellular concrete (aerated concrete) + 4 cm polystyrene insulation with a protective layer (elevation mesh) and gypsum plaster from the inside (Photo 9d),

- inner outcrop (inside the building) O5: probably an old (historical) brick wall + 4 cm polystyrene insulation with a protective layer (elevation mesh) and glazed tiles on the inside (Photo 9e),

- inner outcrop (inside the building) O6: probably an old (historical) brick wall + 4 cm polystyrene insulation with a protective layer (elevation mesh) and gypsum finish from the inside (Photo 9f),

contemporary brick wall + 10 cm polystyrene insulation with a protective layer (elevation mesh) (Photo 9g),

**Photo. 9:** View of the outer wall (from the escarpment side) of the former office rooms (A): a) O1, b) O2, c) O3, d) O4, e) O5, f) O6, g) O7, h) O8, i) O9, j) O10, k) O11

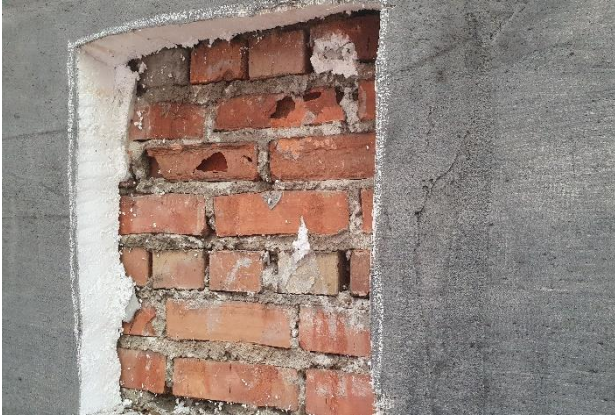
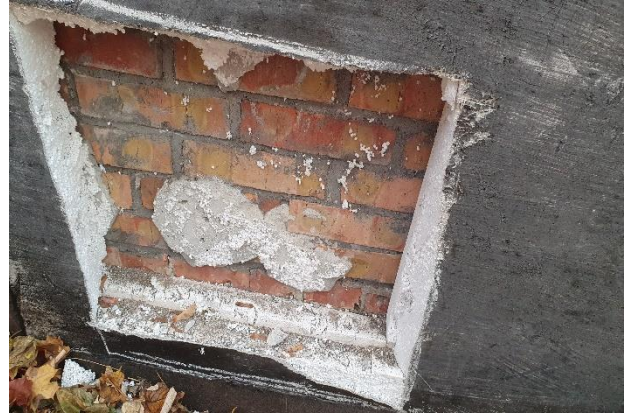
- external outcrop (outside the building) O8:  
contemporary brick wall with a protective layer of plaster + 10 cm polystyrene insulation with a protective layer (elevation mesh) (Photo 9h),
- outdoor outcrop (outside the building) O9:  
contemporary brick wall + 10 cm polystyrene insulation with a protective layer (elevation mesh) (Photo 9i),
- outdoor outcrop (outside the building) O10:  
contemporary brick wall + 10 cm polystyrene insulation with a protective layer (elevation mesh) (Photo 9j),
- outdoor outcrop (outside the building) O11:  
contemporary brick wall + 10 cm polystyrene insulation with a protective layer (elevation mesh) (Photo 9k).

**Photo. 9:** View of the outer wall (from the escarpment side) of the former office rooms (A): a) O1, b)O2, c) O3, d) O4, e) O5, f) O6, g) O7, h) O8, i) O9, j) O10, k) O11

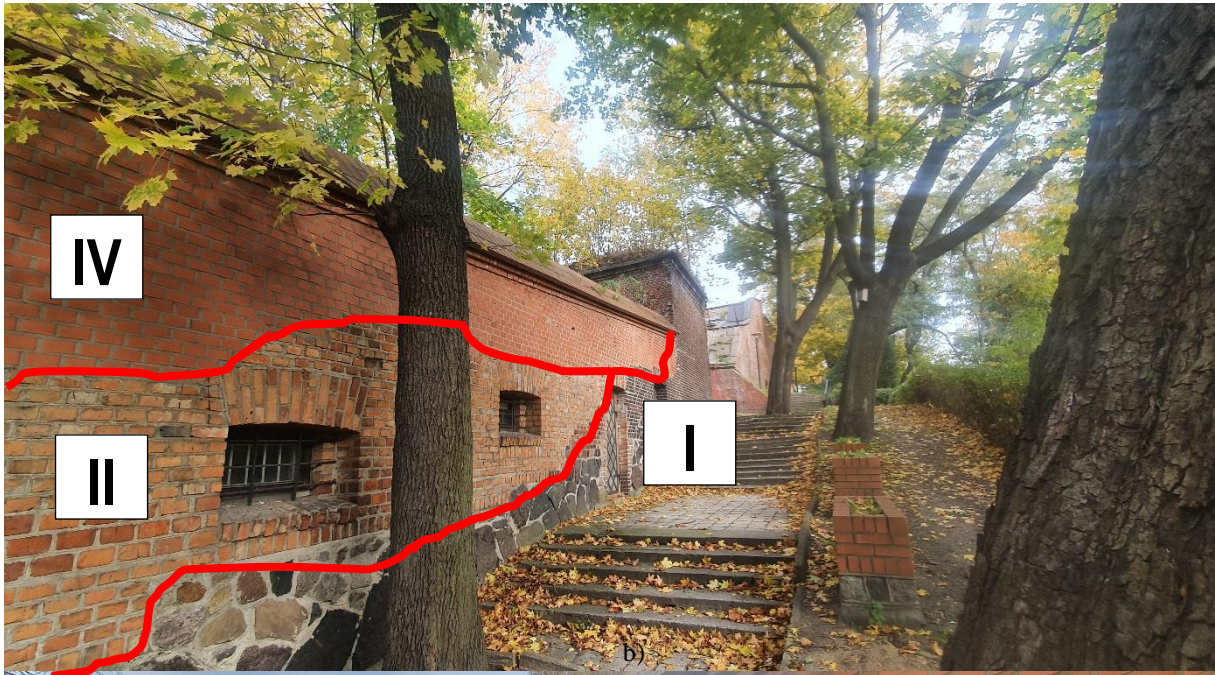
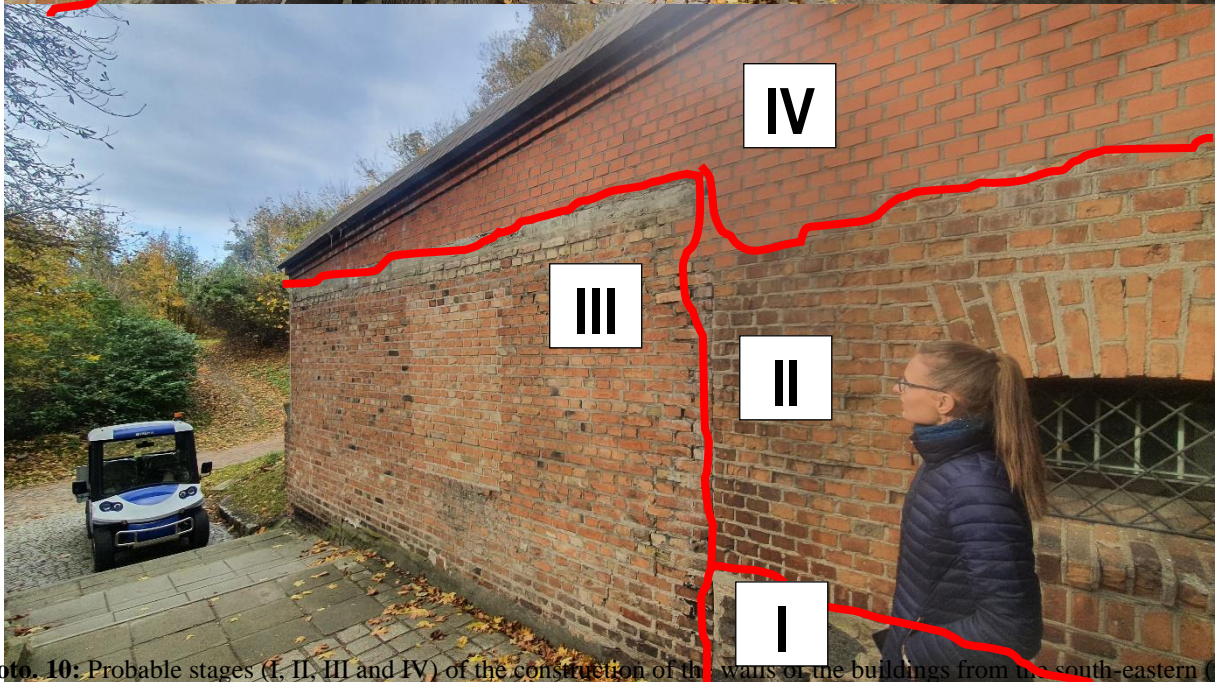
- stage I: in the second half of the 19th century, the construction of the defensive rampart was completed, fragmentary brick reinforcements of the escarpment were made and the Southern Guardhouse was built, which is now part of the former service apartment (B),
- stage II: probably at the turn of the 70's and 80's of the 20th century, a building was constructed which is currently referred to as former office space (A). It is highly probable that in the period between stage I and stage II, utility rooms (C) were added to the front wall of the South Guardhouse,

- stage III: a fragment of the area between the Southern Guardhouse and the former office premises (A) was developed, thanks to which a building was created that was later used as a former business apartment (B),
- stage IV: at the beginning of the 21st century, probably at the turn of 2000-2001, the former office premises were renovated (A)

**Photo. 10:** Probable stages (I, II, III and IV) of the construction of the walls of the buildings from the south-eastern (front) elevation (fragment) of the Complex of Buildings located at the South Guardhouse of Napoleńska Redita in Gdańsk:  
a) former office rooms (A), b) former apartment service (B) + former office space (A)
