Renovation works in buildings in the area of former defensive fortifications

Abstract

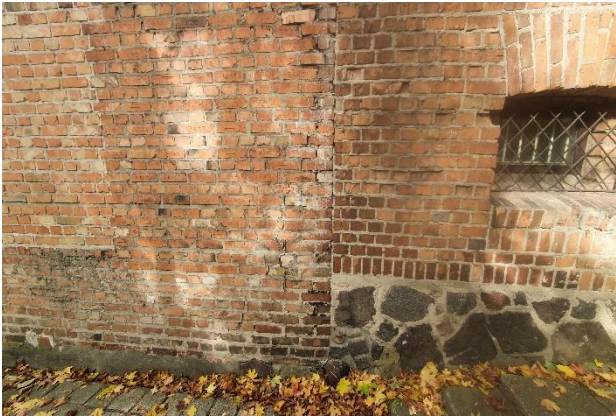
Photo. 2: No masonry bond at the junction of the former office spaces (A) with the former staff apartment (B), part of which are the rooms of the Southern Guardhouse

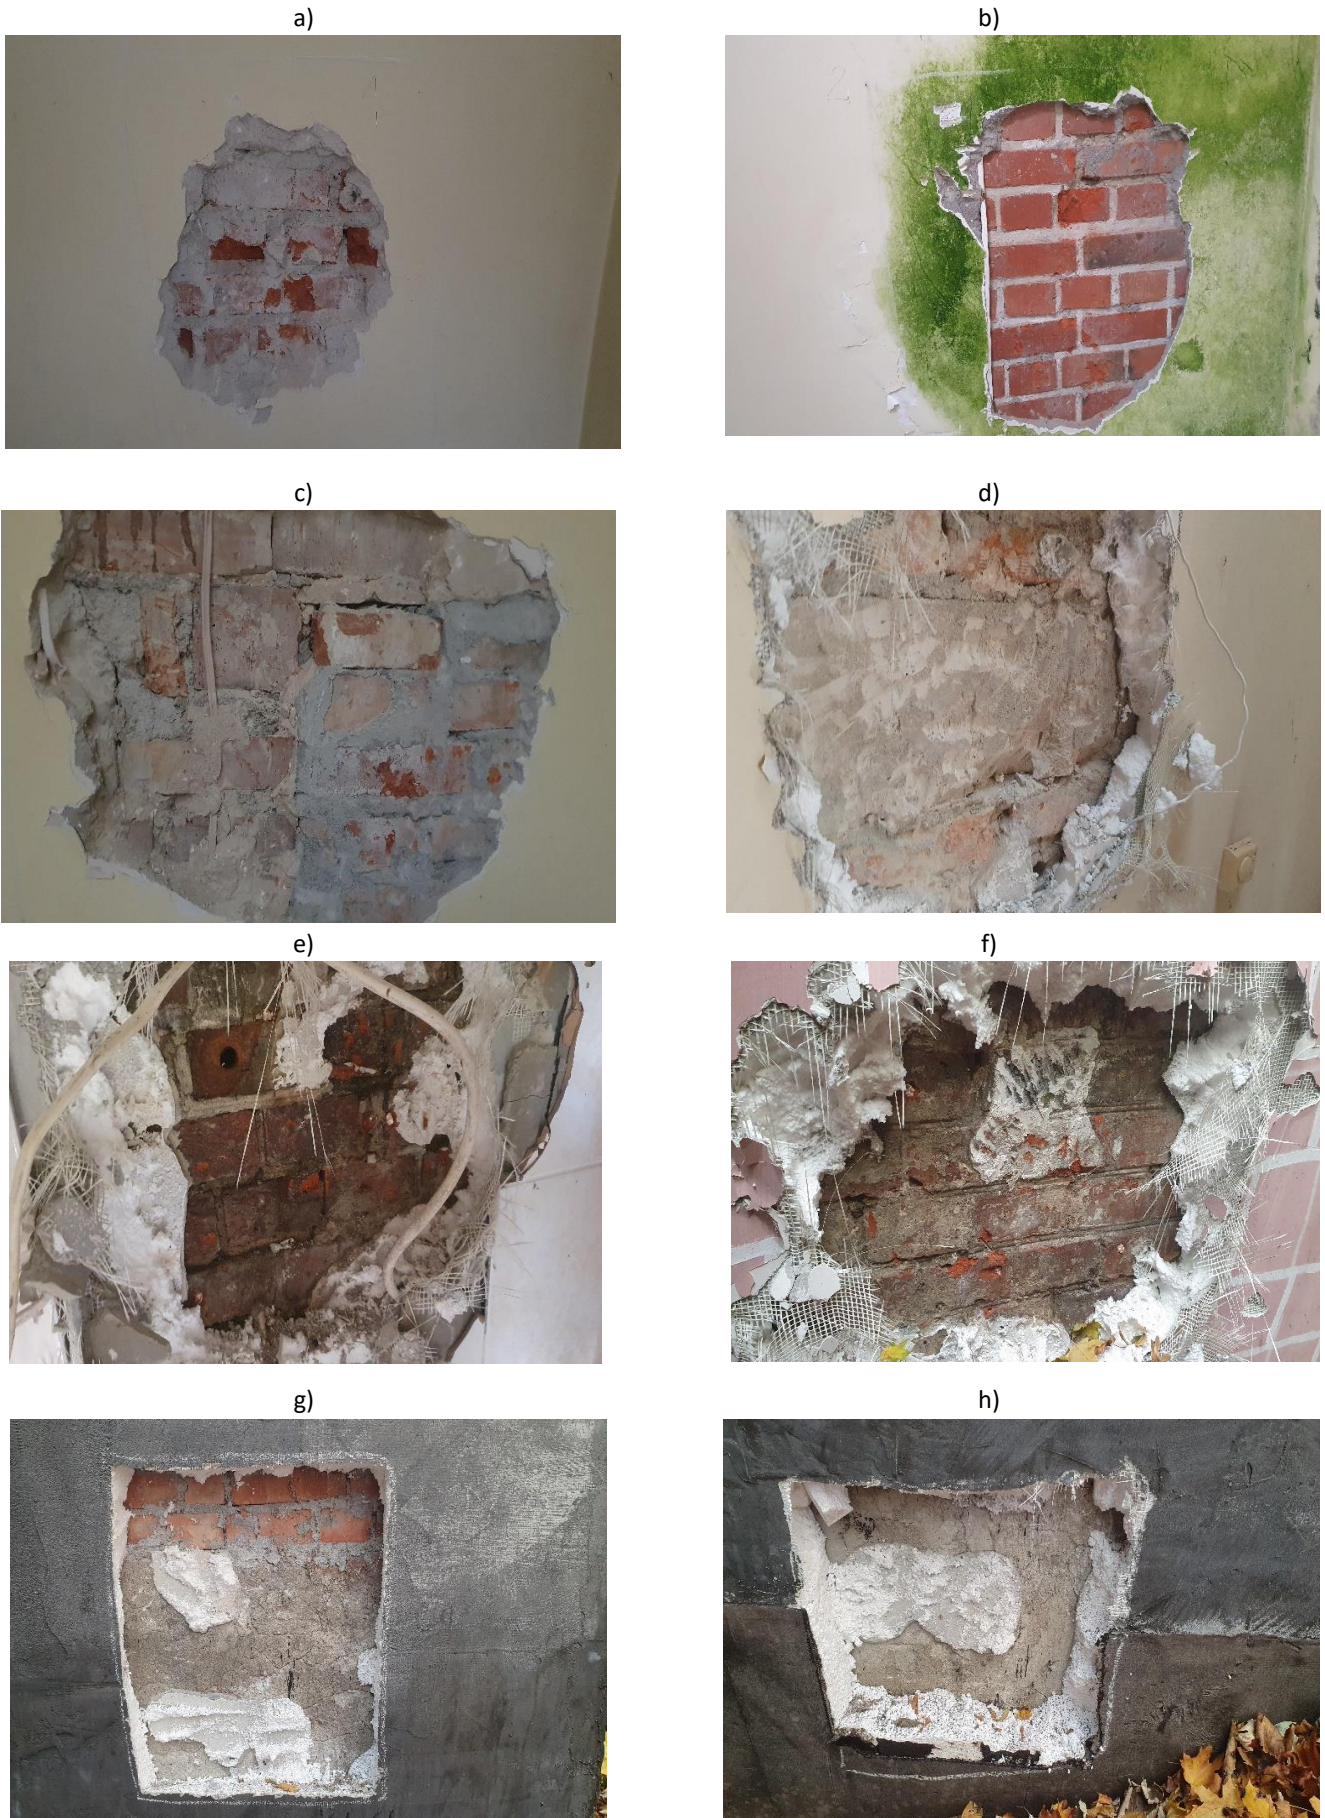
- inner outcrop (inside the building) O1: contemporary brick wall + cement-lime plaster from the inside (Photo 9a),
- inner outcrop (inside the building) O2: contemporary brick wall + cement-lime plaster from the inside (Photo 9b),

- inner outcrop (inside the building) O3: local redevelopment of a modern brick wall with a fragment of a modern wall built later (with high probability in the place of a bricked-up window opening) + cement-lime plaster from the inside (Photo 9c),

- inner outcrop (inside the building) O4: contemporary fragment - brick wall with redevelopment made of cellular concrete (aerated concrete) + 4 cm polystyrene insulation with a protective layer (elevation mesh) and gypsum plaster from the inside (Photo 9d),

- inner outcrop (inside the building) O5: probably an old (historical) brick wall + 4 cm polystyrene insulation with a protective layer (elevation mesh) and glazed tiles on the inside (Photo 9e),

- inner outcrop (inside the building) O6: probably an old (historical) brick wall + 4 cm polystyrene insulation with a protective layer (elevation mesh) and gypsum finish from the inside (Photo 9f),

contemporary brick wall + 10 cm polystyrene insulation with a protective layer (elevation mesh) (Photo 9g),

- external outcrop (outside the building) O8:
contemporary brick wall with a protective layer of plaster + 10 cm polystyrene insulation with a protective layer (elevation mesh) (Photo 9h),
- outdoor outcrop (outside the building) O9:
contemporary brick wall + 10 cm polystyrene insulation with a protective layer (elevation mesh) (Photo 9i),
- outdoor outcrop (outside the building) O10:
contemporary brick wall + 10 cm polystyrene insulation with a protective layer (elevation mesh) (Photo 9j),
- outdoor outcrop (outside the building) O11:
contemporary brick wall + 10 cm polystyrene insulation with a protective layer (elevation mesh) (Photo 9k).

The excavations made in the back wall showed that the wall with faults is a secondary wall and was reconstructed using contemporary bricks. The excavations made from the inside and the outside confirmed mostly the same type of brick built in the checked places, only in the case of excavation no. from the outside) fragments of the wall with contemporary brick bonding are visible. However, it cannot be ruled out that in the past period, local redevelopments were made from the outside using contemporary bricks, it is also possible that the modern redevelopment is visible from the outside, because the places of open pits No. 5 (inside the structure) and No. 11 (outside the structure) are slightly shifted from each other, and in the place of open pit No. 11, it was made as a contemporary brick throughout the entire thickness of the wall.

Photo. 9: View of the outer wall (from the escarpment side) of the former office rooms (A): a) O1, b) O2, c) O3, d) O4, e) O5, f) O6, g) O7, h) O8, i) O9, j) O10, k) O11
