# Settlement of a historic building due to seepage-induced soil deformation

### 3. Soil seepage-induced deformations within the area of the St. Nicholas basilica in Gdańsk – case study

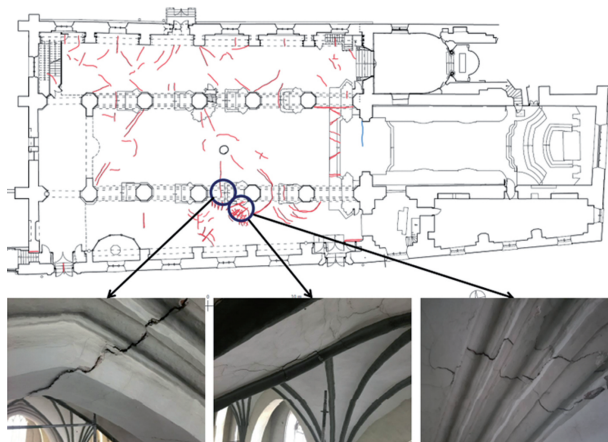
Disturbing damage to the vault over the southern aisle was observed in autumn of 2018, at the end of October. Intense (in terms of number and opening width) scratches of the squinches and deformations (buckling relative to the vault plane) of the ribs were identified during a thorough inspection.

Vault ribs were cracked with a displacement and detached from the squinch surface, and the opening width reached 6–8 mm. Arch wall crack (crevice with a mutual edge shift) between the second and third pillar of the southern aisle, with a maximum opening width of 28 mm was identified. Fig. 3 shows damage concentration in the southern aisle pillar area and the cracks of wall elements.

Fig. 3. Simplified stock-taking of Basilica southern aisle damage [43]

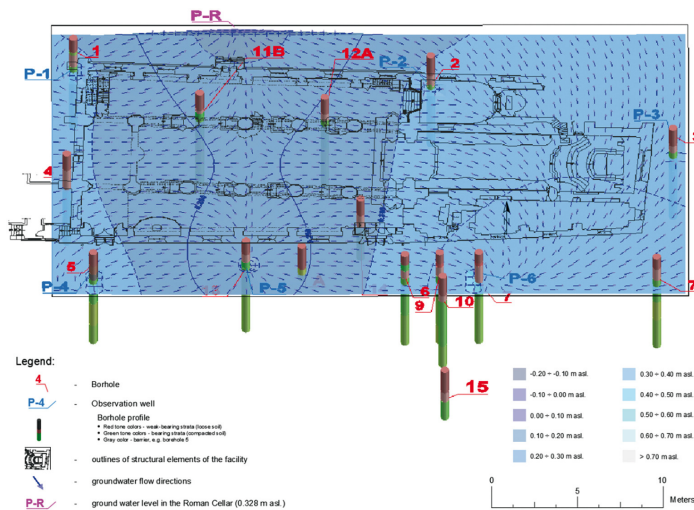
Fig. 5. Groundwater table level map with marked soil profiles at the borehole and piezometer location, with seepage directions for 31/7/2019, against the background of the Basilica basement level plan

31/7/2019, against the background of the Basilica basement level plan, with marked soil profiles in test boreholes and piezometers. Fig. 5 also shows water seepage directions resulting from piezometer groundwater levels. The analysis covered changing water levels on individual piezometers, as well as varying water seepage directions and seepage gradient values. Gradient values were analysed both along the entire length between the piezometers and locally, e.g., in the area of the pillars that experienced the greatest settlement.

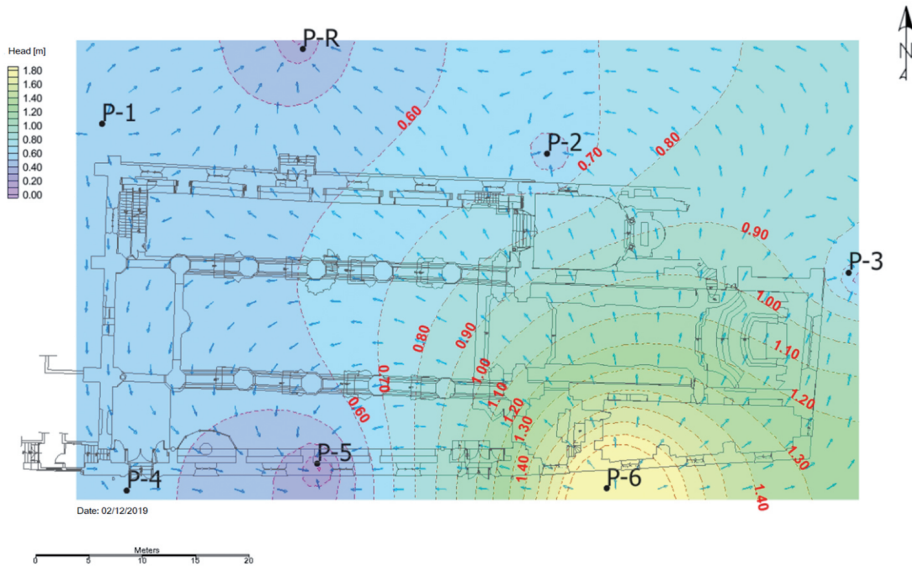
Fig. 6. Groundwater table level map with seepage directions for 2/12/2019, against the background of the Basilica basement level plan

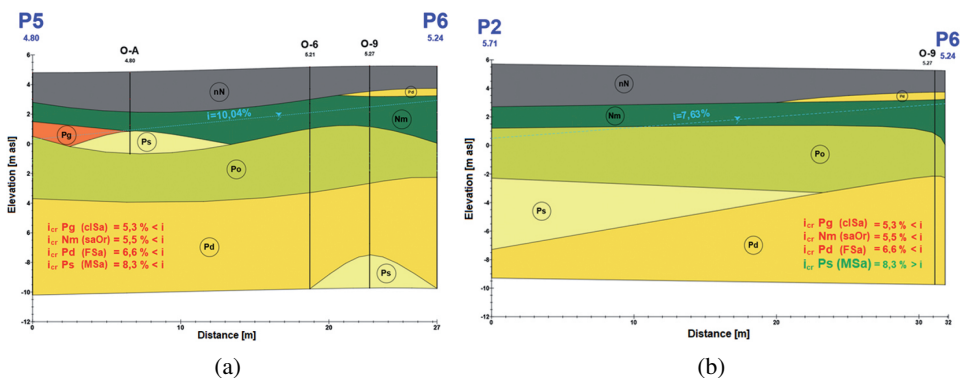
Fig. 7a shows the P5-P6 longitudinal profile and the position of the groundwater table curve position on 2/12/2019, and Fig. 7b shows the P2-P6 longitudinal profile and the position of the groundwater table curve position on 2/12/2019. Fig. 8 shows the P5-P2 longitudinal profile and the position of the groundwater table mean curve position and the local mean curve on 12/7/2019, as well as a diagram of pillar foundation level. Fig. 7–8 also show determined mean gradients between piezometers, relative to the critical gradients for

Fig. 7. Averaged groundwater table position within the Basilica area for 2/12/2019:  
 a) P5-P6 longitudinal profile, b) P2-P6 longitudinal profile

given soil types. Red colour marks the soils with exceeded critical gradient values (Bligh criterion) [37].

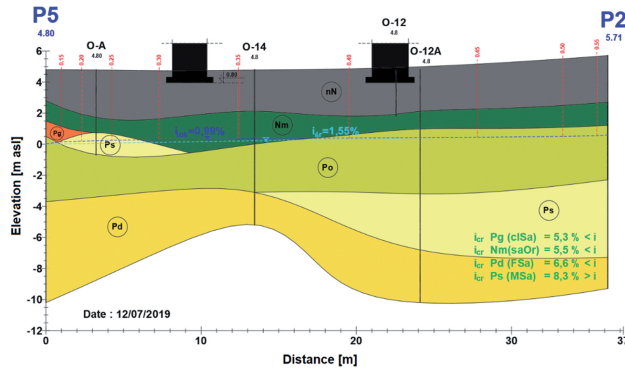
Fig. 8. Averaged groundwater table position and local table change within the Basilica foundation area for 12/7/2019 – P5-P2 longitudinal profile

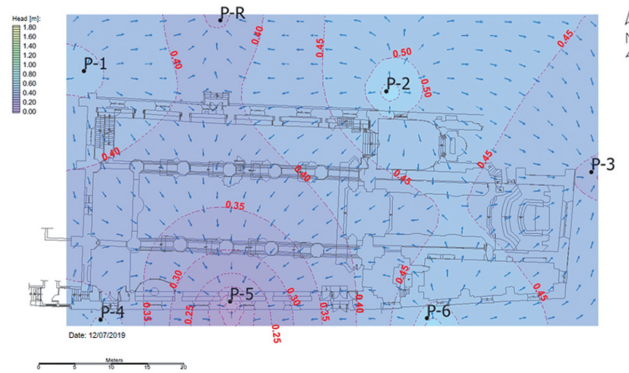
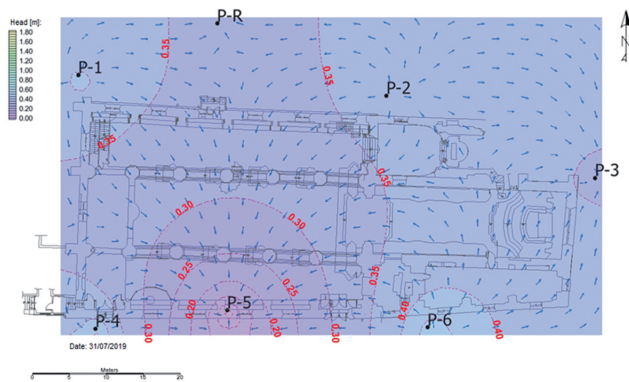
Fig. 9. Groundwater table level map with seepage directions for a) 12/7/2019 and b) 31/7/2019, against the background of the Basilica basement level plan

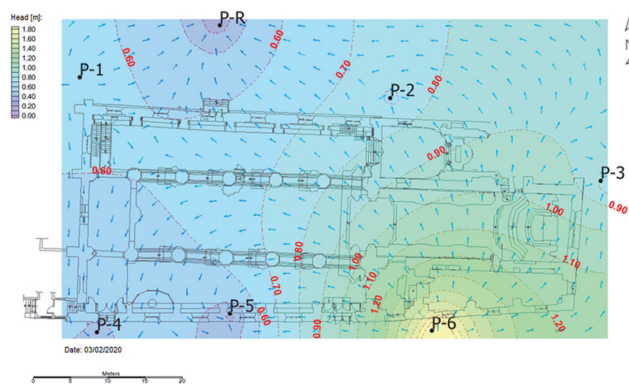
Fig. 10. Groundwater table level map with seepage directions for 3/2/2020, against the background of the Basilica basement level plan

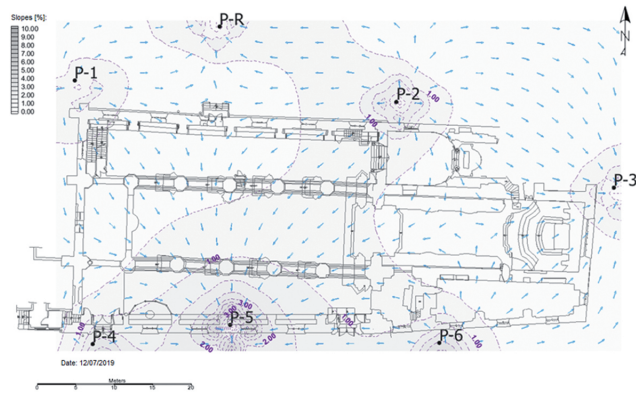
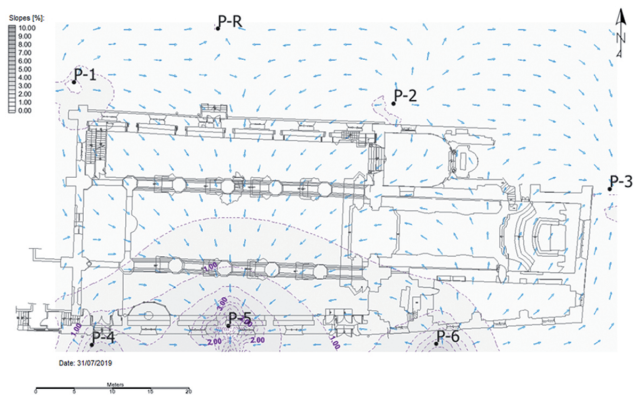
Fig. 11. Map of local groundwater table declines with seepage directions for a) 12/7/2019 and b) 31/7/2020, against the background of the Basilica basement level plan

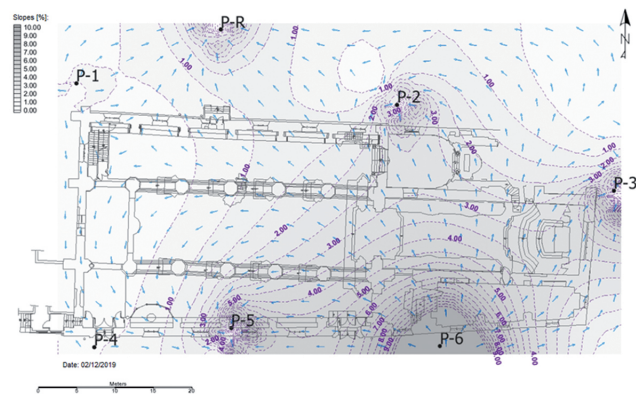
Fig. 12. Map of local groundwater table declines with seepage directions for 2/12/2019, against the background of the Basilica basement level plan
