Settlement of a historic building due to seepage-induced soil deformation

3. Soil seepage-induced deformations within the area of the St. Nicholas basilica in Gdańsk – case study

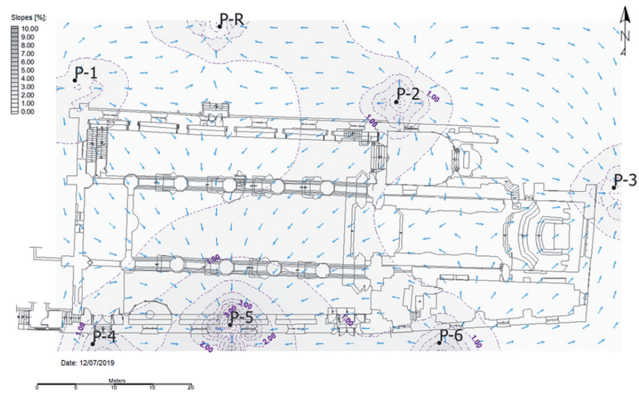
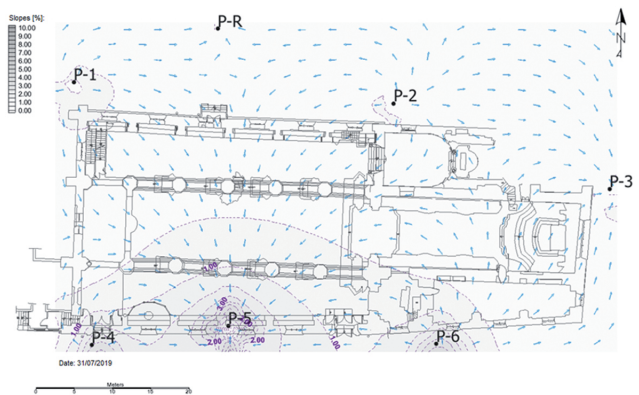
Fig. 11. Map of local groundwater table declines with seepage directions for a) 12/7/2019 and b) 31/7/2020, against the background of the Basilica basement level plan

Subsequent Figs. 11 and 12 show a map of hydraulic gradients – declines in the groundwater table level with seepage directions, for several sample measurement days.
