# Settlement of a historic building due to seepage-induced soil deformation

### 3. Soil seepage-induced deformations within the area of the St. Nicholas basilica in Gdańsk – case study

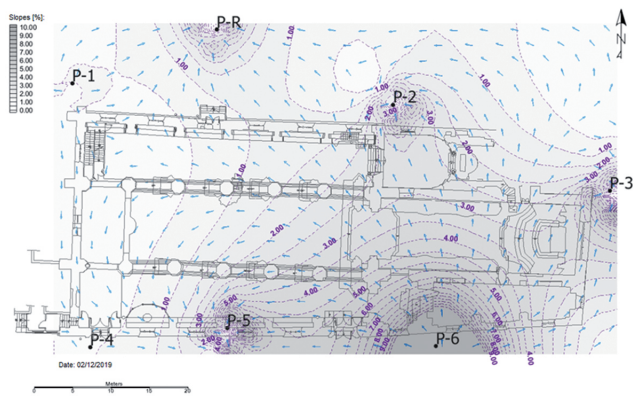
Fig. 12. Map of local groundwater table declines with seepage directions for 2/12/2019, against the background of the Basilica basement level plan

The presented results show how local declines in the Basilica area subsoil change. It can be clearly seen that the phenomenon varies over time, but qualitatively similar situations occur, such as on 2/12/2019 and 3/2/2020. The cyclical changes in the Basilica subsoil hydraulic gradients can initiate the formation of seepage-induced deformations. These changes can have various location, and the detachment of the subsoil from the Basilica floor was also found in several places.
