# Emergency condition of the ceramic facade of a residential building

Maciej NIEDOSTATKIEWICZ\*<sup>1</sup>

<sup>1</sup>Faculty of Civil and Environmental Engineering, Gdańsk University of Technology, Gdańsk, Poland

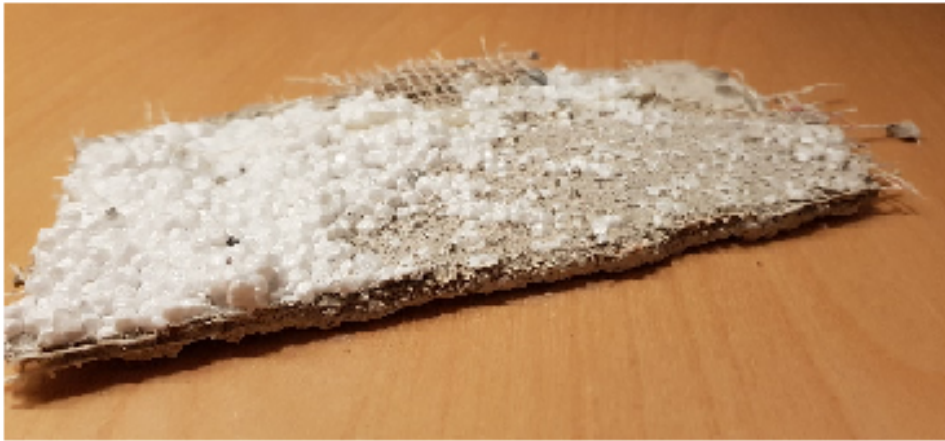
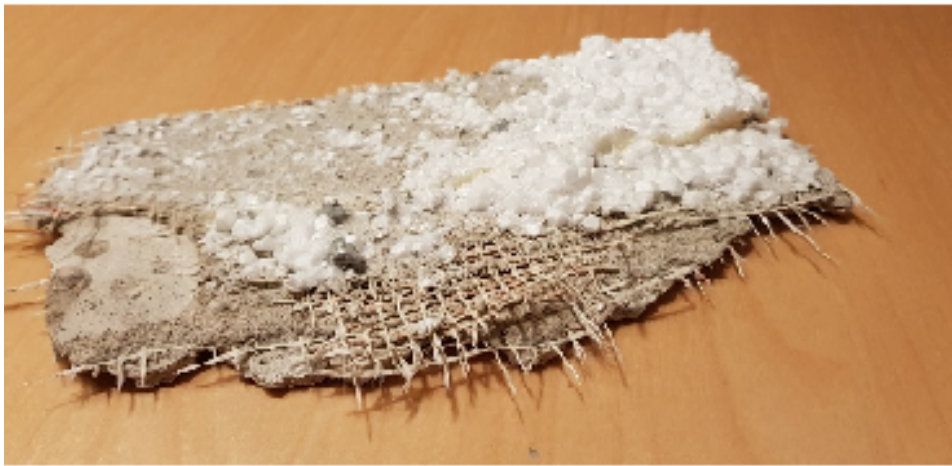
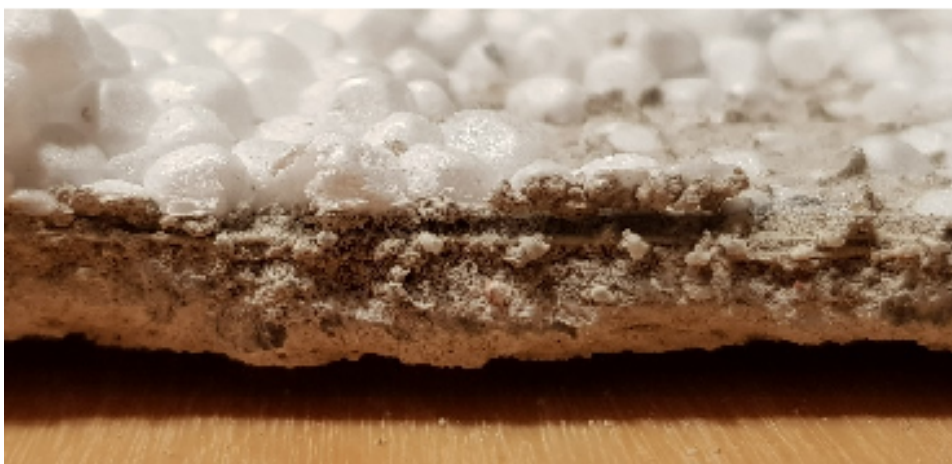
- the pins should be fixed in the first layer of the facade mesh and then covered with the second (top) layer of the mesh with glue - in the outcrops, the use of a double facade mesh and fixing the pins according to the technological requirements (+) was found. The thickness of the glue allows the facade mesh to be fully covered (Fig. 2),

Figure 2. Details of thermal insulation (substrate) a), b) and c) for the ceramic cladding of the building facade
