Monitoring of a historic sacral building on an example Basilica St. Nicholas in Gdańsk

Abstract

The paper describes the case of monitoring the technical condition of a historic sacral building after a failure and during renovation works. In order to monitor the condition of the building, safely conduct diagnostic work, identify the causes of failures and safely carry out renovation works, a detailed Facility Monitoring Program has been developed, which has been implemented, is operational and is a source of valuable data used to assess the current condition of the facility.

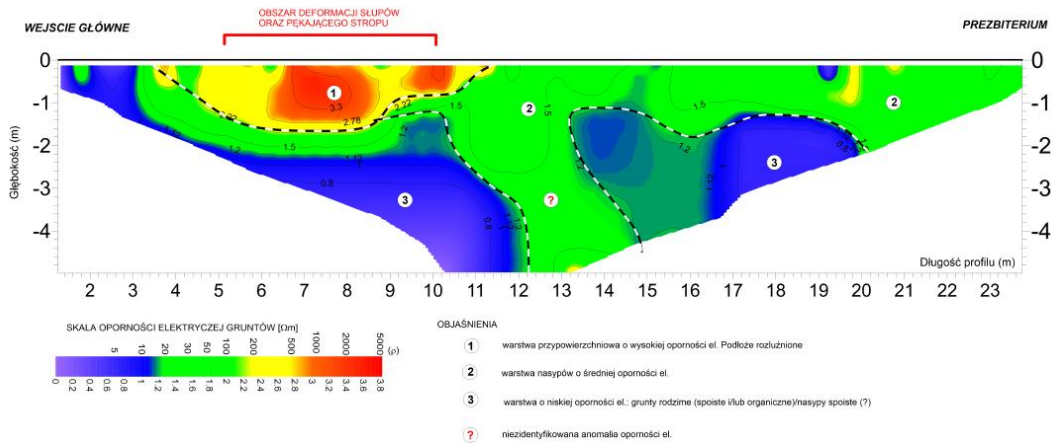
Fig. 4. Electrofusion profile made along the southern aisle of the Basilica of St. St. Mikołaja in Gdańsk based on measurements using electroresistance tomography (ERT) [31]

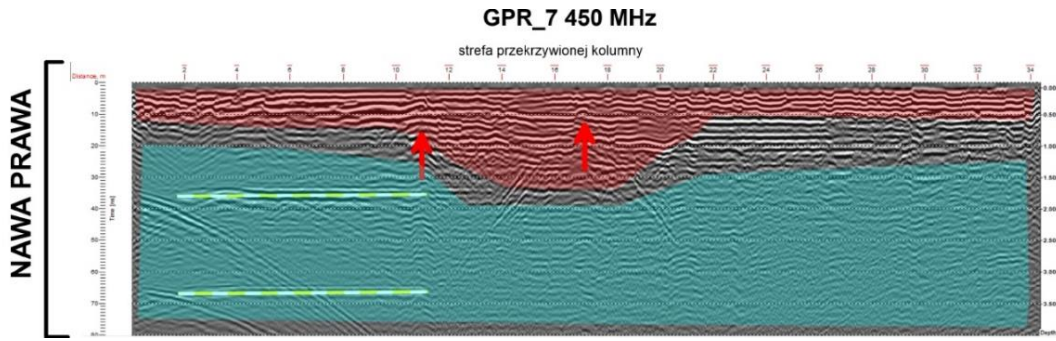
Fig. 5. Selected 450 MHz georadar echogram in the area of the southern aisle of the Basilica of St. St. Mikołaja in Gdańsk based on measurements using GPR [31]

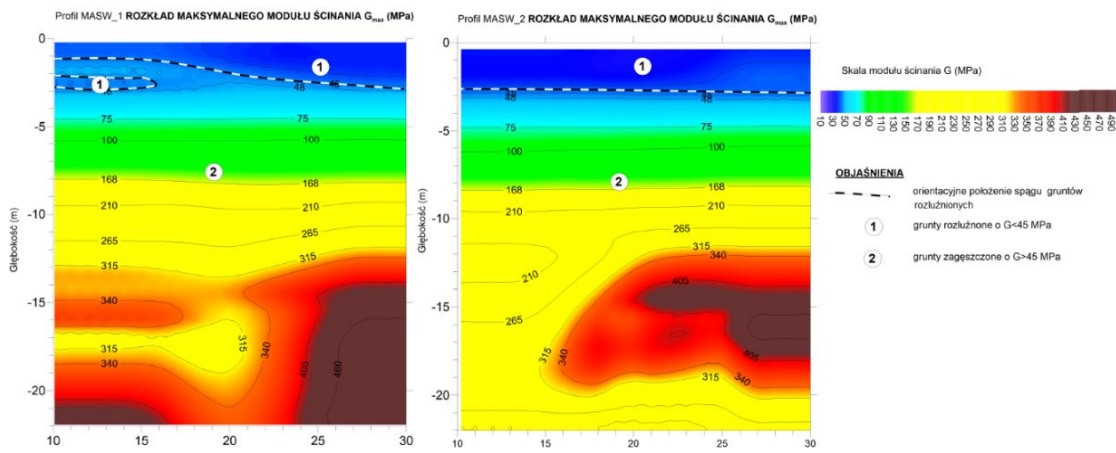
Fig.. 6. Distributions of the G_{max} shear modulus values in the axes of the southern aisle (left figure) and the northern aisle (right figure) of the Basilica of St. St. Mikołaja in Gdańsk based on measurements using multi-channel surface wave analysis (MASW) [31]

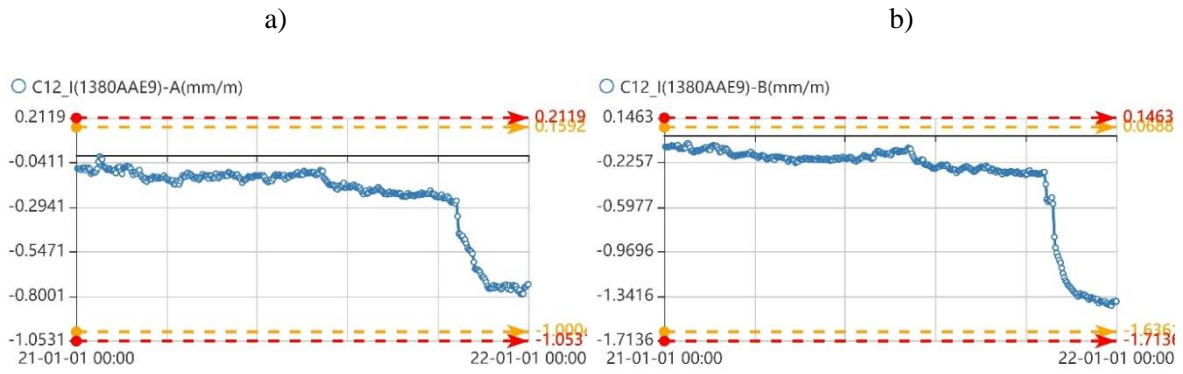
A cracked inter-column arch is based on the F2 and F3 pillars, Fig. 9, Fig. 10 and Fig. 11 show the results of inclination measurements of three selected pillars, F1, F2 and F3, respectively. Fig. 12 shows changes in vertical displacements (settlements) of piers F1 (a) and F2 (b) recorded in 2021. by distance sensors D17_I and D18_I. The charts show changes in the trend of recorded values caused by an increase in the load from the weight of the concrete ribs and the shell reinforcing the arches.

Fig. 9. Inclination of the pillar F1 of the southern aisle in the direction of axis A (a) and axis B (b): readings of the C12_I sensor in the period 01.01÷31.12.2021
