Monitoring of a historic sacral building on an example Basilica St. Nicholas in Gdańsk

Tomasz MAJEWSKI^{*1}, Maciej NIEDOSTATKIEWICZ²

2 Preliminary assessment of the scope of defects and damages

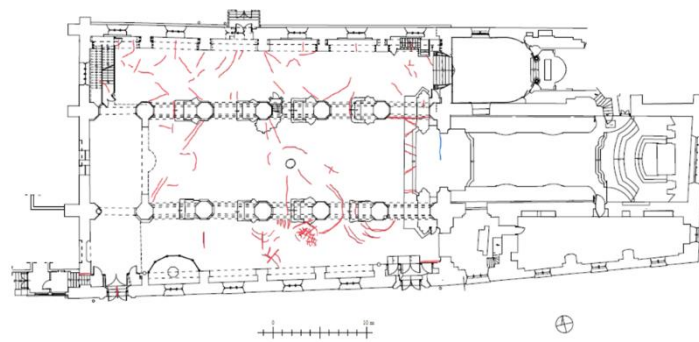
Fig. 1. Basilica of St. St. Mikołaja in Gdańsk: morphology of the features - as of January 19, 2019. [24]

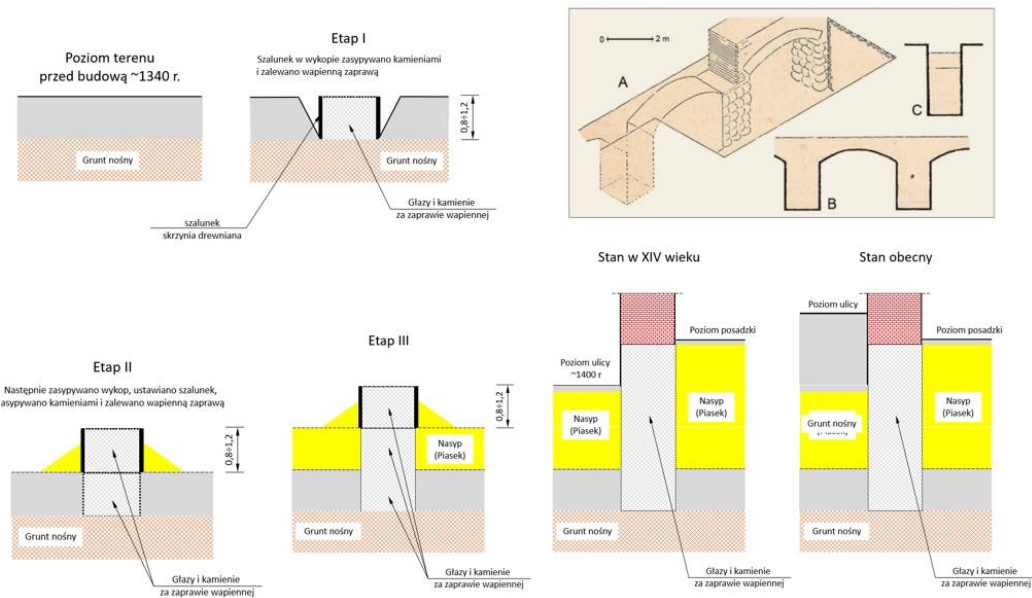
In order to recognize the type and condition of the foundations of the Basilica, classic narrow-spatial excavations were made. The excavations revealed that the foundations of the building were made in the form of stone pillars, on which brick arches are based, above which ceramic walls and pillars of the building were built [31]÷[32]. The condition of the foundations of the building was different in individual excavations. Based on the inspection, it was found that the stone foundations were placed directly on the layers of load-bearing soils (sands and gravels), under which no wooden piles and fascines were found. The layered structure of the pillars at their height was determined. The foundations were made in three stages, approximately 1.0 m high for each layer of stones (Fig. 3). Boulders and stones are laid on lime mortar, and the external surfaces are clad with clay.

Fig. 3. Foundations of the building of the Basilica of St. St. Nicholas in Gdańsk Basilica [31]–[32]

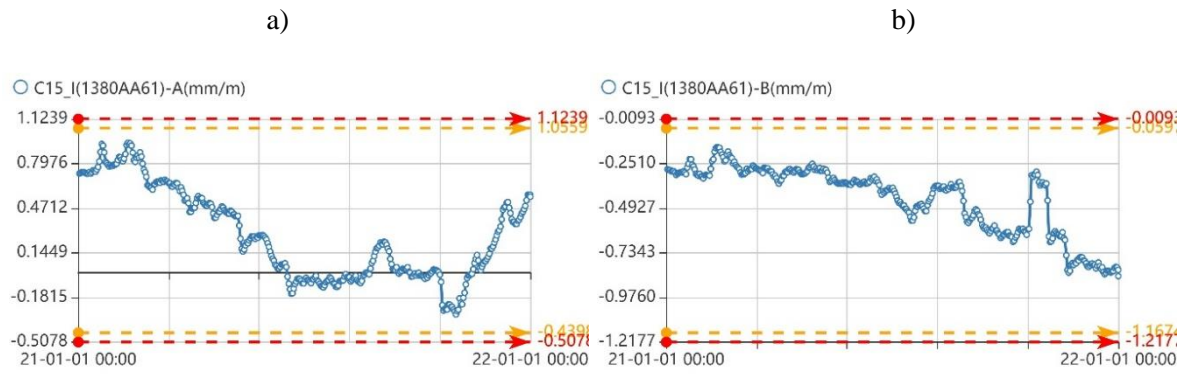
A cracked inter-column arch is based on the F2 and F3 pillars, Fig. 9, Fig. 10 and Fig. 11 show the results of inclination measurements of three selected pillars, F1, F2 and F3, respectively. Fig. 12 shows changes in vertical displacements (settlements) of piers F1 (a) and F2 (b) recorded in 2021. by distance sensors D17_I and D18_I. The charts show changes in the trend of recorded values caused by an increase in the load from the weight of the concrete ribs and the shell reinforcing the arches.

Fig. 11. Inclination of the pillar F3 of the southern aisle in the direction of axis A (a) and axis B (b): readings of the C15_I sensor in the period 01.01÷31.12.2021
