Maciej NIEDOSTATKIEWICZ^{*1}, Jacek BRAMORSKI^{2,3}

¹ Department of Engineering Structures, Faculty of Civil and Environmental Engineering,
Gdańsk University of Technology, Gdańsk, Poland

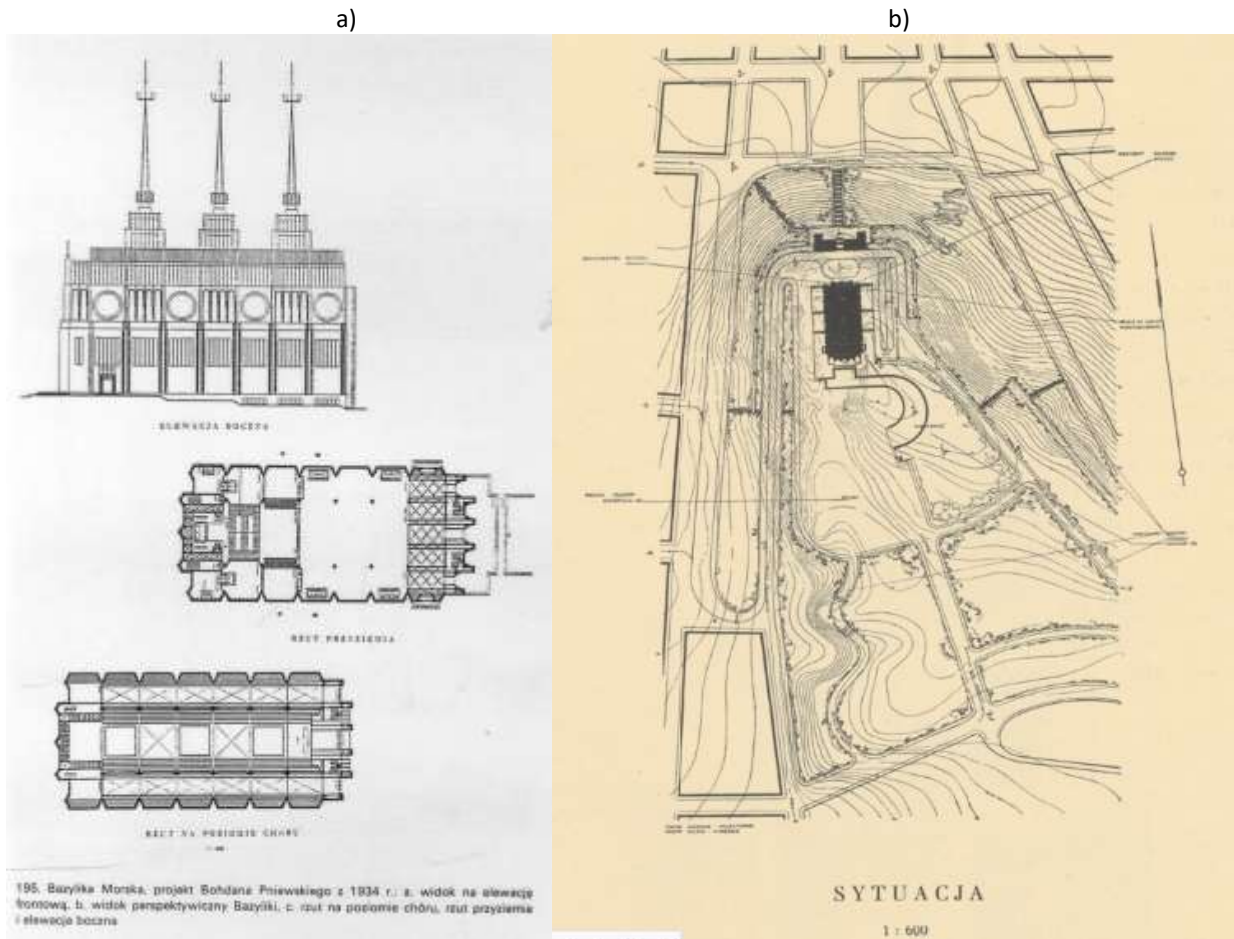
Fig. 2: Maritime Basilica in Gdynia - conceptual design: a) front elevation and projections, b) location on Kamienna Góra (based on [G1])

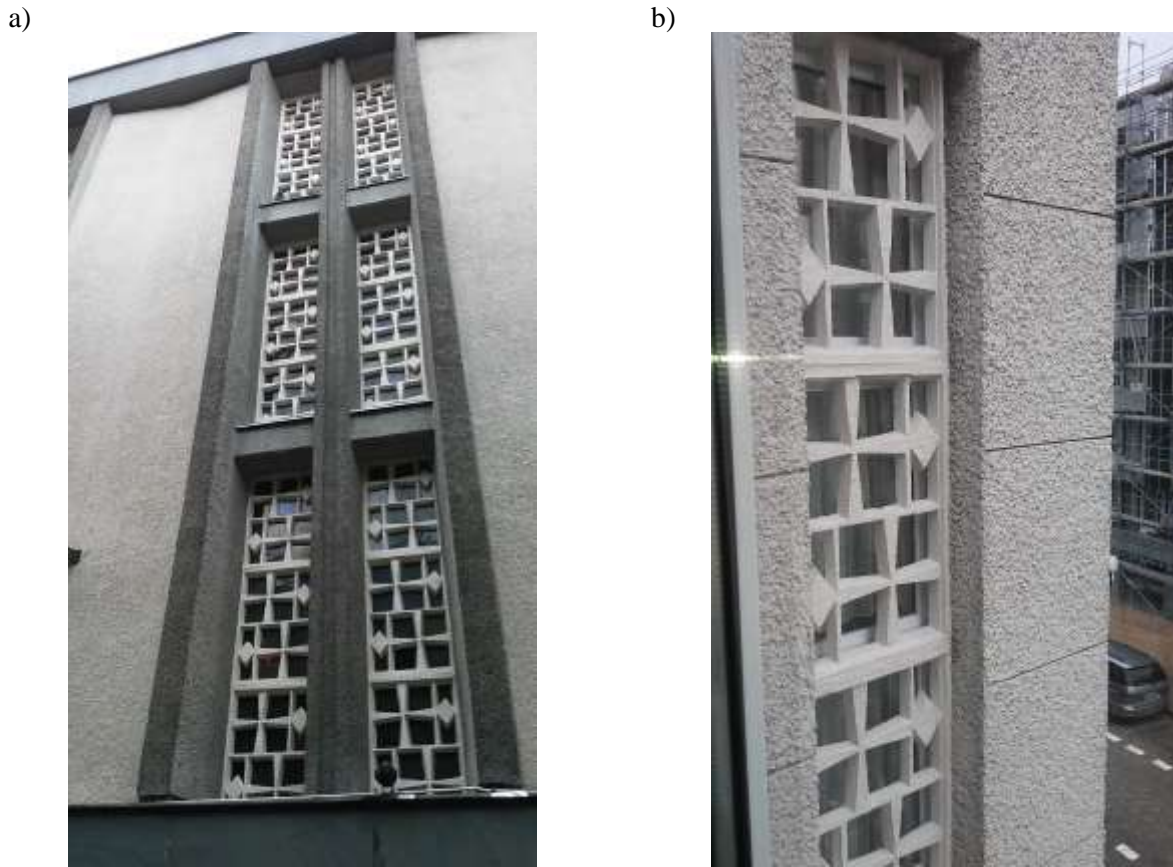
Photo 18: The condition of the facade from the south (along Armii Krajowej Street) after cleaning: a) view of the facade plaster, b) concrete window frames after revitalization (name of the street as of 2023) (photo by Jacek Bramorski)

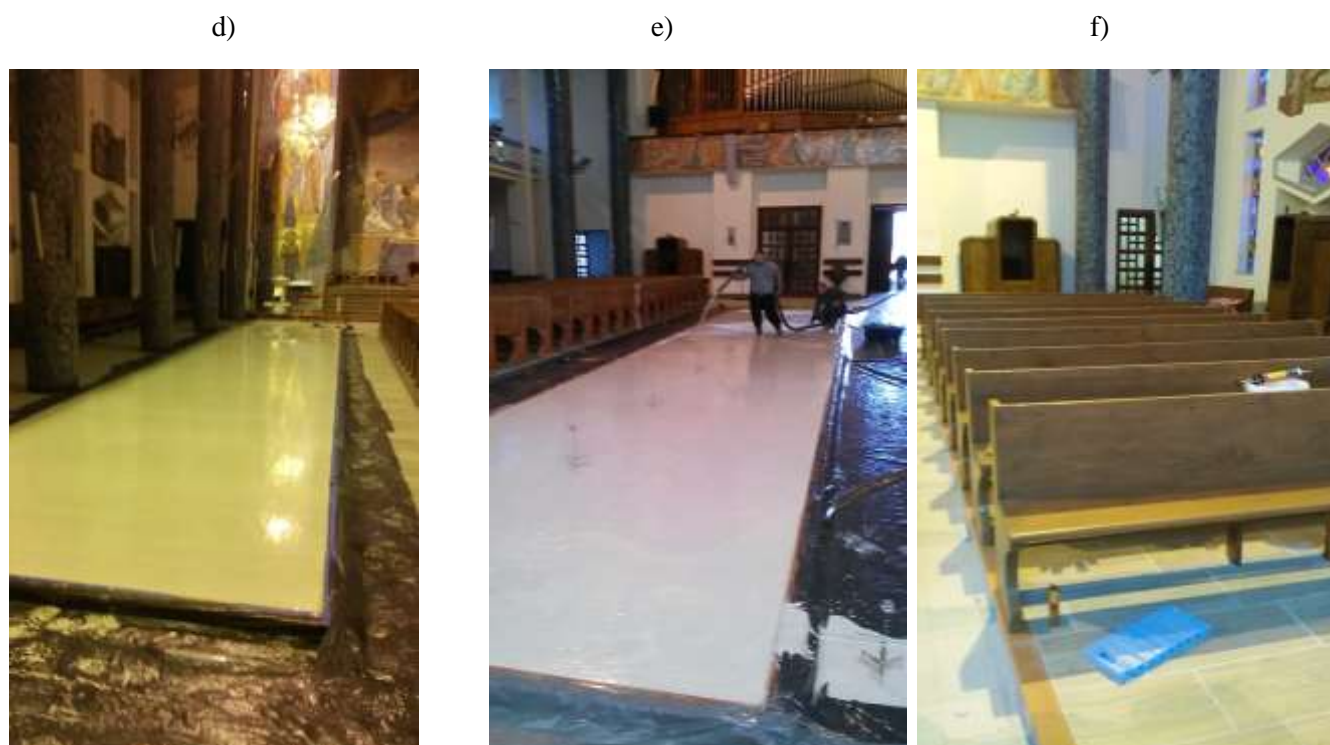
Photo 19: Installation of underfloor heating in the Church of the SHoJ in Gdynia in the rooms of the so-called of the upper church: a), b), c), d), e), f) stages of work (photo by Jacek Bramorski)
