Revitalizing the Sacral Complex of the Parish of the Sacred Heart of Jesus in Gdynia: A Comprehensive Restoration Project in Alignment with Monument Conservator's Guidelines and Technical Prerequisites

Maciej NIEDOSTATKIEWICZ^{*1}, Jacek BRAMORSKI^{2,3}

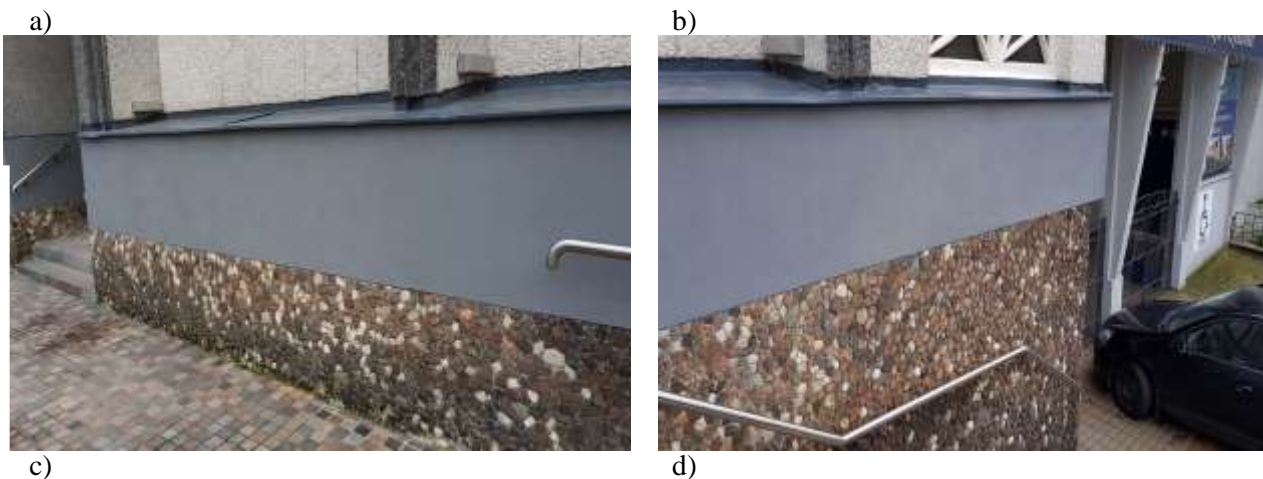
Photo 15. Base cornice after completion of renovation works: a), b) along the western elevation (from the side of 3 Maja Street), c) from the southern elevation (along Armii Krajowej Street), d) along the eastern elevation (from the side of Monsignore Hilarego Jastaka Street), e), f) from the northern elevation (along Stefana Batorego Street) (street names as of 2023) (photo by Maciej Niedostatkiwicz)

The lower part had damage similar to damage to the stone cladding of the wall at the main entrance. The stones were dirty, covered with a coating. Single stones were loosened, some of the joints were chipped. As part of the renovation works, the entire surface of the lower part of the plinth was first wetted with water at a temperature of $\sim 30^{\circ}\text{C}$, and then a thin layer of ammonium fluoride-based cleaning paste was applied to the surface of the plinth using a bench brush and the plinth was again washed with warm water. After cleaning, loose stones were glued in, and then the jointed stone cladding was supplemented with the materials used to repair the stone cladding of the wall at the main entrance.

The upper part of the plinth had damages in the form of plaster burns from the concrete base, the entire surface of the plaster was discolored and faded. As part of the renovation work, the scalded plaster was chipped off and restored. The new plaster was made as a layered plaster, with a primer layer and a top layer, after prior priming of the substrate and making a bond bridge. The top layer of the plaster was made as colored in the mass, with the use of fine quartz aggregate, with the use of a trass mortar dyed in the mass. The newly made external plaster on the plinth was made as rubbed plaster, with a structure matched to the structure of the plaster fragments left. After the local plaster repairs were completed, its entire surface was secured with an additional protective paint coating, in accordance with the conservation guidelines - a silicone facade paint was used, characterized by high water vapor diffusivity. As part of

the repair work, the flashings on the upper surface of the plinth were also replaced. The original flashings were made of zinc sheet, joined with the use of reflected and smooth coils, they were replaced with flashings made of steel-titanium sheet joined with standing seams.
