Maciej NIEDOSTATKIEWICZ<sup>\*1</sup>, Jacek BRAMORSKI<sup>2,3</sup>

<sup>1</sup> Department of Engineering Structures, Faculty of Civil and Environmental Engineering,  
Gdańsk University of Technology, Gdańsk, Poland

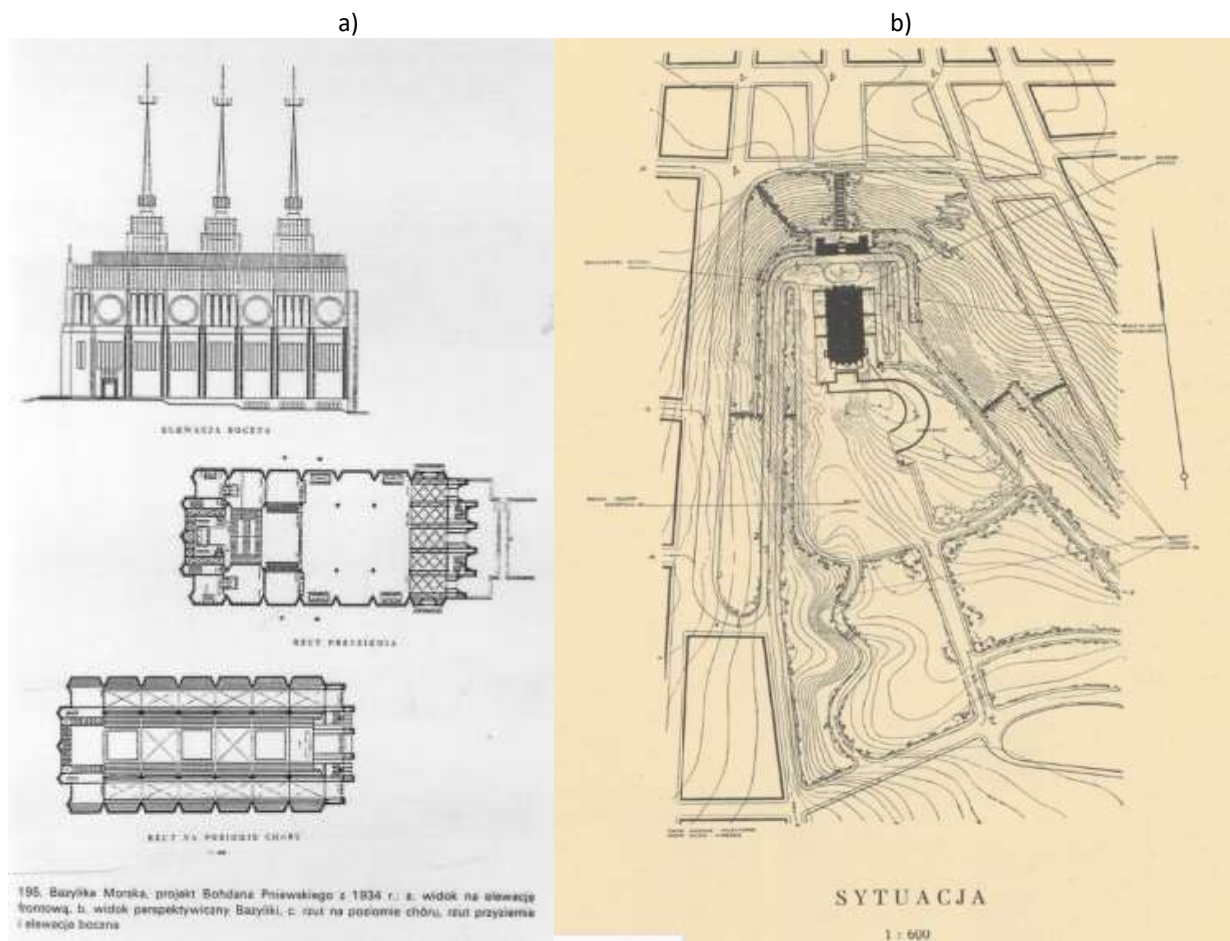
**Fig. 2:** Maritime Basilica in Gdynia - conceptual design: a) front elevation and projections, b) location on Kamienna Góra (based on [G1])

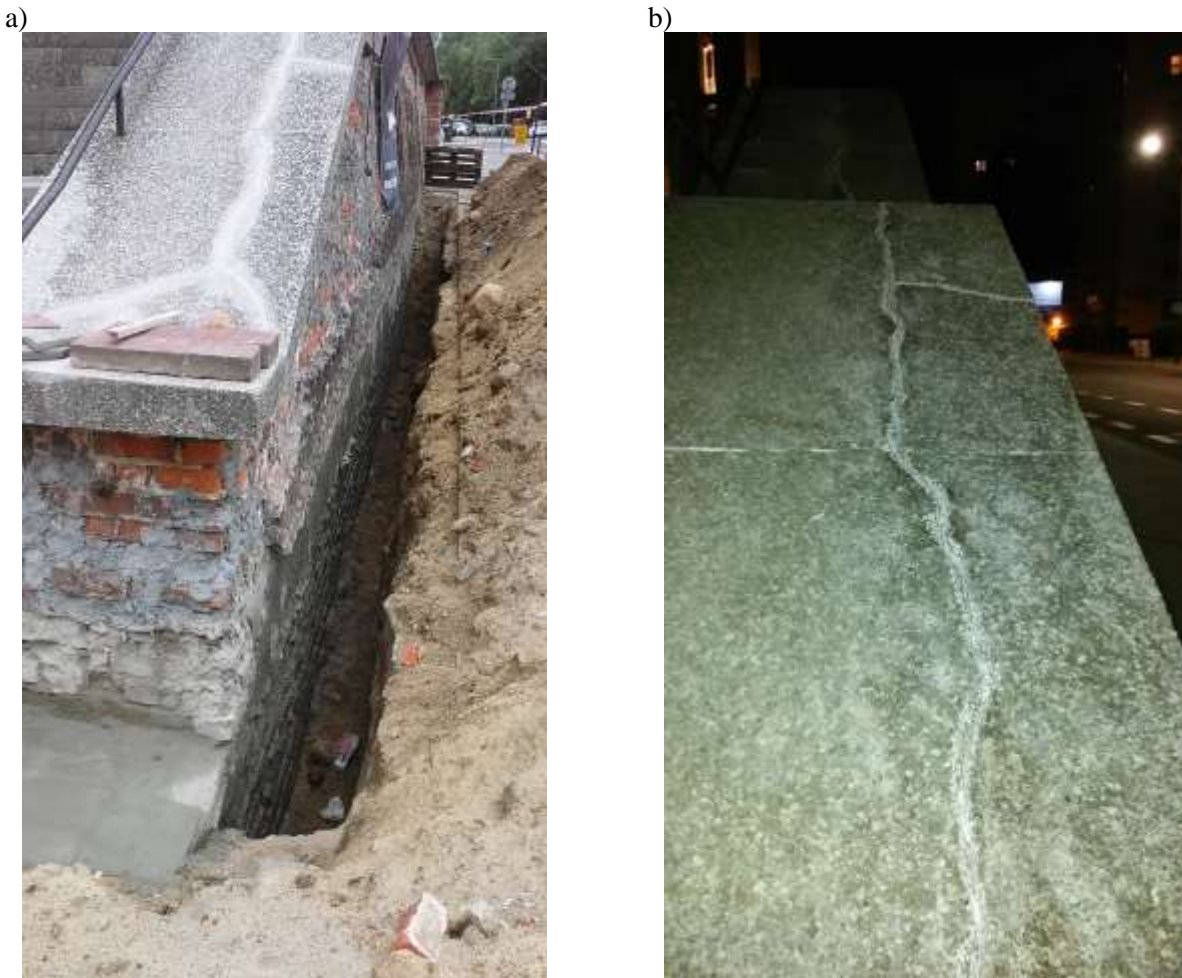
**Photo 14.** The wall at the entrance from the west elevation (along 3 Maja Street) during renovation works: a) dismantled cracked stone cladding and implementation of vertical damp-proof insulation, b) repaired cracks in the terrazzo cladding of the wall cap (names of the street as of 2023)  
(photo by Jacek Bramorski)
