Assessment of Technical Conditions in Adapting a Historic Warehouse's Space Functionality

Maciej NIEDOSTATKIEWICZ^{*1}, Tomasz MAJEWSKI²

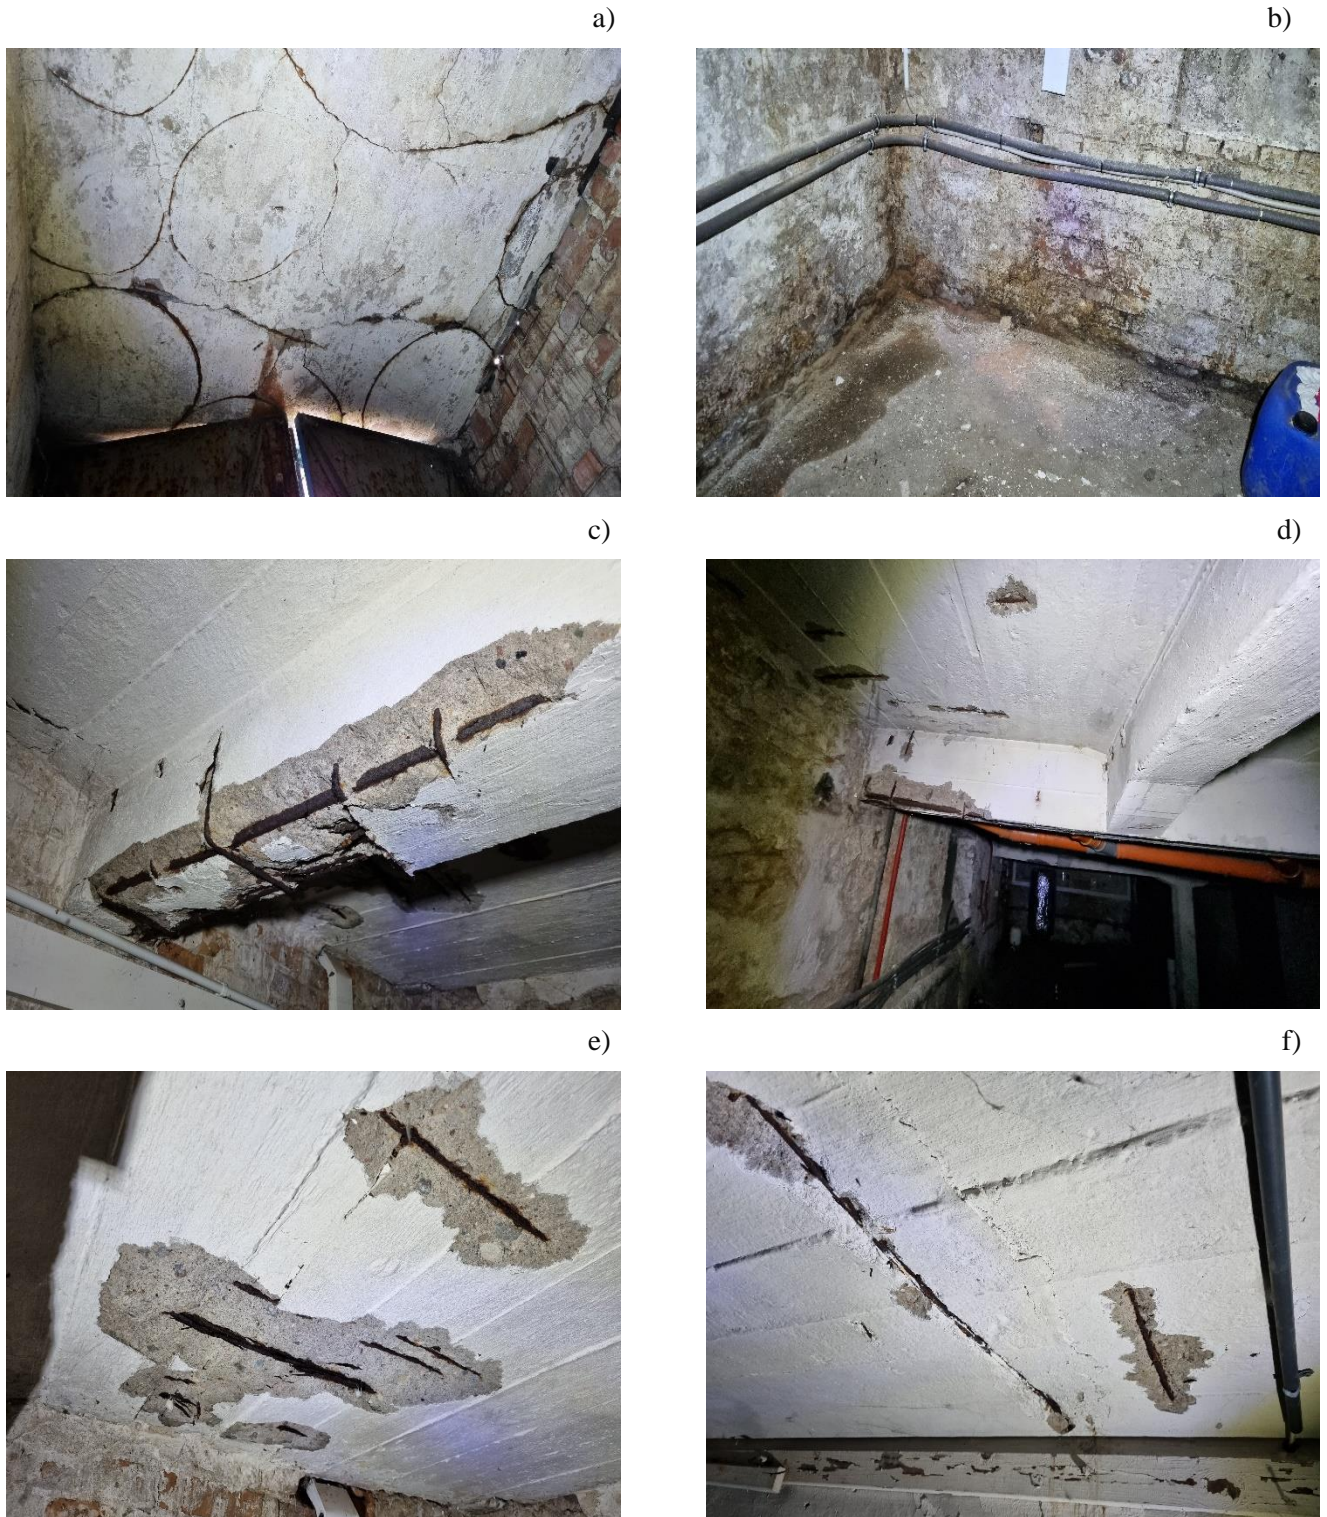
Photo 3. Warehouse Building - elevations: a), b) south-eastern, c), d) south-west Warehouse Building - basement: a) view from the bottom of the ceiling above the annex, b) dampness of the external walls, damage to the concrete cover of the reinforcing bars: c) , d) beams, e), f) ceiling slab

In the view from below, the ceiling of the extension had very intensive damage. It was made as a concrete slab reinforced with metal strips cut from metal barrels (Photo 3a). The strips were partially straightened and arranged as reinforcement elements of the concrete slab. A beam element (steel ceiling beam) was visible in the middle of the extension's length. Both the elements made of metal strips and the steel beam showed corrosion, and traces of moisture were visible on the underside of the covering board.

Intense dampness was visible on the external walls on the basement level (Photo 3b). Moisture intensified in the floor area, especially in the southern part of the building. The floor in the basement was collapsed and cracked, and on a large area of the basement floor the floor was very damp. The monolithic reinforced concrete structure of the ceiling above the basement shows no signs of overload - there were no visible signs of scratching in the middle of the span of both the beams, the internal ribs and the external ribs. There were also no traces of scratches in the area of structural joints, i.e. at the junction of columns, transoms and internal ribs. No signs of overload were identified at the junction of the external ribs with the transoms.

Reinforced concrete elements, in particular beams and internal and external ribs in the zone of external walls, showed very intensive falls of the concrete cover. Reinforcing bars, both the main (structural) reinforcement and the stirrups, showed extensive corrosion, including pitting corrosion (Photo 3c, d). Intensive corrosion damage was also visible on the bottom of the ceiling slabs filling the system of beams and ribs (Photo 3e, f). The rooms on the basement level were not used.

During the inspection, very intensive loss of the concrete cover from the beam elements of the ceiling above the basement was found. The cause of the fall of the concrete cover is the swelling corrosion of the reinforcing bars, both the main reinforcement and the stirrups. In the exposed reinforcing bars, corrosion losses of the main reinforcement bars were found, reaching 20÷30% of the cross-sectional area. The cause of corrosion of reinforcing bars is increased humidity in basement rooms. Intensification of moisture damage to the reinforced concrete elements of the ceiling above the basement takes place in the wall zone, where condensation occurs on the basement walls.

A completely technically and economically justified solution, and at the same time recommended from a technical and economic point of view, was the demolition of the existing ceiling above the basement, which had corrosion damage, and the possible subsequent use of fragments (elements of the original structural system as non-load-bearing elements), in accordance with detailed conservation recommendations.

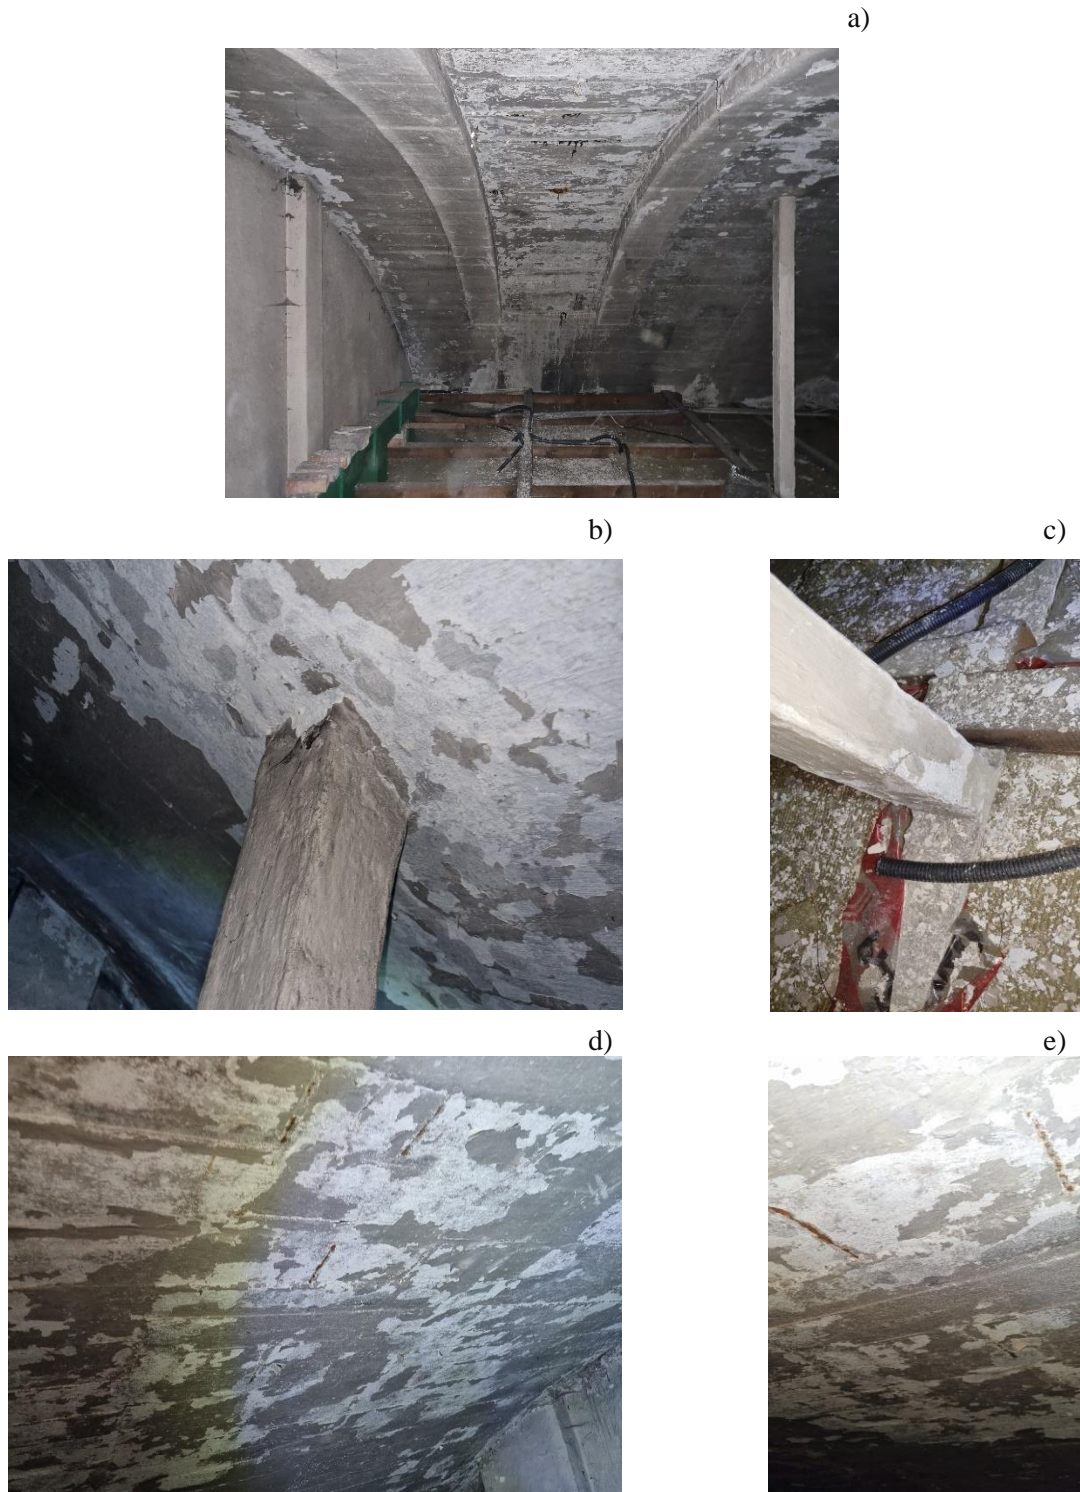
Photo 6. Warehouse building - attic space: a) stiffening ribs below the curvilinear covering slab, connection: b) post - curvilinear covering slab, c) post - horizontal tie, d), e) damage to the concrete cover of the reinforcing bars of the curvilinear covering slab

During the inspection, only part of the attic was possible (Photo 6a). The view from the bottom of the slab arch showed traces of moisture, the concrete cover was falling off locally, and corrosion of the reinforcing bars was visible (Photo 6a, d, e). The spacing of the reinforcing bars was on average 30 cm. There were no visible signs of damage where the posts were connected to the slab arch (Photo 6b), similarly to the case where the posts were connected to the tie (Photo 6c).

The curved surface of the arch, viewed from the bottom, showed traces of the reinforcing bar cover falling off, which was caused by swelling corrosion of the reinforcement resulting from the moisture of the concrete element.

A completely technically and economically justified solution, and at the same time recommended from a technical and economic point of view, was the demolition of the existing roofing constructed as a slab arch with ties and the possible subsequent use of fragments of the original elements, in accordance with detailed conservation recommendations.
