Assessment of Technical Conditions in Adapting a Historic Warehouse's Space Functionality

Maciej NIEDOSTATKIEWICZ^{*1}, Tomasz MAJEWSKI²

The aim of the paper is to present the results of the analysis of the technical condition of a historic Warehouse building located in the former shipyard area in connection with the planned construction in the place of the existing location of the production hall warehouse building.

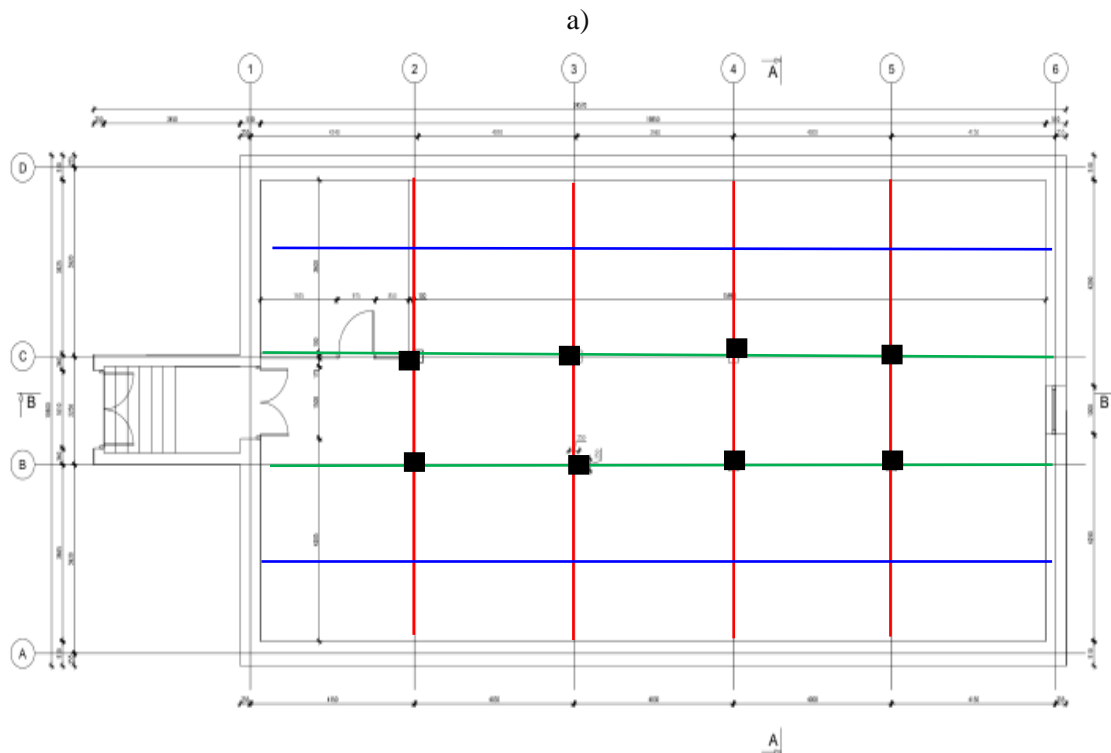
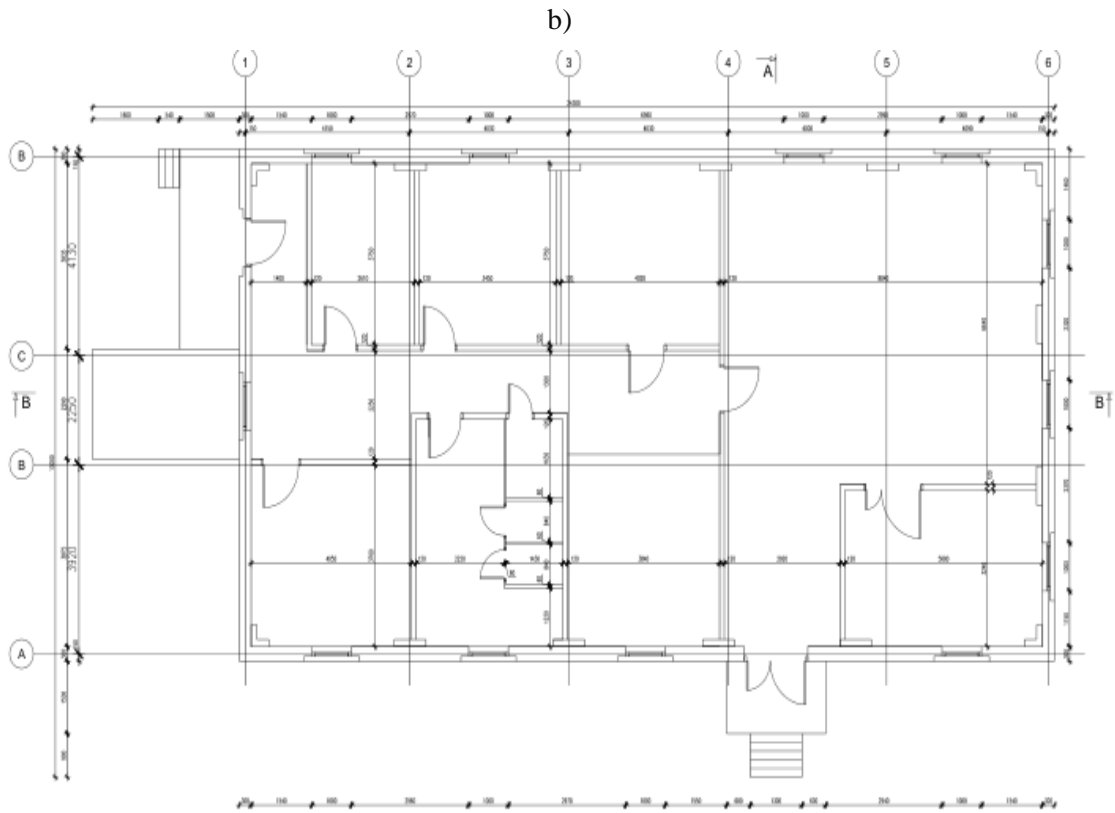
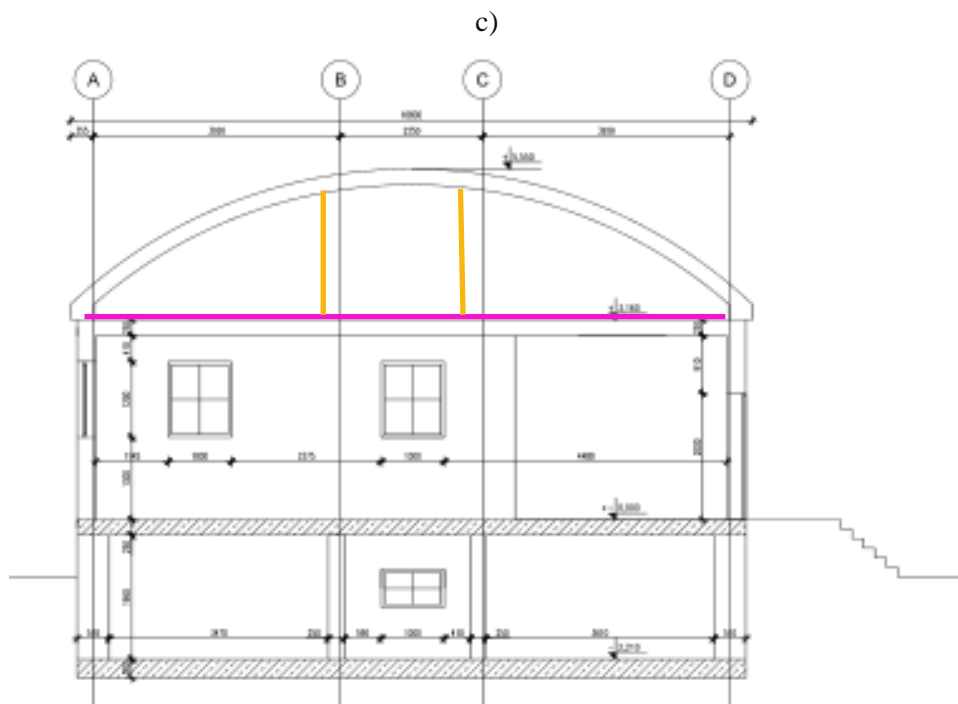
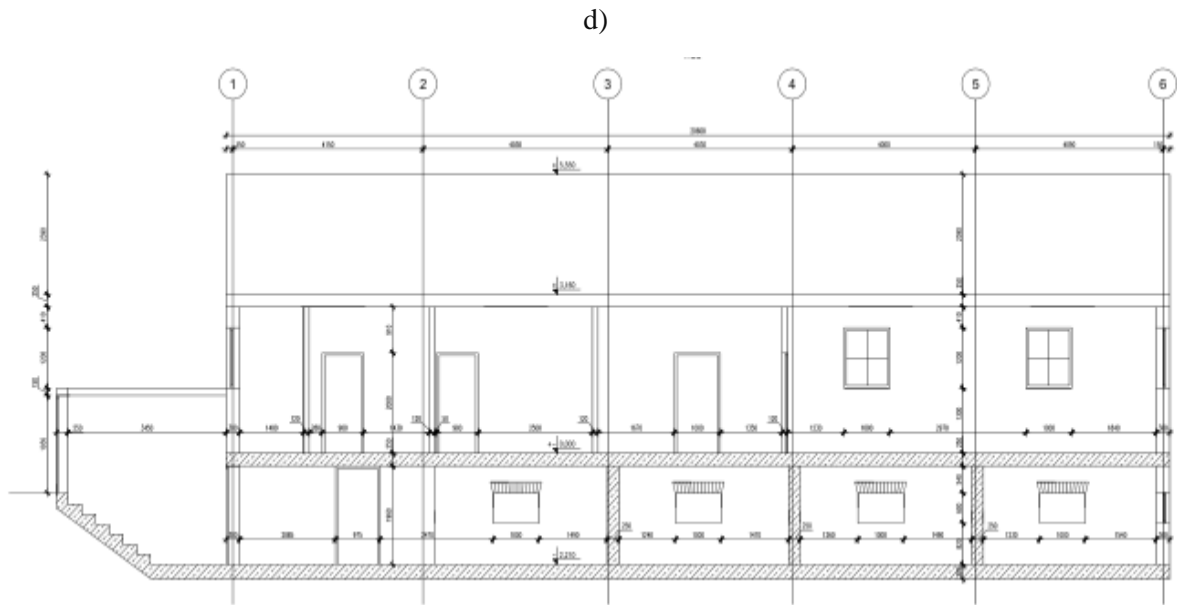
Fig. 1. Warehouse building: projections: a) basement floors, b) ground floor, cross-sections: c) transverse, d) longitudinal (*based on inventory*) continued
