Typology, current state and non-destructive testing of timber roof trusses of historic churches in the West Vistula Delta, Poland

Tomasz Zybała^{1*}, Monika Zielińska¹, Magdalena Rucka^{2,3}, Jarosław Przewłócki¹ and Karol Grębowski¹

Abstract

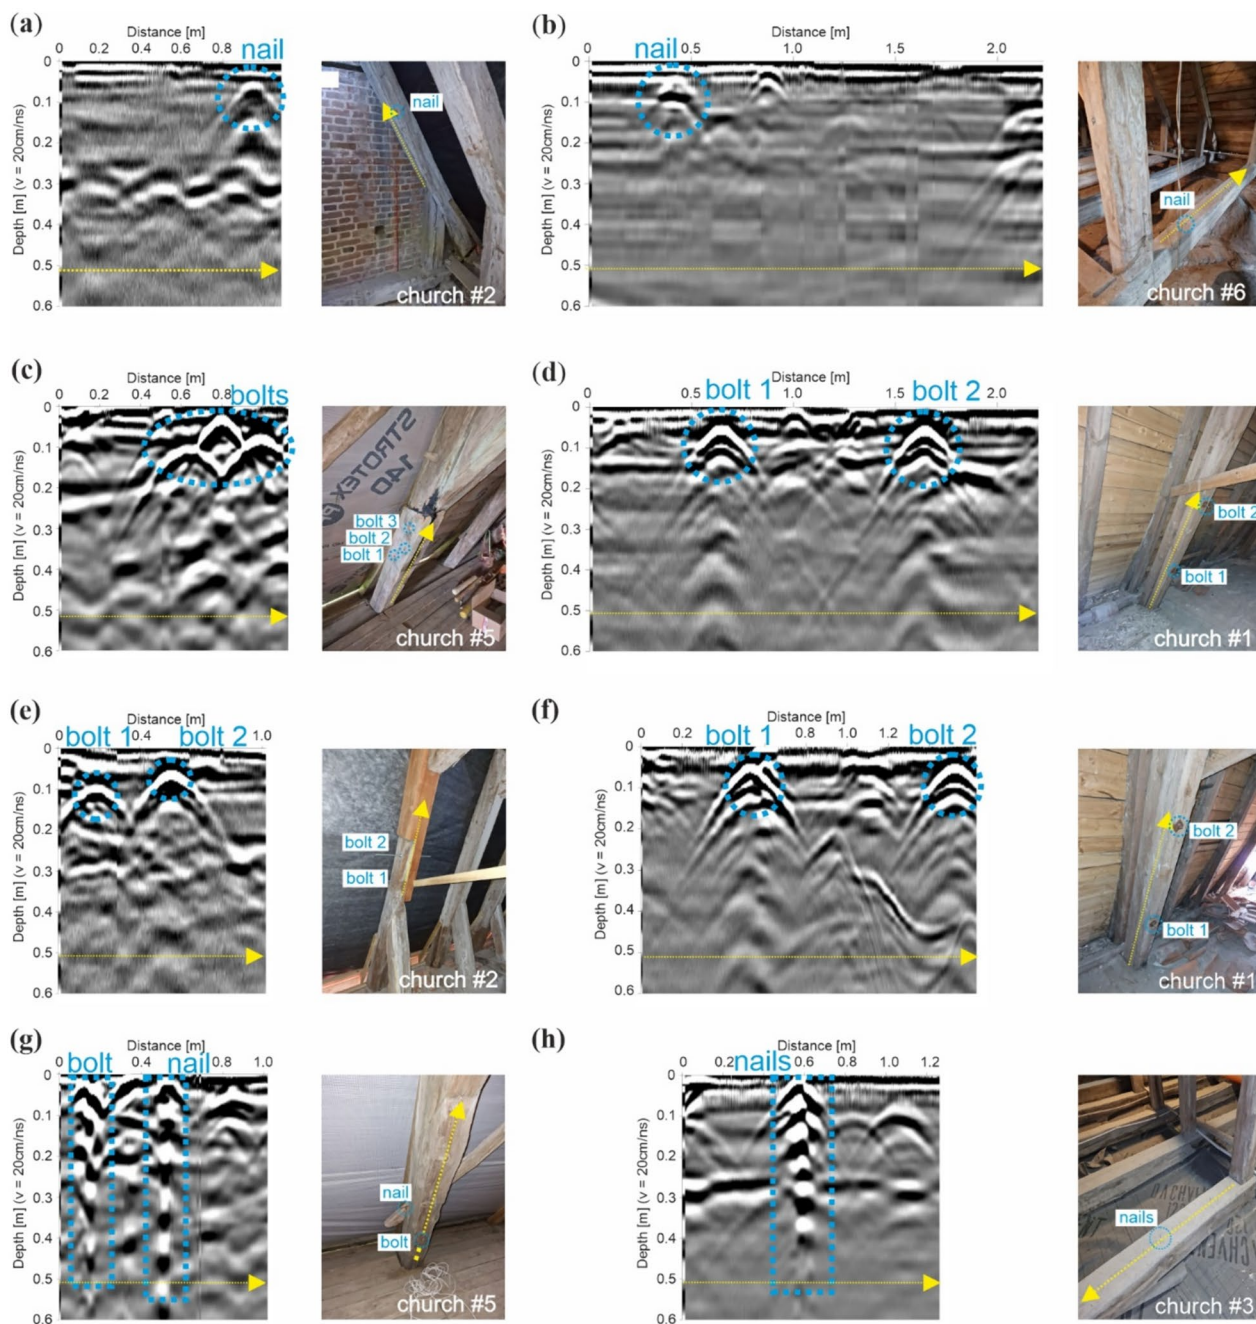
Fig. 8 GPR radagrams locating bolts and nails in timber beams a plane parallel (a–f) and perpendicular (g, h) to the moving GPR antenna

GPR is particularly sensitive in detecting metal components. In wood, these are mainly screws used to connect several beams or nails used to mount small elements such as lighting lamps or cable holders. Examples of the location of such elements in a plane parallel to the plane along which the antenna is led are shown in Fig. 8a–f. These elements are marked as a single hyperbolas and their distance from the tested surface depends on the depth at which a particular element is located.

In the case of screws and nails, where the main axis is perpendicular to the direction of GPR movement, their location is marked on the B-scan in the form of several hyperbolas located one above the other (Fig. 8g, h). GPR
