Typology, current state and non-destructive testing of timber roof trusses of historic churches in the West Vistula Delta, Poland

Tomasz Zybała^{1*}, Monika Zielińska¹, Magdalena Rucka^{2,3}, Jarosław Przewłócki¹ and Karol Grębowski¹

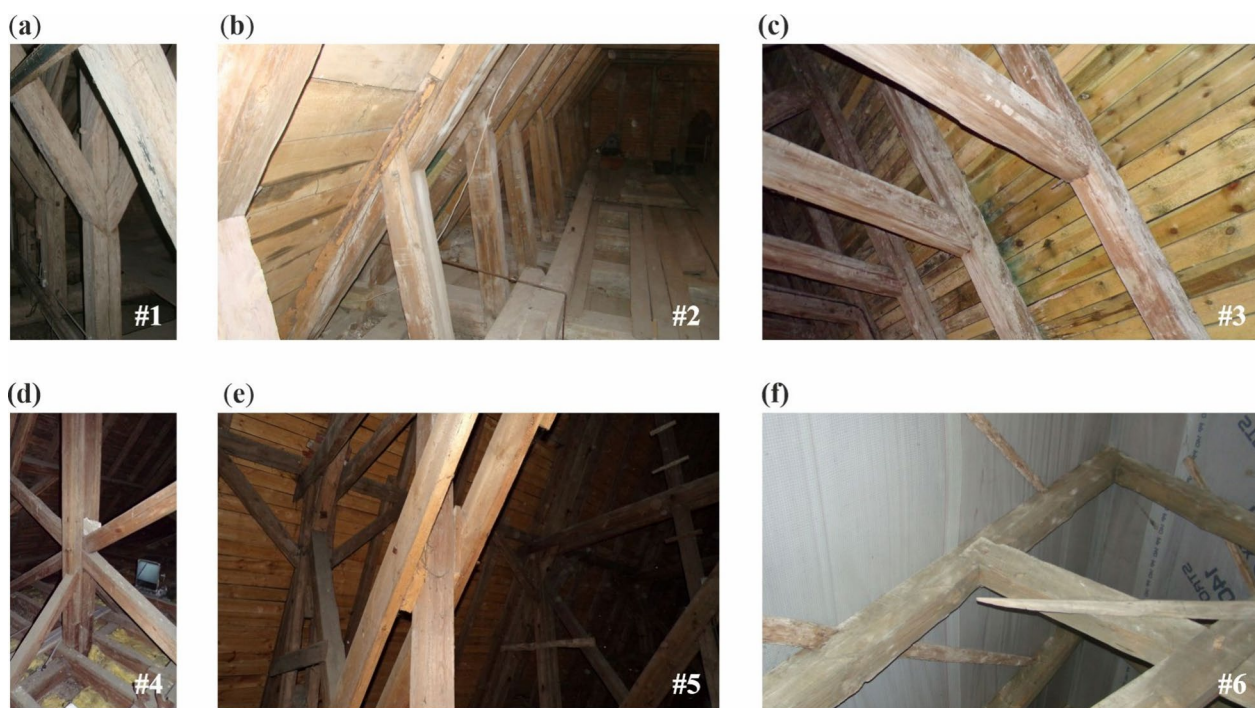
Fig. 6 Carpentry joints in church roof trusses: **a** Mitobądz (#1), **b** Pruszcz Gdański I (#2), **c** Kiezmark (#3), **d** Pruszcz Gdański II (#4), **e** Koźliny (#5), **f** Trutnowy (#6)

The rafters in the ridge of churches #2, 3, 5, 6 are connected with a bridle joint (Fig. 6f). The connections of rafters with collar beams are more varied. In churches #3 and #5 they are the same: mortise and tenon (Fig. 6c), in church #6 it is the dovetail log. The king post with struts is connected with a dovetail log (Fig. 6a) in church #2. The rafters and angle ties are connected with a lap joint in church #6 (Fig. 6b). In the roof trusses constructed in the twentieth century (churches #1 and #4), the carpentry joints are pinned and bolted (Fig. 6d, e) (Tables 1 and 2).

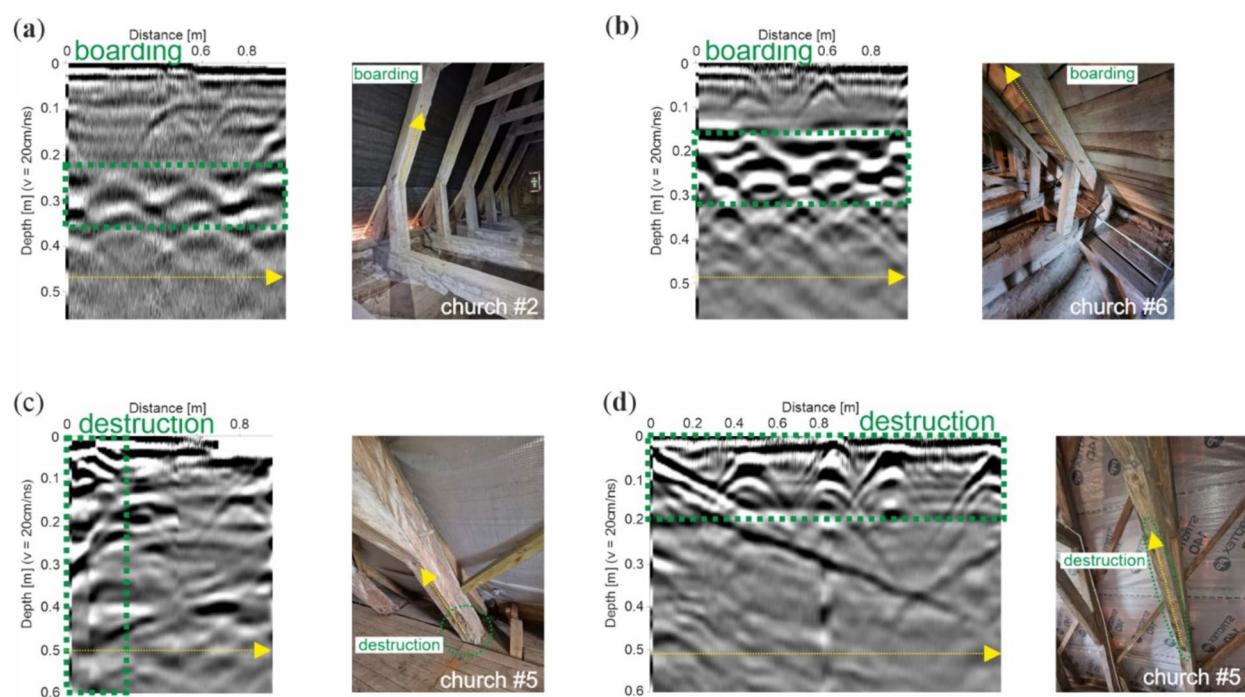
Fig. 10 GPR radagrams locating the boarding of the roof truss and decay of timber beams: **a**) Pruszcz Gdański I (#2); **b**) Trutnowy (#6); **c**) and **d**) Koźliny (#5)

The reflections from the boarding are also characteristic and they form a sequence of evenly spaced hyperbolas on the radargrams, indicating the locations of board joints (Fig. 10a, b). Damage to timber elements causes disturbances in GPR radargrams. Figure 10c shows a local failure on the lower part of the beam. The beam shown in Fig. 10d is completely and shallowly damaged, causing numerous reflections. Figure 11 shows beams from three different girders from the churches in Trutnowy, Pruszcz Gdański I, Kiezmark, and Koźliny, respectively which show varying degrees of destruction. The scans prepared for undamaged beams can be considered as reference. The reflections from the bottom of these beams are visible here, which allows the thickness of the element to be assessed. The scans prepared for the damaged beams indicate a significant disturbance in the propagation of electromagnetic waves. This demonstrates high sensitivity of the GPR method to any defect in a timber element. The reference scan is not always feasible, but it makes the interpretation of the results much easier.
