Diagnosics and protection methods a residential building in connection with the reconstruction of a road located in its immediate neighborhood - case study

Maciej NIEDOSTATKIEWICZ ^{1*}

¹ *Department of Engineering Structures, Faculty of Civil and Environmental Engineering,
Gdansk University of Technology, Gdansk, Poland*

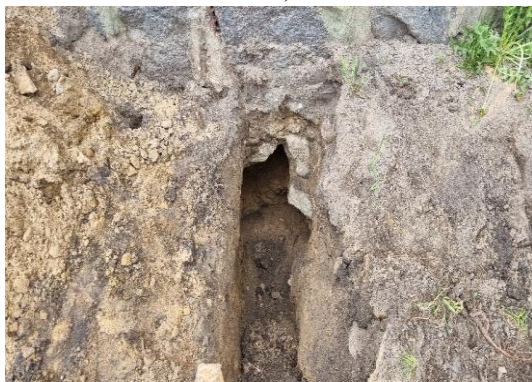
Fig. 3: Location of the outcrops in the residential building: a) view of the building from the street (front elevation), b) internal outcrop (in the basement): O1, external outcrops: c) O2 and d) O3

Based on the excavations made, it was determined that the building is founded on stone walls that do not have any offsets.

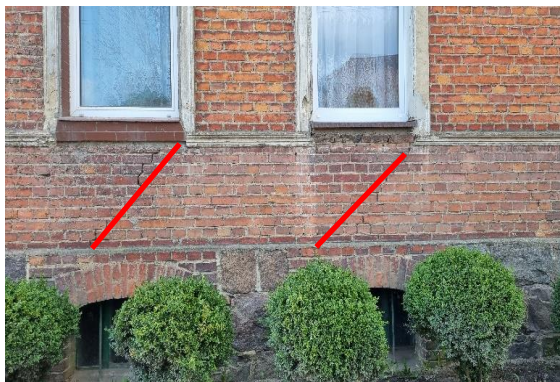
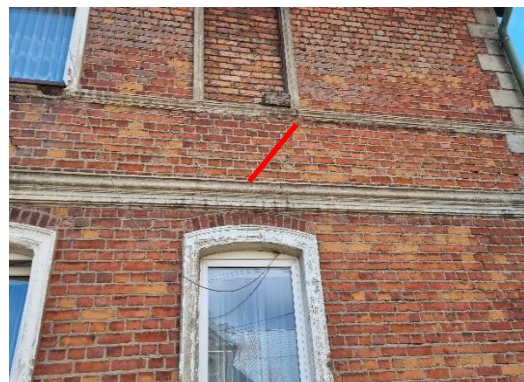
Fig. 4: Distribution of damages to the front wall (northern elevation) in the residential building: a) general view of the front elevation, b) left side (L) (basement part), c) right side (R) (non-basement part)

On the front, longitudinal wall (northern façade), damage to the brick wall of the longitudinal wall was visible: scratches to the strips under the windows occurred both on the ground floor and on the first floor, in the basement part (L) and in the non-basement part (R). The scope of damage in the basement part was greater: scratches and cracks in the brick strips under the windows were larger. The brick wall of the front wall was not plastered.

Scratches and cracks were visible on the front (northern) elevation (Fig. 4). Scratches were also visible on the garden (southern) elevation. The morphology of the above damage, especially that visible on the unplastered brick wall, i.e. on the front elevation, indicated that they were the result of uneven settlement of the building as a consequence of its partial basement. A similar picture of damage can be found in the literature on the subject (Fig. 5): in the case of the building in question, the analogy to the examples from the literature is that, similarly to Fig. 5, damage to the wall is visible, i.e. its cracks above the window arches that are tilted to the right, in the basement part (L) and to the left in the part without a basement (R). The inclination of the cracks is consistent in terms of direction

with the place of change in stiffness caused by the partial basement. The foundation of the part without a basement (R) in the ground freezing zone additionally contributed to the formation of damage to the wall - this method of foundation results in damage to the front elevation tilted to the right: in the winter, the corner of the building was uplifted upwards, and in the summer it settled excessively, which resulted in the formation of diagonal cracks tilted to the right. Unquestionably, the lack of tie beams between floors and the probable lack of frontal and side anchoring of the ceiling beams contributed to the extension of the damage to the wall. In practice, it was impossible to estimate quantitatively to what extent the previous traffic on the street contributed to the damage to the building's walls. Certainly, vibrations from moving vehicles had a negative effect, especially since the analyzed building had no foundations, which made it even more sensitive to vibrations from road traffic, propagating through the ground and affecting its structures - however, it was impossible to assess quantitatively the impact of traffic on the technical condition of the walls in practice.
