Diagnosics and protection methods a residential building in connection with the reconstruction of a road located in its immediate neighborhood - case study

Maciej NIEDOSTATKIEWICZ ^{1*}

¹ *Department of Engineering Structures, Faculty of Civil and Environmental Engineering,
Gdansk University of Technology, Gdansk, Poland*

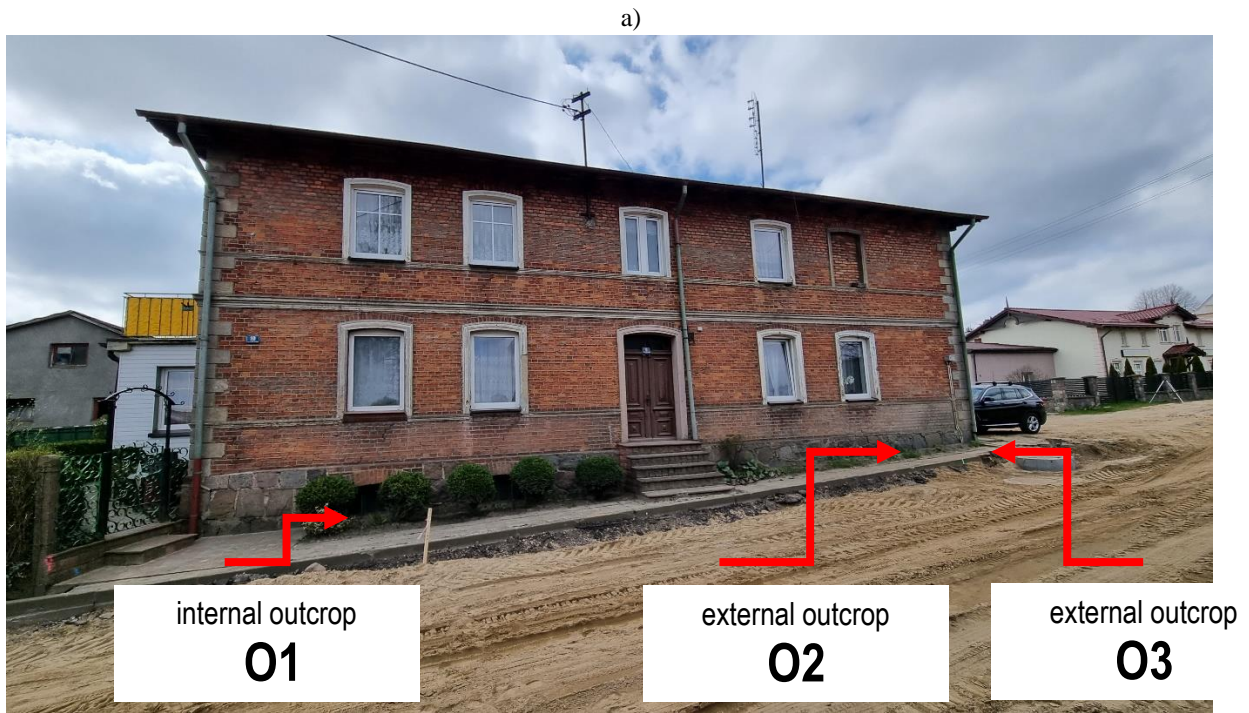
Fig. 3: Location of the outcrops in the residential building: a) view of the building from the street (front elevation), b) internal outcrop (in the basement): O1, external outcrops: c) O2 and d) O3

Based on the excavations made, it was determined that the building is founded on stone walls that do not have any offsets.
