ASSESSMENT OF EVAPORATOR TUBES CORROSION IN LOW-EMISSION STEAM BOILERS

Degradation examinations of outer surface of low-emission steam boiler evaporator tubes are presented in the paper. Metallographic evaluation of scale morphology, its micro sites chemical composition analysis and distribution of elements on cross sections have been performed. Water-wall tubes were exposed in steam boiler for up to two years period. Common tubes made of 16Mo3 steel suffered sulfide and molten salts corrosions. Thermal sprayed tubes with the single layer of 70%Ni 30%Cr alloy show better corrosion resistance, but become also susceptible to sulfide corrosion due to presence of internal voids and cracks. Double layer Al₂O₃/Ni-30Cr coatings withstand corrosion attack for more than one year operation, then failed due to internal heterogeneity and cracks generation.

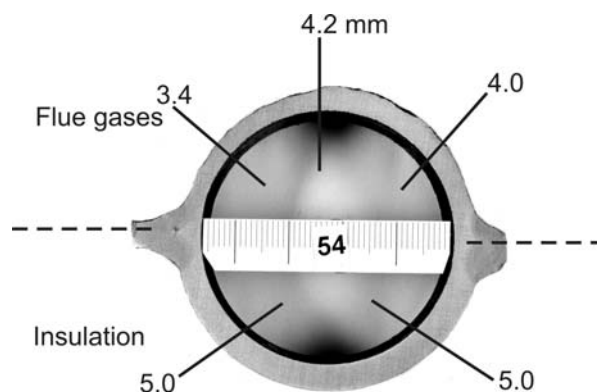
The appearance of cross section of uncoated tube after one year exploitation is shown in Fig.1. Thickness of tube wall was measured at the points indicated in Fig. 1.

The reduction in wall thickness was not uniform on tube perimeter. The front side of the tube facing the combustion radiant heat suffered the worst metal wastage and reaches 68% of its nominal value. Reductions in wall thickness from insulation side of tubes were not recorded.

Fig. 1. Cross section of $\varnothing 57 \times 5.0$ mm evaporator tube after one year exploitation in low-emission boiler

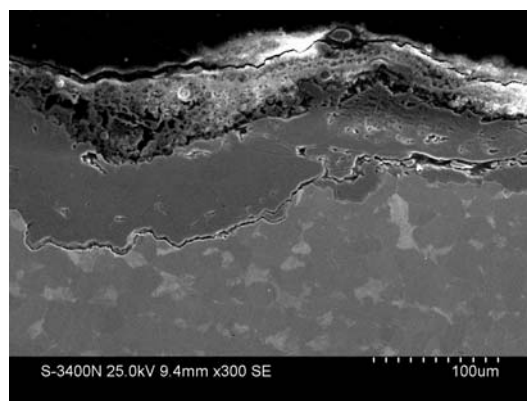
Investigations show that both mechanisms of corrosion (sulfide corrosion and molten salts corrosion) took place on uncoated tubes. Chemical analysis indicated presence of alkaline metals (K, Na, Mg, Ca) and iron sulfides (FeS , FeS_2) in the scales. The morphology of scales consisted of two layers. External, which is porous and weakly connected with the tube surface, and internal, which is dense and adherent to the base metal (Fig. 2 and 3). In these two layers the bands rich in sulphur were detected. Concentration of sulphur in these bands reached 22 wt.%. Outer layers consisted of iron, oxygen, sulphur, silicon, aluminium and alkaline metals. Inner layer consisted mainly of iron oxides and iron sulfides. The traces of chlorine were also detected mainly at the interface of inner layer and base material.

Fig. 2. Cross section of $\varnothing 57 \times 5.0$ mm evaporator tube after one year exploitation. Deposits on the fireside of the tube

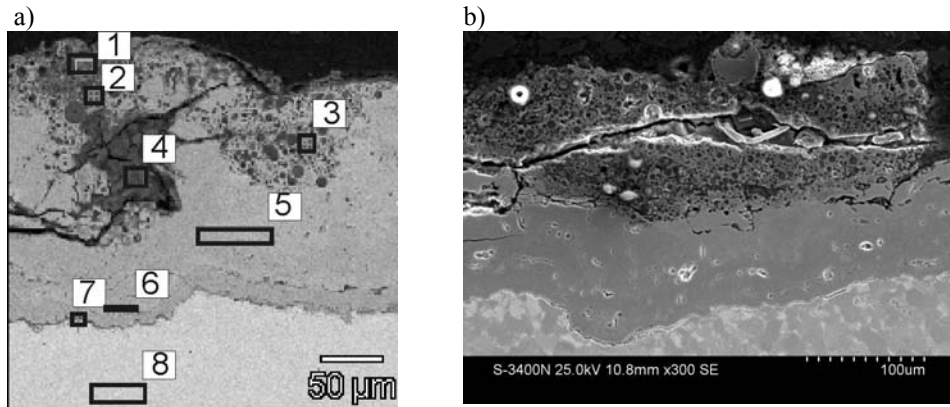
Fig. 3. Cross section of $\varnothing 57 \times 5.0$ mm evaporator tube after one year exploitation; a) places for chemical analysis (EDS), b) general view

Table 1. Chemical analysis at the points indicated in Fig. 3a (wt.%)

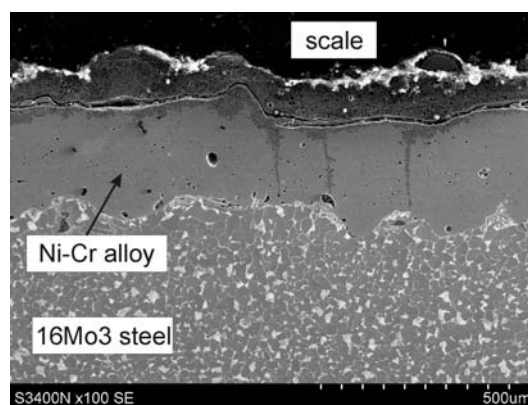
The tube surface with arc sprayed single layer of 70% Ni and 30% Cr alloy after one year operation is shown in fig 4 and 5. The thickness of this layer varied from 300 to 450 μm . Bonding with base material was rather weak because of evidence of many voids and porous structure at material-coating interface.

Fig. 4. Cross section of $\varnothing 57 \times 5.0$ mm evaporator tube with thermal sprayed Ni-30Cr layer after one year exploitation

were severely cracked (Fig.5b) - probably during exploitation, and this allow the corrosive species to attack the base material through the cracks. Cracks penetrated all the way through the coating. The ways of corrosive attack through the Ni-30Cr coating are visible in Fig. 4 and 5a. Sulphur presence was confirmed along the cracks and on the interface coating-base material.

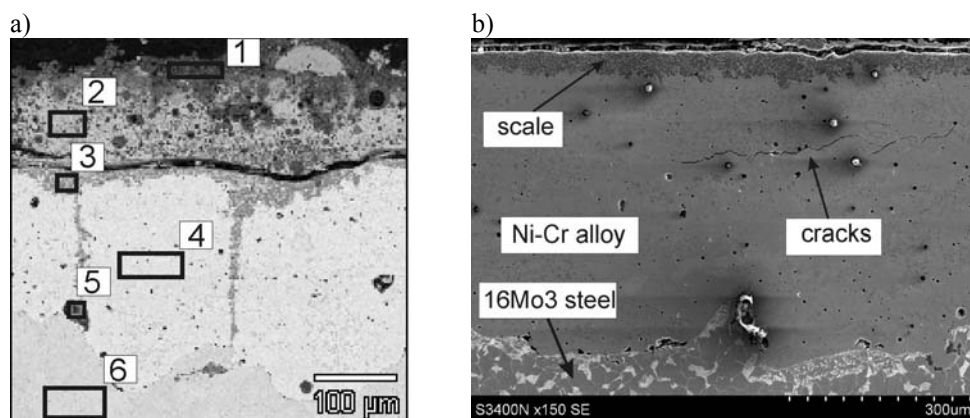
The layer of 50-100 μm in thickness consists of oxides and sulphides of chromium were formed on top of thermal sprayed coating. Other elements originated from combustion process were also detected in the scale (Tabl.2). The dense structure of coating prevents corrosion progress inside material. But it was revealed that coating

Fig. 5. Ni-30Cr coating after one year exploitation, a) places for chemical analysis (EDS), b) general view

Table 2. Chemical analysis at the points indicated in Fig. 5a (wt.%)

Tubes with single Ni-30Cr arc sprayed surface layer were also susceptible to flue gases reducing environment. The corrosion resistance of Ni-Cr coatings depend on their composition and increases with increasing chromium content [3,4]. Quality of nickel based coatings depends on their structure. Oxides at splat boundaries, cracks and voids can open the way for movement of chemical species and are a reason of corrosion damages. To enhance properties of Ni based coatings, heat treatment or laser melting processes are recommended.

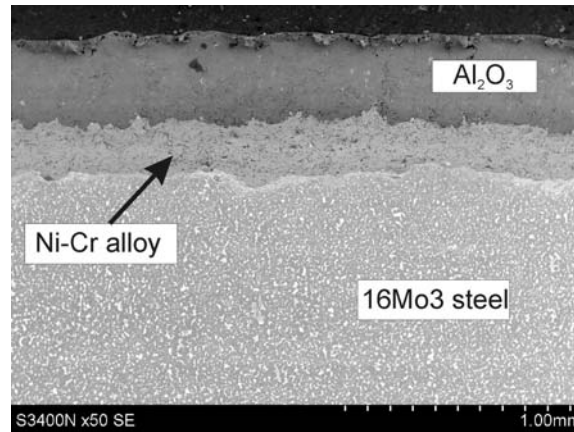
Plasma thermal sprayed coating with double layer consists of Ni-30Cr alloy and ceramic Al_2O_3 layer is shown in Fig.6 and 7. The total thickness of the coating reaches 650 μm . Inner Ni-30Cr layer of 250 μm in thickness show the lamellar structure of particle splats with oxides at splat boundaries and voids (Fig. 7a). This layer is well adherent to the base material. Due to high energy of particles striking the tubes surface the steel grains were deformed and folded making good mechanical bonding between the base material and coating.

Fig. 6. Cross section of $\varnothing 57 \times 5.0$ mm evaporator tube with double plasma sprayed layer after one year exploitation

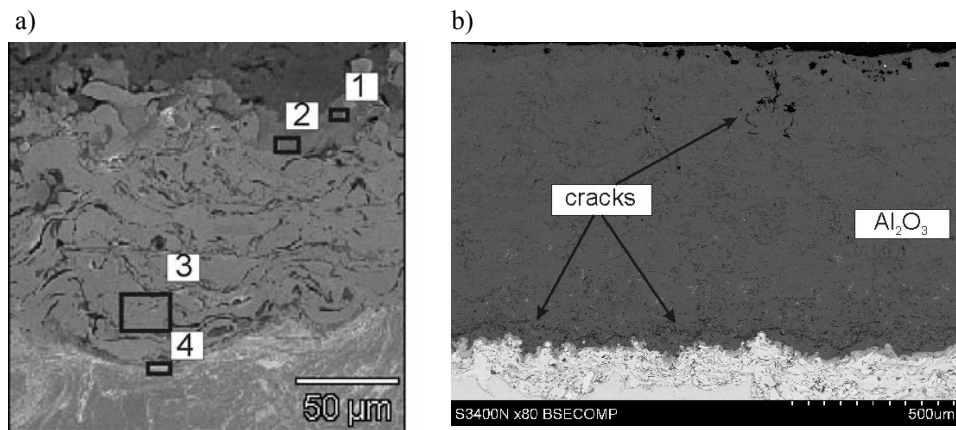
The thickness of outer Al_2O_3 layer exceeds 350 μm . This layer was rather porous, and contains many voids at splat boundaries. Inspection after one year operation in steam boiler indicated presence of many short cracks running perpendicularly to the surface with tendency to join into macrocracks. Many cracks situated parallel to the tube surface were detected near Al_2O_3 / Ni-30Cr interface (Fig.7b)

Ceramic Al_2O_3 layer seems to be completely immune to corrosion attack in low emission combustion environment. The surface of coating was only locally covered with thin deposits of ashes. Although detailed investigations revealed that corrosive species could reach base material through cracks and porosity of both layers. Spot chemical analysis of splat boundaries in inner Ni-30Cr layer indicated increased sulphur concentrations even at the base material interface (Fig. 7a, Table 3).

Fig. 7. Double, $\text{Al}_2\text{O}_3/\text{Ni-30Cr}$ coating after one year operation, a) places for chemical analysis (EDS), b) general view

Table3. Chemical analysis at the points indicated in Fig. 7a (wt.%)

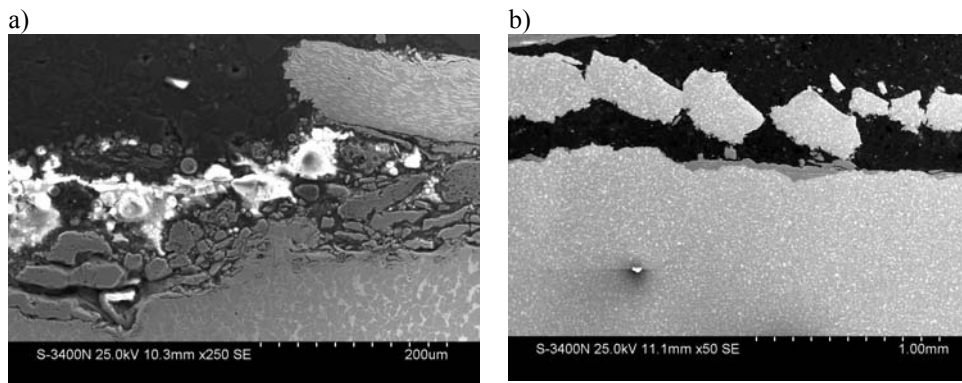
Inspection after two years exploitation was performed only on tubes with double $\text{Al}_2\text{O}_3/\text{Ni-30Cr}$ coatings. The huge degradation of protective coatings was recorded. Great areas of tubes surfaces were found without thermal sprayed layers at all. The only evidence of former coatings was the deformed layer of base material adjacent to Ni-30Cr layer. Corrosion products found on the base material consist only of iron oxides and sulfides.

Sulphides at coating-base material interface after one year operation attacked steel and cause disintegration of the coating (Fig. 8a,b). Firstly corrosion pits penetrated base material perpendicularly to the tube surface. Then corrosion process spread parallel to the surface causing separation of coatings and uncovers base material to combustion environment.

Fig. 8. Disintegration of the layer of base material of $\varnothing 57 \times 5.0$ mm evaporator tube
