Corrosion of evaporator tubes in low emission steam boilers

S. Topolska ^{a,*}, J. Łabanowski ^b

Keywords: Corrosion; Low-emission steam boiler; Evaporator tubes; Sulfide corrosion

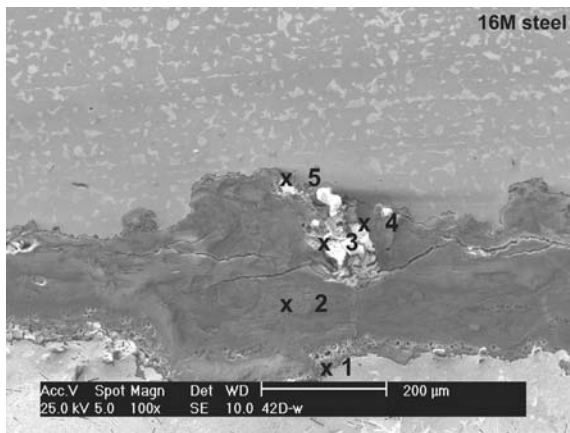
Scales consist mainly of iron oxides with considerable amount of sulfides. Detected elements were not uniformly spaced at the scale. The bands rich in sulfur were detected as well as zones enriched in chlorine. More alkaline metals were observed at scales covered samples taken from the level of 18m. Maximum sulfur contents were 32% and chlorine about 6%.

Fig. 5. Cross section of the fire side face of water wall tube. Sample 42D taken from the level of 10 m, "X" indicate points of spot analysis

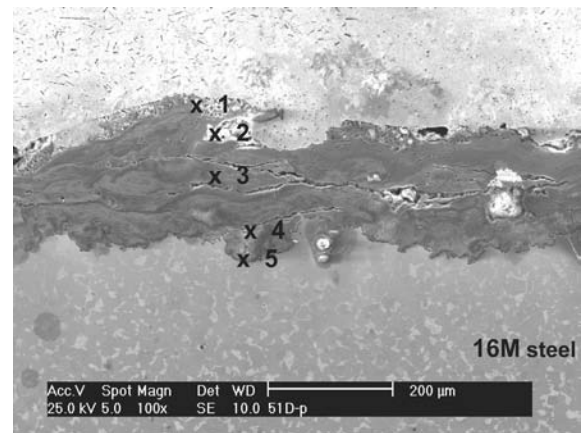
Fig. 7. Cross section of the fire side face of water wall tube. Sample 51D taken from the level of 10 m, "X" indicate points of spot analysis

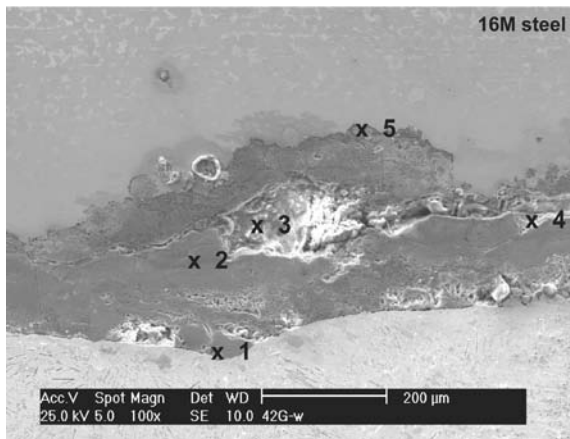
Fig. 6. Cross section of the fire side face of water wall tube. Sample 42G taken from the level of 18 m, "X" indicate points of spot analysis

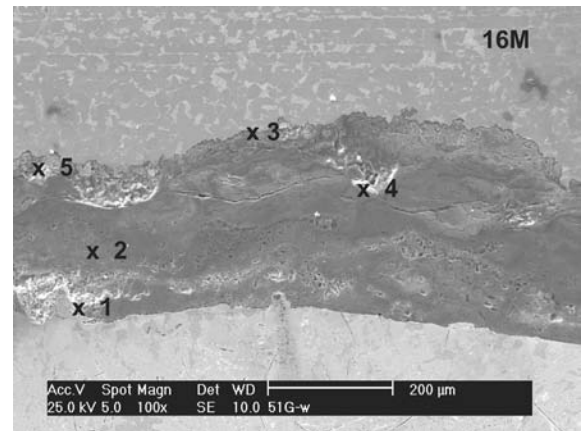
Fig. 8. Cross section of the fire side face of water wall tube. Sample 51G taken from the level of 18 m, "X" indicate points of spot analysis

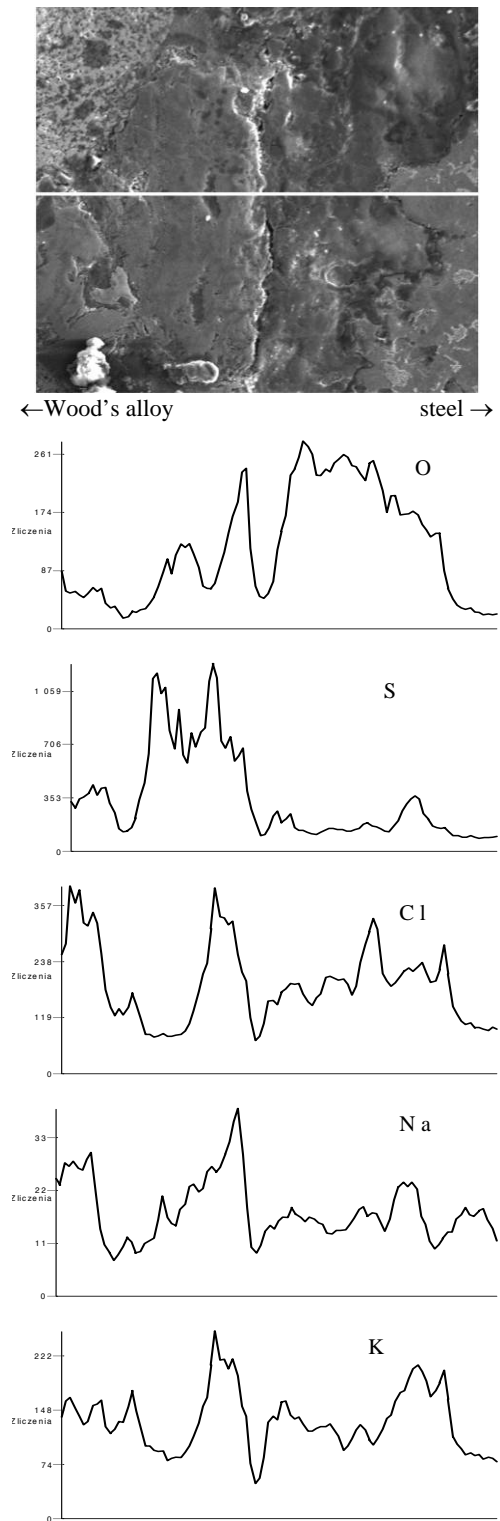
Linear distribution of elements (Figs. 9 and 10) has shown the increased concentration of chlorine and alkaline metals in the areas adjacent to the interface of base material and scale. Such shape of element distribution is dominant for samples taken from the level of 18 m.

Fig. 10. Linear distribution of elements on cross section of deposit layer on $\varnothing 57 \times 5.0$ mm evaporator tube, level of 18 m

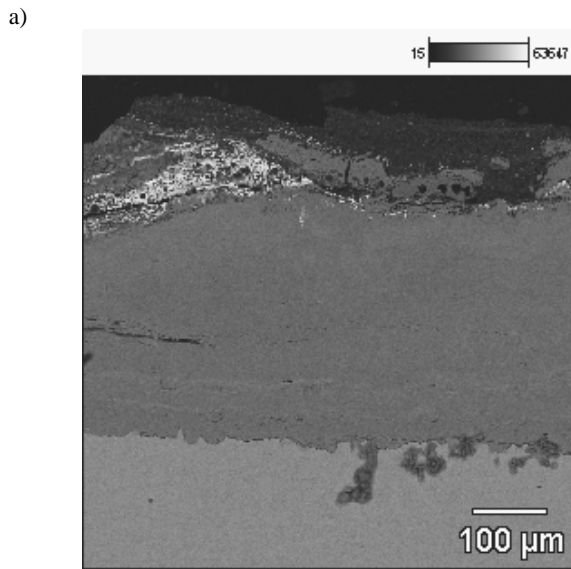
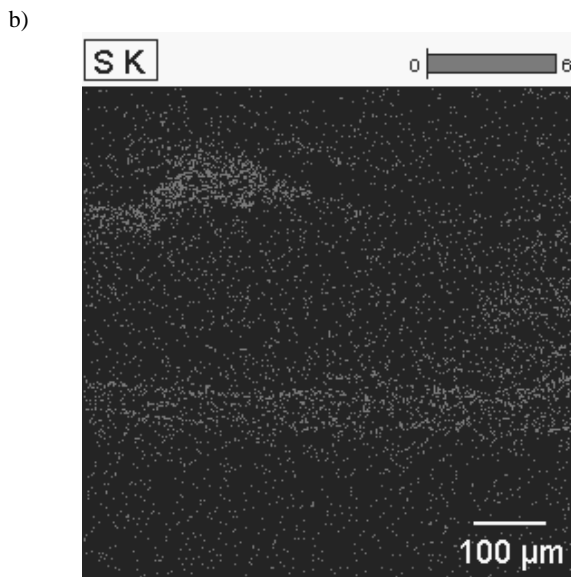
Fig. 11. Cross section of fire-side face of water wall tube subjected to reducing combustion conditions a) optical micrograph b) x-ray elemental dot map for sulphur

Dot maps confirmed observation on inhomogeneous of scale composition. Fig. 11 shows bands enriched in sulfur situated at external layer of the scale and second band close to the interface of base material and scale.

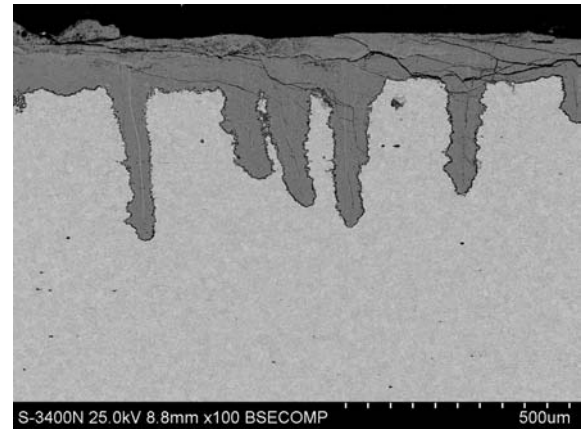
Detailed observations revealed pits and deep penetrations into the tube wall on the samples taken from the level of 18 m (Fig. 12). Such deep pits can form as a result of low melting ash constituent action. Local microanalyses of chemical composition (Figs. 13 and 14) indicated enriched concentrations of sulfur, chlorine and potassium close to the borderline of base material and scale.

Fig. 12. Cross section of fire-side face of water wall tube, level - 18m. Dip penetrations into the tube wall

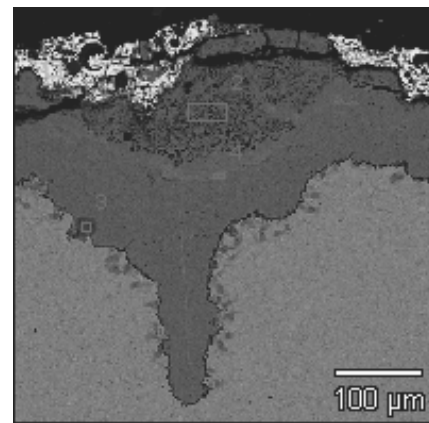
Al	Si	S	Cl	K	Fe
1	3.36	6.72	11.41			bal
2	7.05	10.9	0.95		0.87	bal
3	0.58			2.46	1.14	bal
4		0.49	18.04			bal

Fig. 13. Chemical analysis of the scale at the corrosion pit (wt.%). Level - 18m, measure points indicated in micrograph

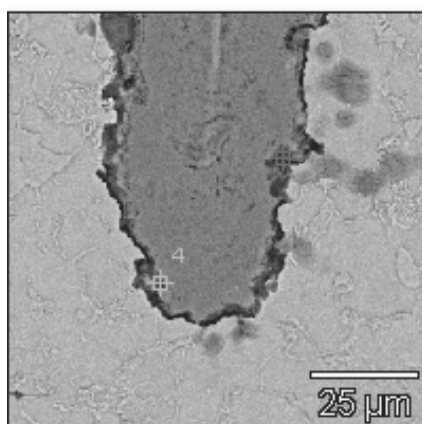
Al	Si	S	Cl	K	Fe
1		1.47	0.62	0.73	0.82	bal
2		0.80	0.94	0.98		bal
3	0.43	0.44			1.01	bal
4		0.98	1.1	0.91		bal

Fig. 14. Chemical analysis of the scale at the tip of corrosion pit (wt. %). Level - 18m, measure points indicated in micrograph
