# Acoustic emission for detecting deterioration of capacitors under aging

## Abstract

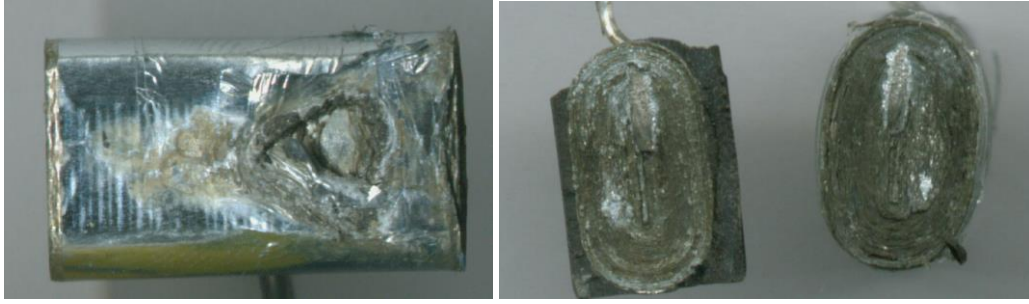
Figure 11

The above mentioned results of correlation between the AE signal and other capacitors parameters are consistent with reasons of the capacitor failures observed after disassembling the failed capacitors (Fig. 11). The main reason of complete or substantial capacitance drop was a detachment of the metalized heads. Even harsh partial discharges were able to destroy only a part of the wound foil and consequently decreased the capacitance only slightly. We suppose that the detachment process is induced by local foil overheating due to intensive partial discharges and mechanical stress between the wound foil and the metalized head across a narrow boarder line (Fig. 12) . Additionally, partial discharges between the foil edge and the metalized heads lead to tiny metal losses only (Fig. 12) and cannot be considered as the main reason of the observed capacitor failure. Thus, we can suppose that capacitors of class X2 having intensive partial discharges would have shorter life span due to local overheating that induces process of metalized heads detachment. At the same time, a very thin dielectric is often completely destroyed locally when affected by partial discharges. The destroyed dielectric does not influence significantly on correlation between intensity of AE signal induced by partial discharges and resistance isolation of the tested capacitor. That result was observed experimentally for capacitors of class X2 having thin dielectric foil.

Fig. 11. Measurement results of the tested  $C_T=27$  nF capacitors: a) resistance isolation, b) power spectral density of the registered AE signal at 293 kHz.

Fig. 12. Foil of the 470 nF capacitor deteriorated by intensive partial discharges: a) with the melted dielectric and b) its detached brownish metalized heads.

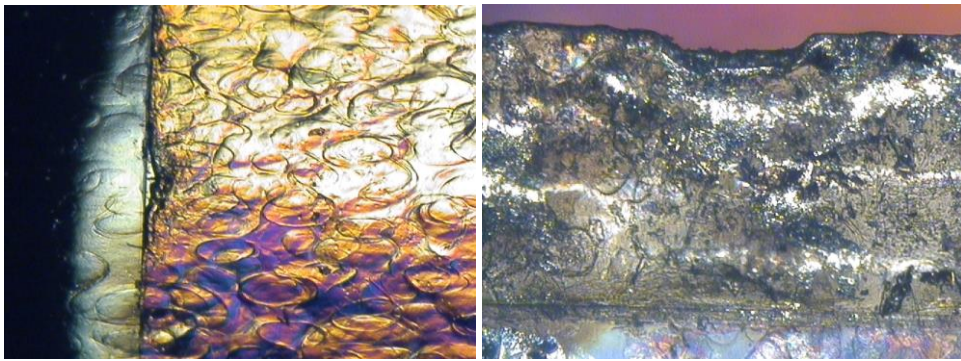
Figure 12

Fig. 13. Microscopically examined 470 nF capacitor: a) deteriorated edge of metalized foil with a slight metal loss, b) identifiable junction of the sprayed metal head and the metalized foil (visible border line along the bottom part).
