## NON-DESTRUCTIVE DIAGNOSTICS OF CONCRETE CANTILEVER BEAM AND SLAB BY IMPACT ECHO METHOD

Magdalena RUCKA<sup>1</sup>, Krzysztof WILDE<sup>1,2</sup>

<sup>1</sup> Department of Structural Mechanics and Bridge Structures, Faculty of Civil and Environmental Engineering, Gdansk University of Technology

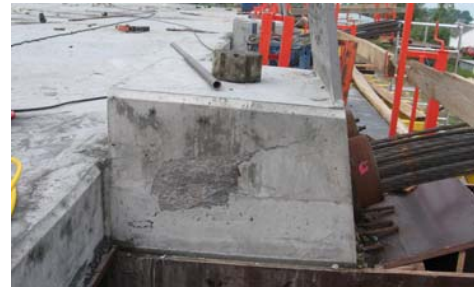
The object of the study is the road bridge (Fig. 2) in Nowy Dwór Gdański over the road no. 7 Gdańsk-Warsaw. During construction process the cantilevers of transverse beams were prestressed according to the plan (this state is referred here as 'state 0'). After prestressing process, cracks and cavities appeared on the cantilever surfaces (Fig. 3). Therefore repair operation was undertaken in the form of additional reinforcement and new gunite parts, but the cracks were not injected before gunite process. The aim of performed diagnostics was assessment of technical condition of cantilevers after repair (this state is referred here as 'state 1'). The impact-echo method was applied to non-destructive testing of the considered structure.

Fig. 3. Damaged cantilever no. 4 after prestressing

As results, a map of distribution of wave speeds in 59 measurement points was plotted in Fig. 7a for the cantilever no. 4 at 'state 1'. The average value of P-wave speed in cantilever no. 4 was 4352 m/s. There are several points in which wave speeds are significantly smaller than average value. Points in which wave speed was smaller than 90% of average values were indicated as damaged areas (points 5, 7, 11, 12, 22, 23, 36, 37, 54). They are marked in Fig. 5 and they cover with localization of cracks observed at 'state 0' (c.f. Fig. 3).

In order to improve reliability and safety of the bridge, the injection of the epoxy resin was preformed. Both cantilevers were injected with about 5 liters of epoxy resin, and then ultrasonic testing was repeated. After injection the values of wave speeds considerably increased and the distribution of wave speeds became regular (Fig. 7b). In the cantilever no. 4 wave speeds hold in the range of 88% to 110% of the average values.

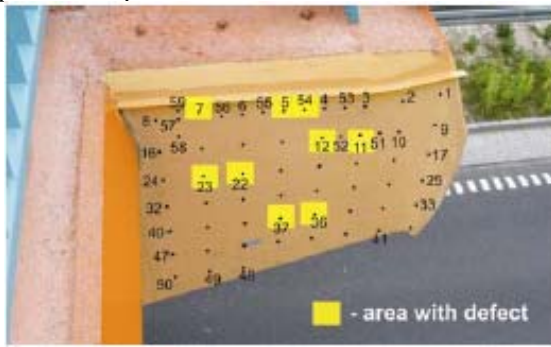
Measurements have been made on two cantilevers, no. 3 and no. 4, as indicated in Fig. 2b. Waves were generated on the left side of the cantilever, while the accelerations were measured on the left side as well as the right side (Fig. 4b). Measurements were performed at selected 59 points distributed on the cantilever surfaces. Location of measurement point is illustrated in Fig. 5. The distance of the wave travelling was constant for each point and equal to 0.986 m.

Fig. 5. Measurement points for cantilever no. 4 with marked damaged areas

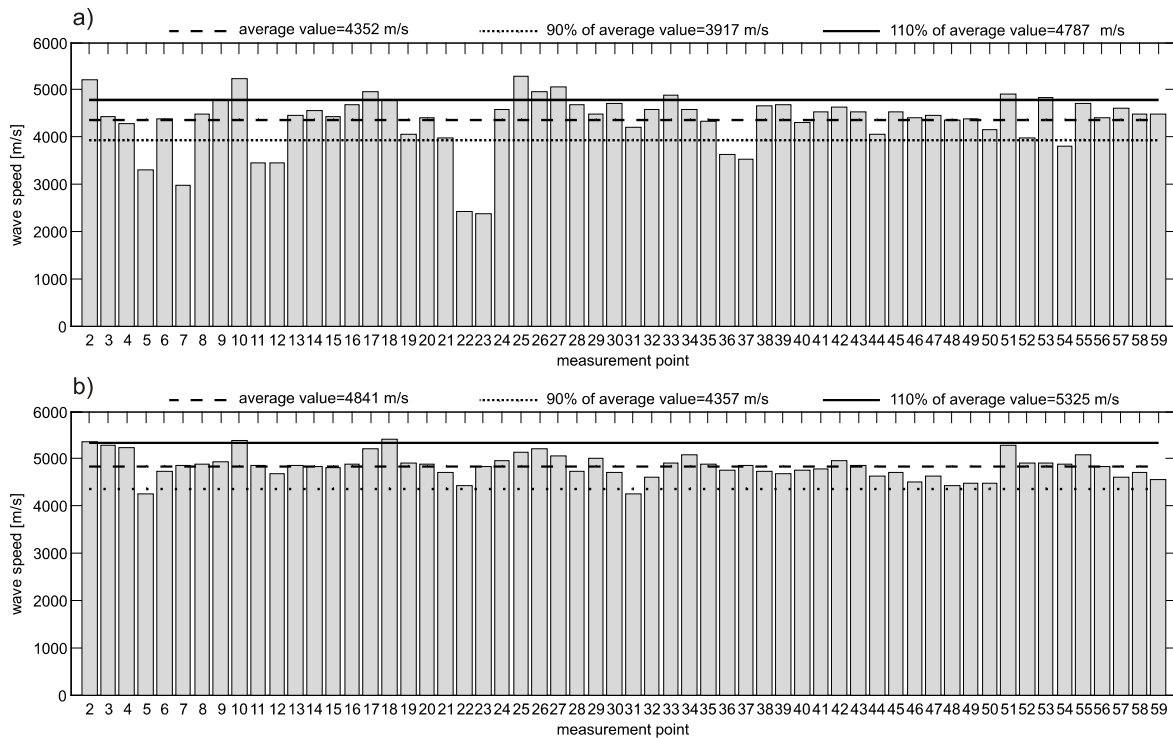
Fig. 7. Distribution of wave speeds in measurement points: a) cantilever at 'state 1'; b) cantilever after injection ('state 2')

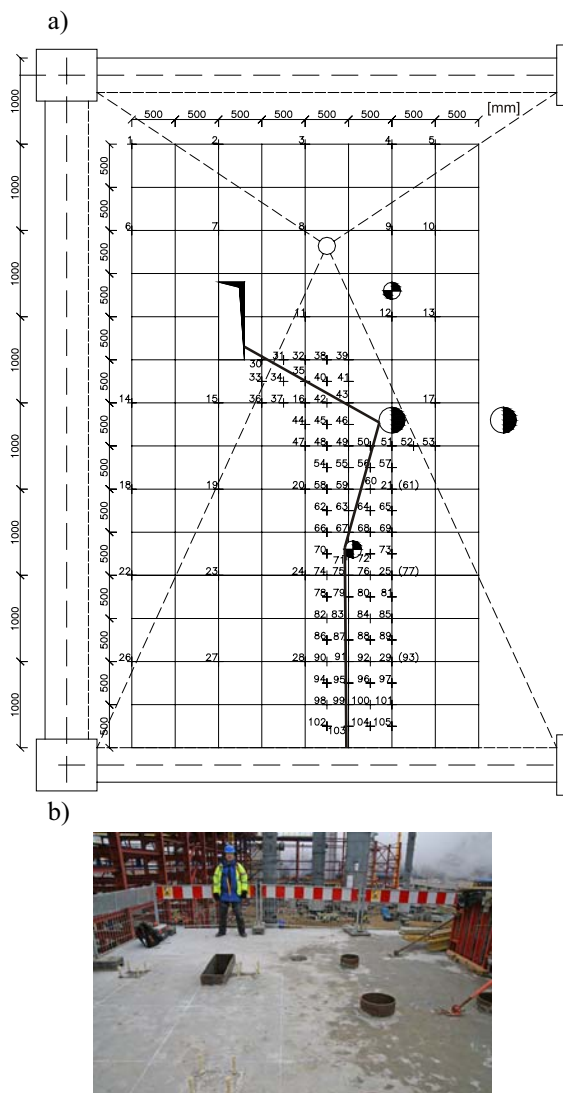
The object of the research was the concrete floor slab (Fig. 8). Due to disturbances in concrete delivery during the slab casting, the homogeneity of the concrete became in question. The non-destructive test was performed with the use of the impact-echo method to determine presence of discontinuities.

The geometry of the slab is shown in Fig. 8a. The number of measurement points was 105. They were distributed along the line of potential discontinuity, depicted as thick solid line in Fig. 8a. The hardware equipment was the same, as in the case of bridge measurements (c.f. Section 3.2). In this experiment, one-side measurement was performed, i.e. both mechanical impact and acceleration measurements were realized on the upper side of the slab only. The slab height, varied from 17 to 19 cm, was calculated in the measurement points based in known slab slopes.

Fig. 8. Concrete floor slab: a) geometry and measurement points; b) the photo

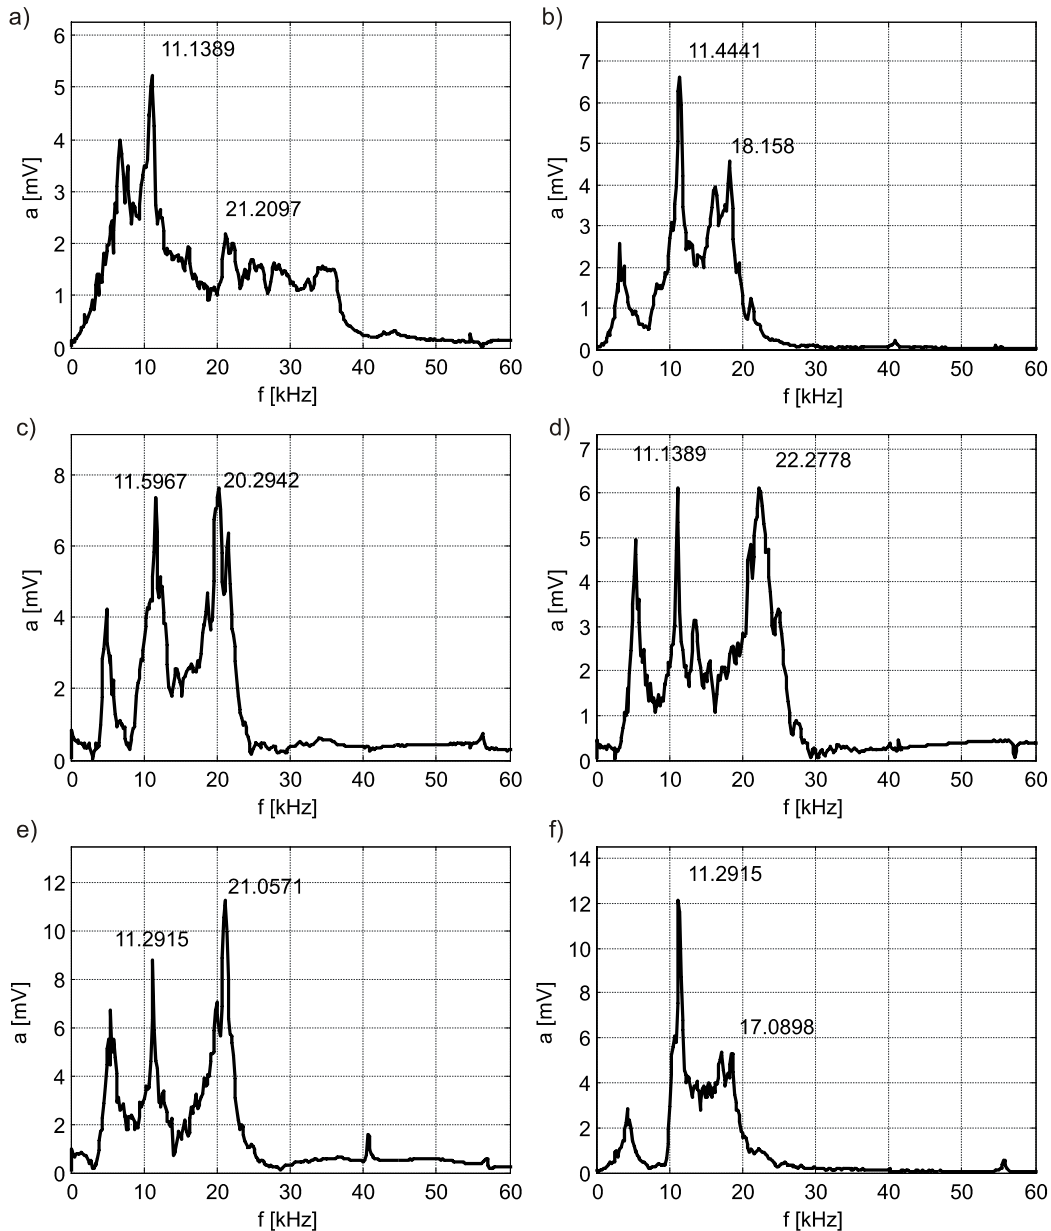
Fig. 10. Spectrums of signals measured at selected points: a) point 30; b) point 31; c) point 32; d) point 33; e) point 34; f) point 35

Spectral responses in majority points were similar to the spectrum shown in Fig. 9b. However, in points no. 30 to 35 additional peak appeared in the signal transformed to the frequency domain. Fig. 10 shows spectra for points 30 to 35. For all these points, additional peaks appeared of frequency 17.0898 kHz to 22.2779 kHz. The presence of higher frequencies indicates reflection of wave from internal defect at depth about 10 cm (from 8.96 cm to 11.84 cm). Points 30 to 35 were situated in the neighbourhood of the line of potential discontinuity.
