## **SOME ADJUSTMENT AND EXPLOITATION PROBLEMS OF THE CONTROLLABLE PITCH PROPELLER PNEUMATIC AND HYDRAULIC CONTROL SYSTEMS**

**Czesław Dymarski**

*Gdansk University of Technology  
Faculty of Ocean Engineering and Ship Technology  
11/12 G. Narutowicza Str., 80-233 Gdańsk, POLAND*

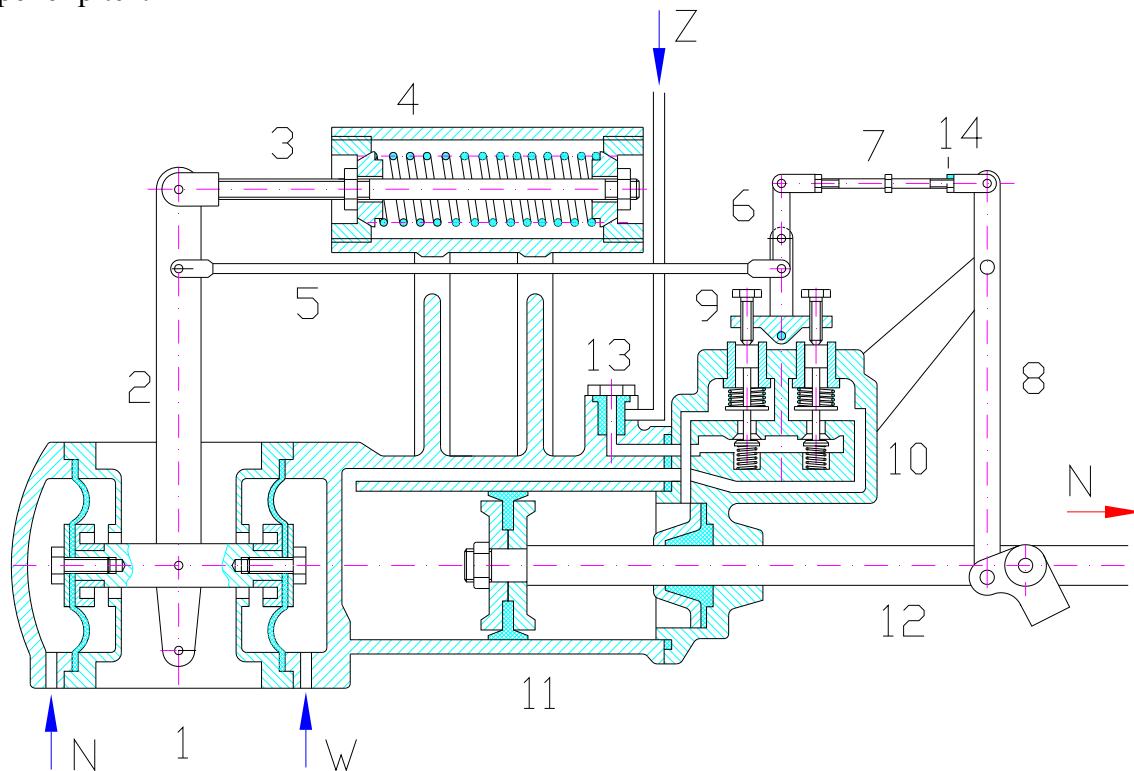
Fig. 4. A simplified drawing of the pneumatic servomotor of the controllable pitch propeller remote control system. Letter nomenclature: N – „ahead” direction, W – „astern” direction, Z – air supply.

Two hours after collision during the engine room machinery inspection the ship’s engineer spotted the broken connecting link (item 7 on fig. 4). A break intersection was at a fore face plain of a left lock-nut, which is shown on fig. 5. No other damages were found.

The remote pneumatic control system without broken connecting link was also tested. Even by very light finger pushing on the upper end of the lever 6 (on fig.4) the piston rod 12 moved in one or another direction according to direction of finger pushing. In full range of control it worked correctly. During this test I have noticed one characteristic feature of the pneumatic servomotor. It was that from each set position of the piston rod after stopping pushing on lever 6, it automatically moved to “full ahead” position.

A test of the system reaction on a rapid disconnection of the connecting link 7 and lever 6 was conducted by pulling off the pin connecting both these elements, which simulated a break of the connecting link. The simulation was done for both extreme and a few intermediate pitch settings. Every time at a moment of disconnection of the system caused a change of the propeller pitch to “full ahead” position.

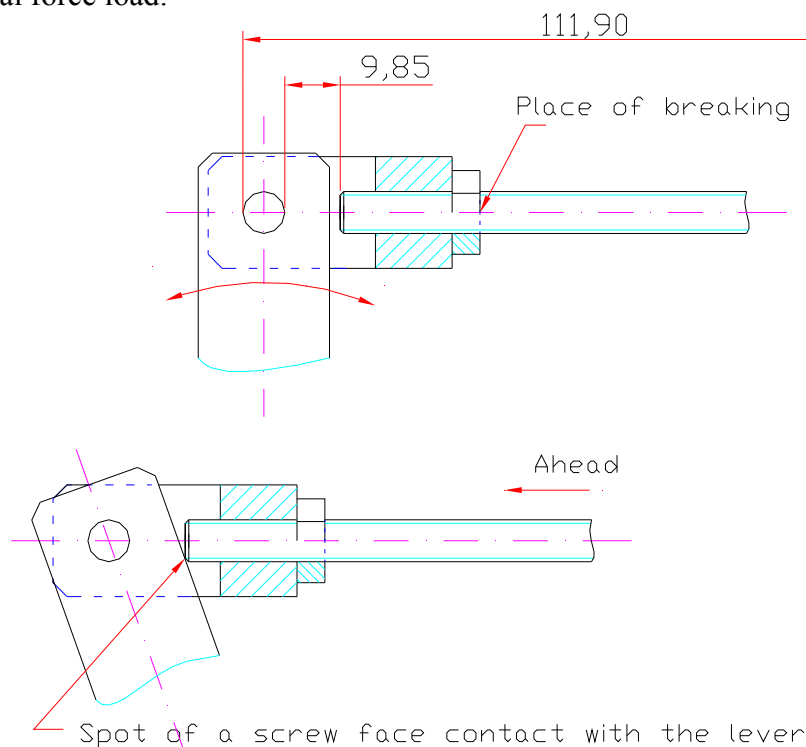
would be exactly the same as in the damaged one. Conformity of two most significant dimensions, namely a distance between outer surfaces of botch pins of connecting link and distance between the pin and face surface of the connecting link screw, which are shown on fig. 5, was checked in front of the commission.

The following tests were conducted with using the remote pneumatic control system and checking conformity of the set values with real values of the propeller pitch during a few full cycles of the pitch changing. Also this time the system worked correctly. In this situation I have decided to repeat last test changing gradually, step by step the propeller pitch and each time observing and touching the connecting link 7, gently pressing it by finger. In almost all steps the pressing connector displaced slightly crosswise in a clearance range, but just in positions “full ahead” and close to it the connector tensed and stiffened. Precise observation of this connection unit revealed a reason of this stiffness. Just in mentioned above position close to „full ahead”, a face surface of the connector link screw rested against the lever 6 in such way, as is shown on fig. 5. Because of it, a bending moment in the screw was generated. This additional bending moment load was undoubtedly many times bigger than a nominal axial force load.

Fig. 5. An articulated joint of the connecting link with the lever in “zero” and “full ahead” positions with shown two dimensions checked in front of the commission

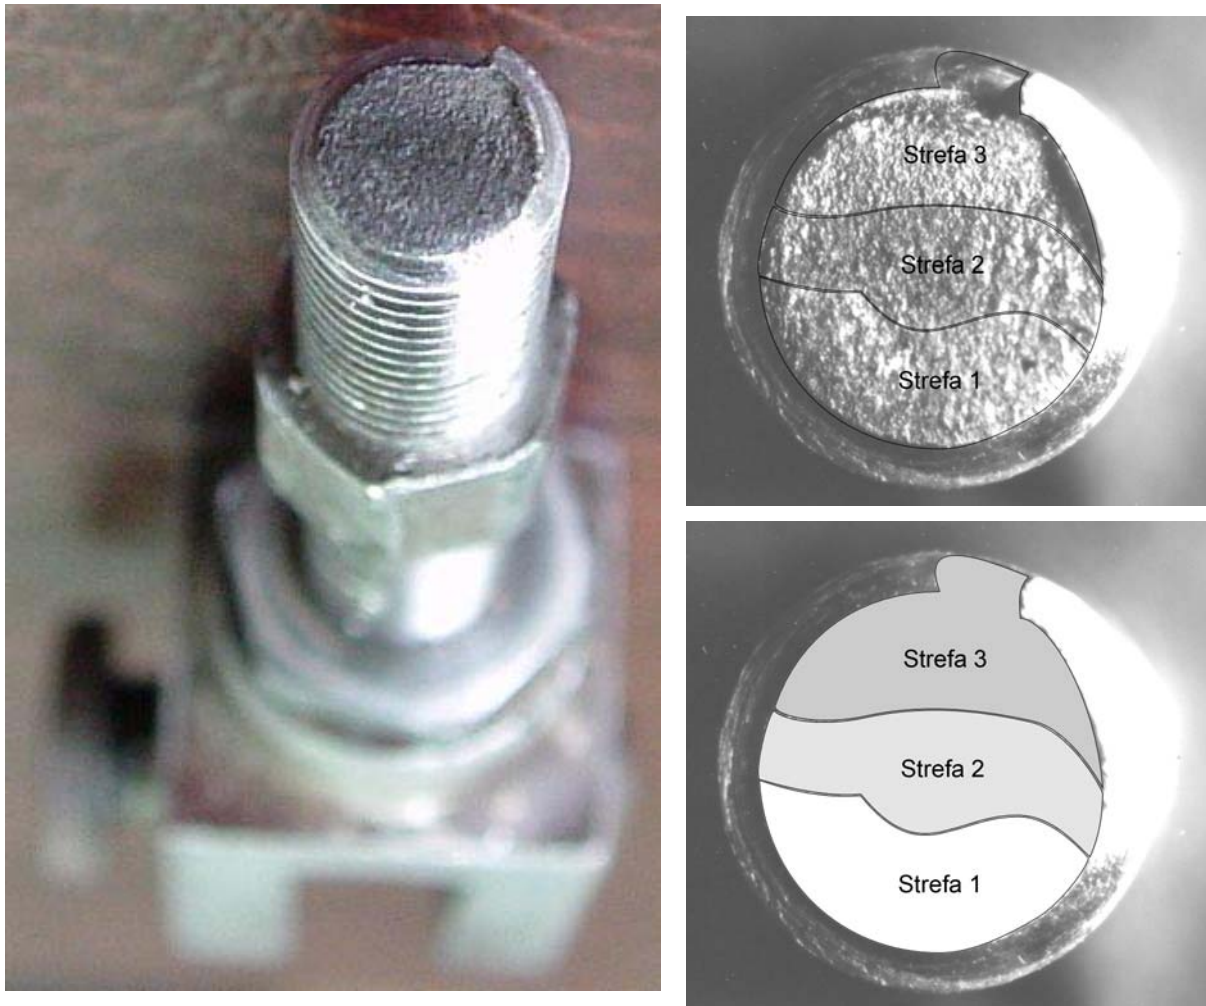
Apart from described works a metallographic examination of a broken screw surface was conducted at the Faculty of Ocean Engineering and Ship Technology of Gdansk University of Technology Laboratory. The results of the examination shown that the connecting link breaking was caused by material fatigue under influence of changing bending moment loads in a long period of time.

Photographs of the screw fatigue fracture with marked zones of conducting fatigue damages are presented on fig. 6. A fatigue crack was a result of acting in the first area a parallel but displaced in comparison with a screw axe force in long period of time, what generated a bending moment. This kind of load caused sequential “opening” and “closing the fatigue crack which propagated in the zone”2” direction. With the passage of time the crack was slowly increasing and after reaching the zone “2” the increase was successively faster because of a more significant decreasing of a loaded cross-section area and growing value of stresses. When the crack reached zone “3” about 60% of a screw cross-section area was lost and stresses excided strength of the material what caused final breaking

The above presented analytical works and inspections as well as the CPP control system tests and a metallographic examination of the fatigue fracture enabled to find a real reason of the collision. It was an incorrect adjustment of the feedback elements connection in the pneumatic servomotor unit. More precisely speaking the screw of the connecting link 7 was too deep screwed in the lug at the side of lever 6 (fig. 4 and fig. 5). Because of it, every time in the “full ahead” propeller pitch position the screw face contact with the lever occurred. It caused an additional load of the bending moment on both these elements. The moment was acting at a vertical surface of their movement. The effects of such loads were most unfortunate for this screw, because its cross-section area was the smallest and the thread was a significant notch. It should be marked that during the nominal work the load of the screw, that is – axial force being very small, about 1 N, the generated stresses could not cause such damage. But the additional periodic bending moment loads were multiply bigger and generated much higher stresses. Value of these stresses was lower than static strength so did not caused short term breaking, but repeating continuously in long period of time led to fatigue breaking. Mechanism of this kind of damage was explained in the metallographic examination of a broken screw surface report [1].

It is worth mention that there is conformity of the damage area propagation direction with the bending moment acting surface, what is noticeable on fig.6

*Fig. 3. A view of the fatigue fracture with marked zones of conducted fatigue damage*

Essentials feature of the presented CPP remote control system was its incorrect adjustment contradictory to a rule widely accepted in engineering that damage of any control system or supply unit element should cause stoppage of the device or switching over on the most safe operation conditions. In this case a break of the connecting link should have caused a setting change rather to “full astern” than “full ahead”. It should be marked that modern CP propellers are made with a blade geometry designed in such a way to generate on its surface hydrodynamic forces and moments automatically causing the turning of the blade, from each actual pitch to “full astern” position. It is advantageous from two reasons. Firstly, in case of any failure the hydraulic control system and oil pressure drop the propeller pitch

automatically changes to “full astern” position, which causes decrease of the ship velocity. It enables to switch off the main engine at the proper moment and to stop the ship. Secondly, a constant direction of external load assures system operation with a slightly one-direction tensioned elements, which eliminates an influence of the any clearance and increases accuracy of the CPP control system.
