Operational causes of fatigue failures within passages of gas turbine engines

Zbigniew Korczewski, Assoc. Prof.
Gdansk University of Technology

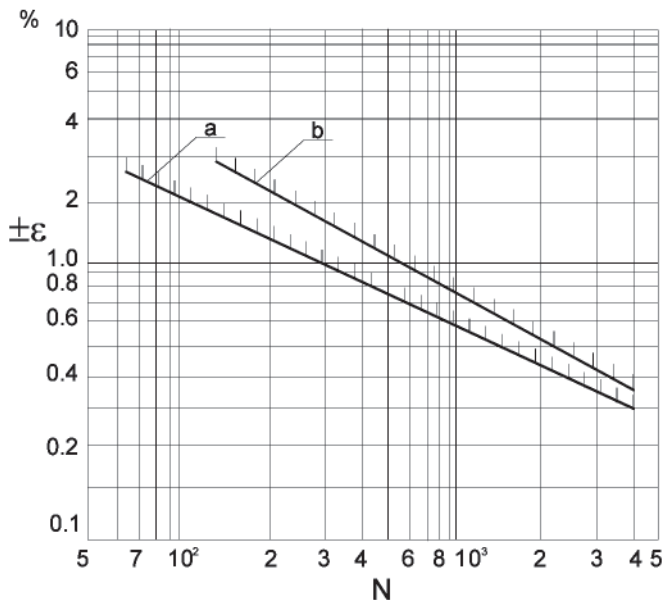
If low-cycle fatigue characteristics of a structural material are known it can be possible to easily determine a number of cycles after which surface cracking may happen, depending on a single amplitude value of the strain ϵ which occurs during one heating-cooling cycle of the material operation, Fig. 8.

From the numerical data given by the fatigue characteristics the conclusion can be made that if the engine, for example an UGT3000 Zorya engine, has to be started 2÷3 thousand times during its life-time determined to be 12 years equivalent to 4 thousand working hours, then one-sided deformations of the material (short-range local strain) should not exceed 0.2÷0.3%, at each start-up, [15].

Fig. 8. Low-cycle fatigue characteristics: ϵ – strain (single amplitude), N – number of cycles (heating - cooling), **a, b** – fatigue limit (shown for two different materials)
