H. Smoleńska, W. Kończewicz¹

Gdańsk University of Technology, Faculty of Mechanical Engineering, Department of Materials Science and Engineering, Gdansk, Poland

FAILURE ANALYSIS OF THE EXHAUST VALVE FACE IN DIESEL MARINE ENGINE

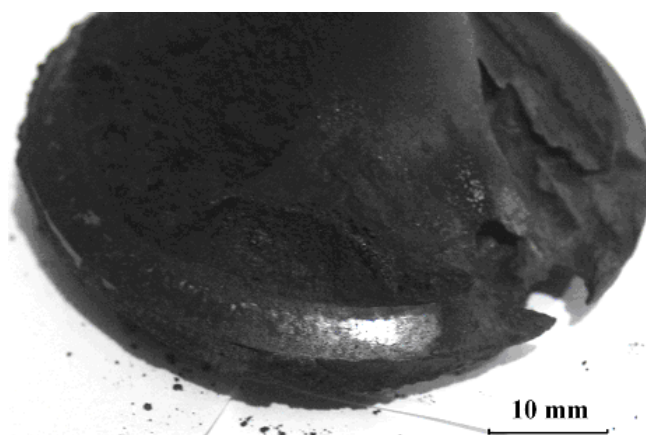
The failed valve head was presented on fig.1. The part of the face and valve disk was completely destroyed while the rest of the valve head had no visible damages. Even the valve face was still shining in the great deal.

Fig. 1. Macro photograph of the failed valve head

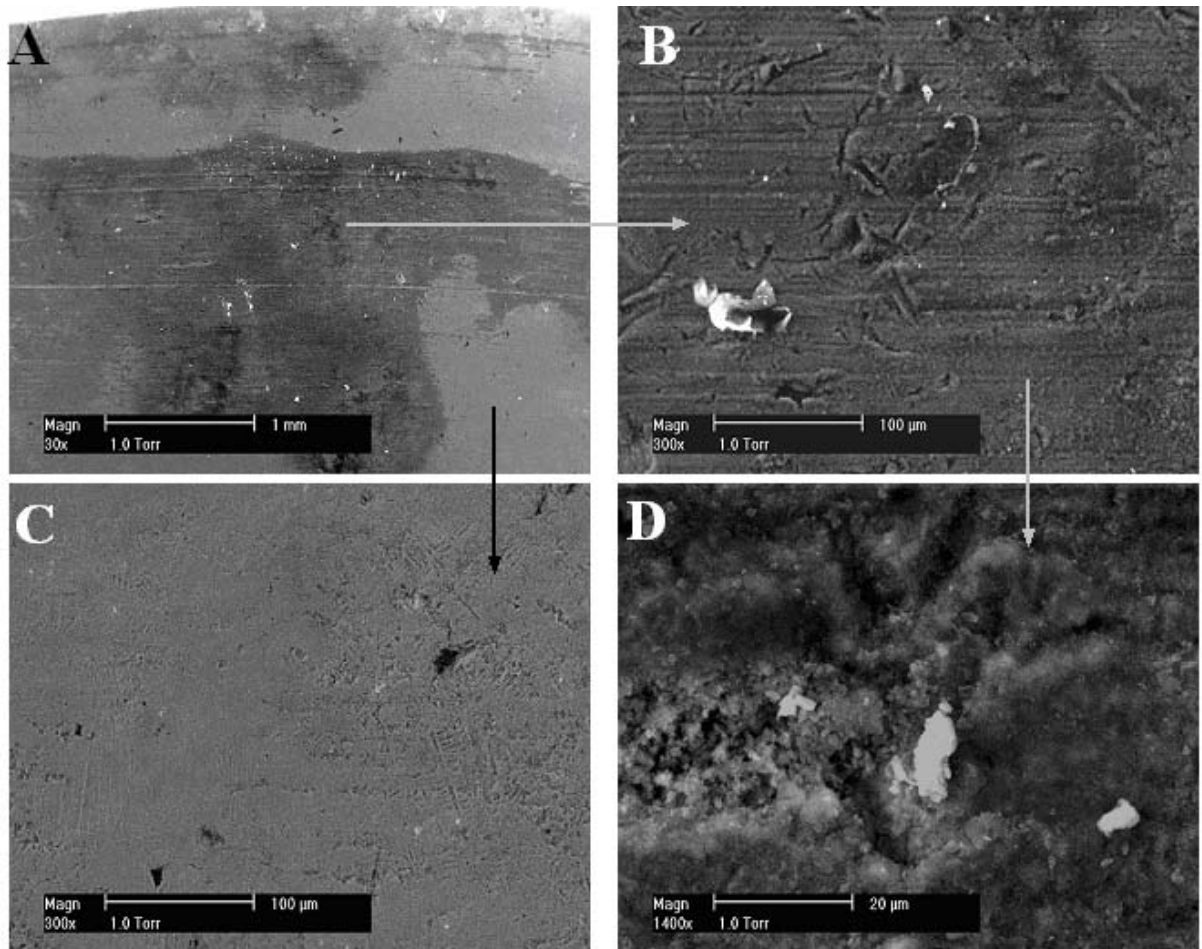
The results of the observation of the undamaged face were presented in Fig.2. The “dark” and “white” regions were noticed. The higher magnification of these “white” (Fig.2B) and “dark” places (Fig. 2C) allowed to state that the “dark” region were more intensive worn, even plastic deformed, than the “white” regions. Additionally the remains of the corrosion products were noticed in the “dark” region (Fig.2 D).

Fig. 2. SEM pictures of the undamaged face surface: A- the whole surface; B- higher magnification of the “dark” region; C- higher magnification of the “white” region; D- high magnification of the “dark” region

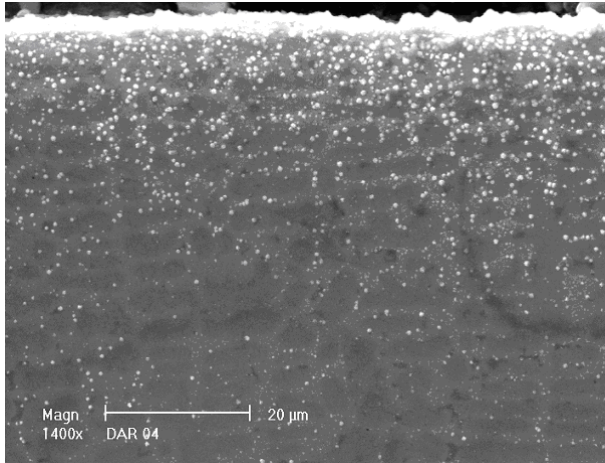
The radial cross-section, prepared through the valve face surface, were ground and polished according to standard metallographic practise. Fig. 3 shows the microstructure of the clad surface for the both samples. The photographs present typical dendritic structures however for the Fig. 3a additionally the undefined white precipitates are visible. Chemical analyses revealed differences in the composition of the clad layer. The results of EDS analyses are presented on fig. 4. The “damaged” region is enriched in most of the alloying elements (especially in molybdenum and nickel) while higher amounts of cobalt and silicon is noticed in undamaged region. Such a chemical composition is not conformable with the powder which should be applied according with the design.

Fig. 3a. SEM cross-section micrograph of the clad layer surface, close to the damaged region (A)

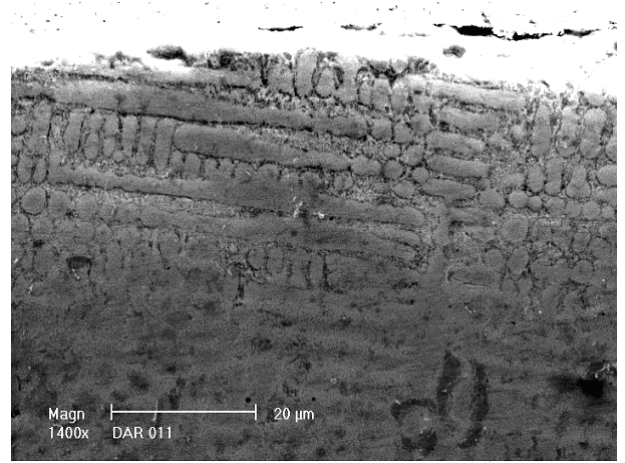
Fig. 3b. SEM cross-section micrograph of the clad layer surface from undamaged region (B)

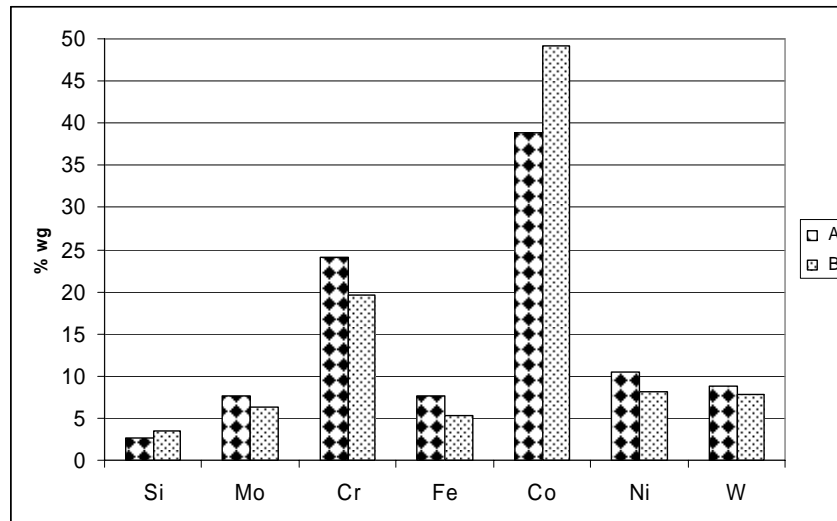
Fig. 4. Chemical analysis from the micro region situated close to the surface, on the cross-section of the clad, after service; A – close to the damaged region of the valve face, B – undamaged region of the valve face

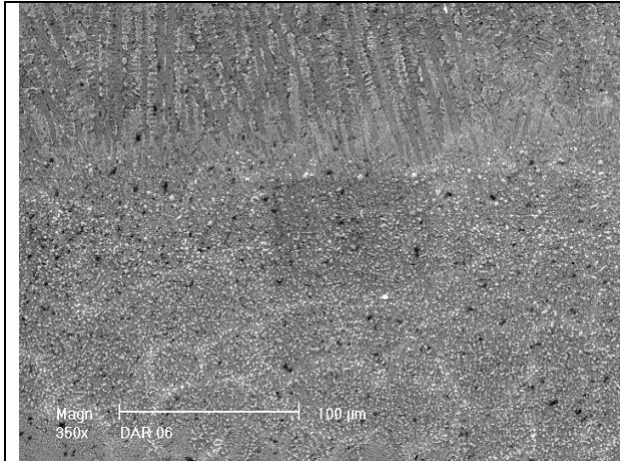
Metallurgical observation of the part of the clad situated deeper from the surface provided rather surprised picture of the microstructure. In the middle region of the clad both dendritic and globular structures are observed. Such a dual microstructure was similar for all region of the valve (Fig. 5a and 5b). Also chemical composition of these regions is different how ever for undamaged part of the valve those differences are less dramatic. Fig. 6 and 7 presents the results of the analysis.

Fig. 5a. SEM cross-section micrograph in the middle of the clad layer, close to the damaged region (A)

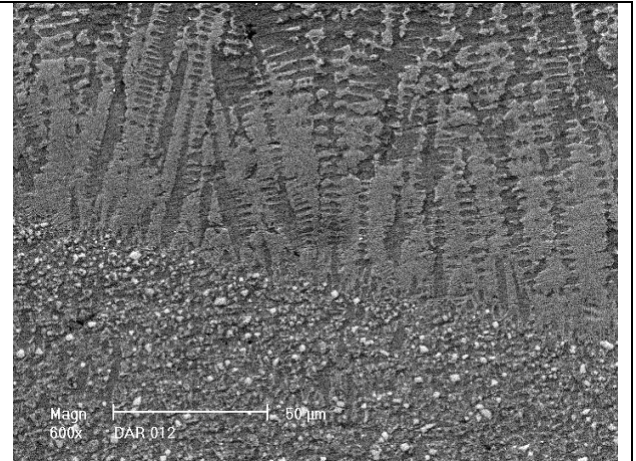
Fig. 5b. SEM cross-section micrograph in the middle of the clad layer from undamaged region (B)

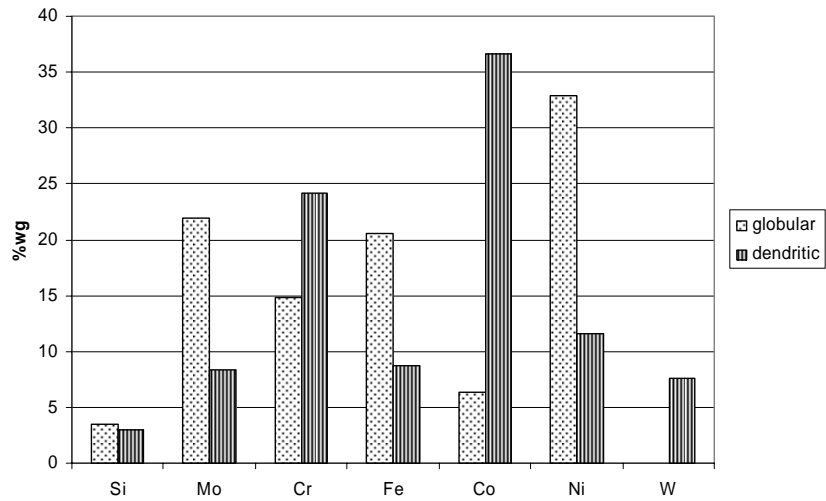
Fig. 6. Chemical analysis from the micro region situated in the middle of the clad, close to the damaged part (A) of the valve face, for globular and dendritic regions from the fig. 5a

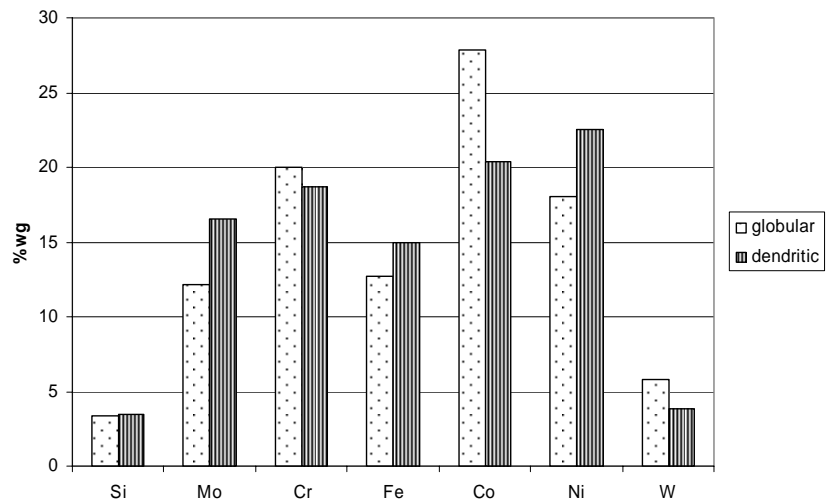
Fig. 7. Chemical analysis from the micro region situated in the middle of the clad, undamaged part (B) of the valve face for globular and dendritic regions from the fig. 5b

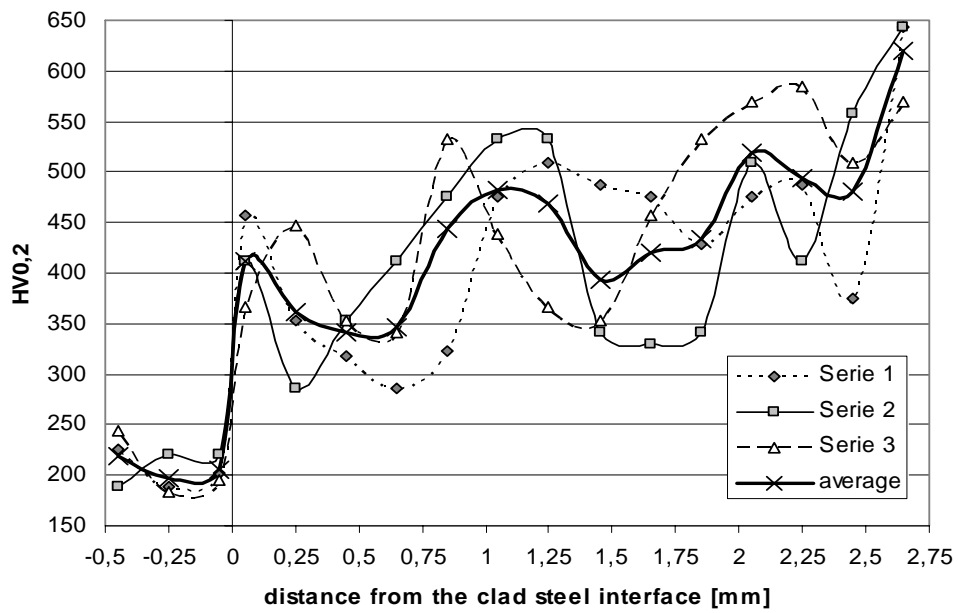
Fig. 8. Average hardness numbers for sample A (damaged region)

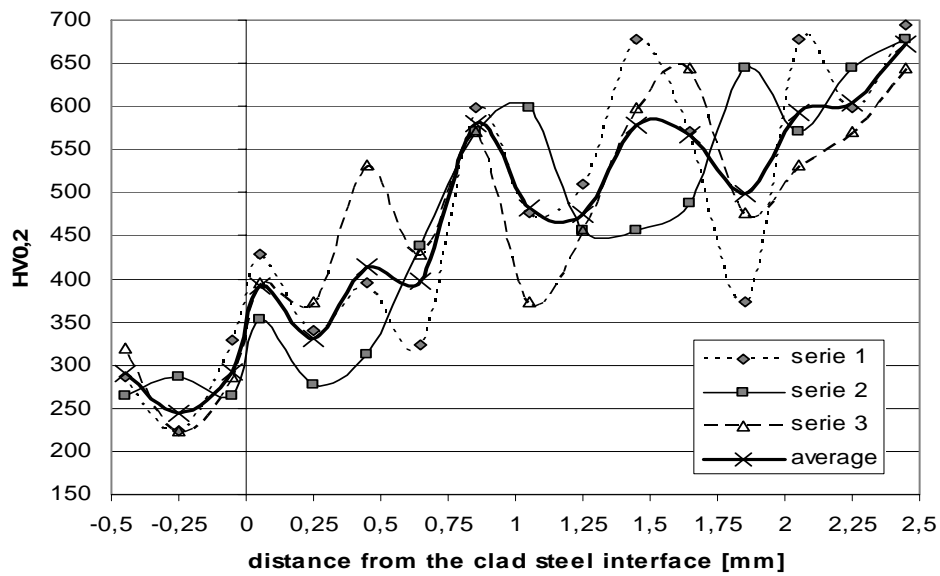
Fig. 9. Average hardness numbers in sample B (undamaged region)

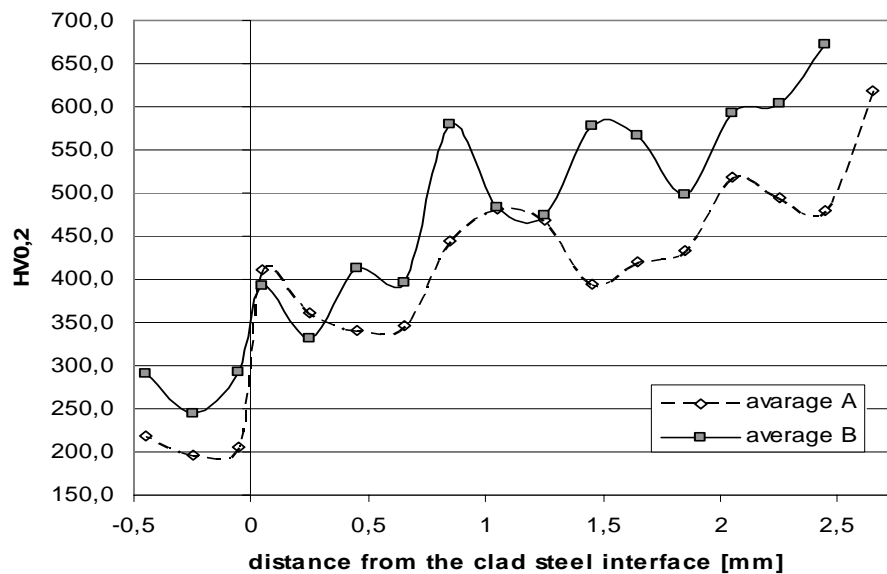
Fig. 10. Comparison of average numbers for A (damaged) and B (undamaged) region

Undamaged region presents higher hardness especially in the outer area of clad layer. It may result with the higher wear resistance and service time for this part of the valve face. However such huge differences in chemical composition, microstructure and mechanical properties are unacceptable for the safe reasons. Probably there were any disturbances during the cladding process which resulted with improper chemical composition (mixed powders) and improper microstructure (improper cladding parameters?). Generally producer did not keep regimes of the product engineering.
