H. Smoleńska, W. Kończewicz¹

Gdańsk University of Technology, Faculty of Mechanical Engineering, Department of Materials Science and Engineering, Gdansk, Poland

FAILURE ANALYSIS OF THE EXHAUST VALVE FACE IN DIESEL MARINE ENGINE

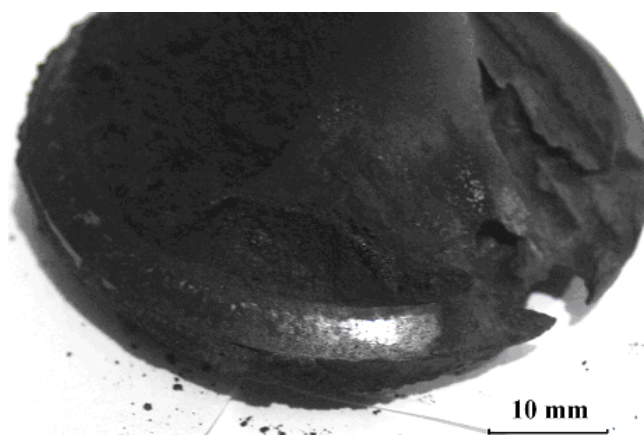
The failed valve head was presented on fig.1. The part of the face and valve disk was completely destroyed while the rest of the valve head had no visible damages. Even the valve face was still shining in the great deal.

Fig. 1. Macro photograph of the failed valve head

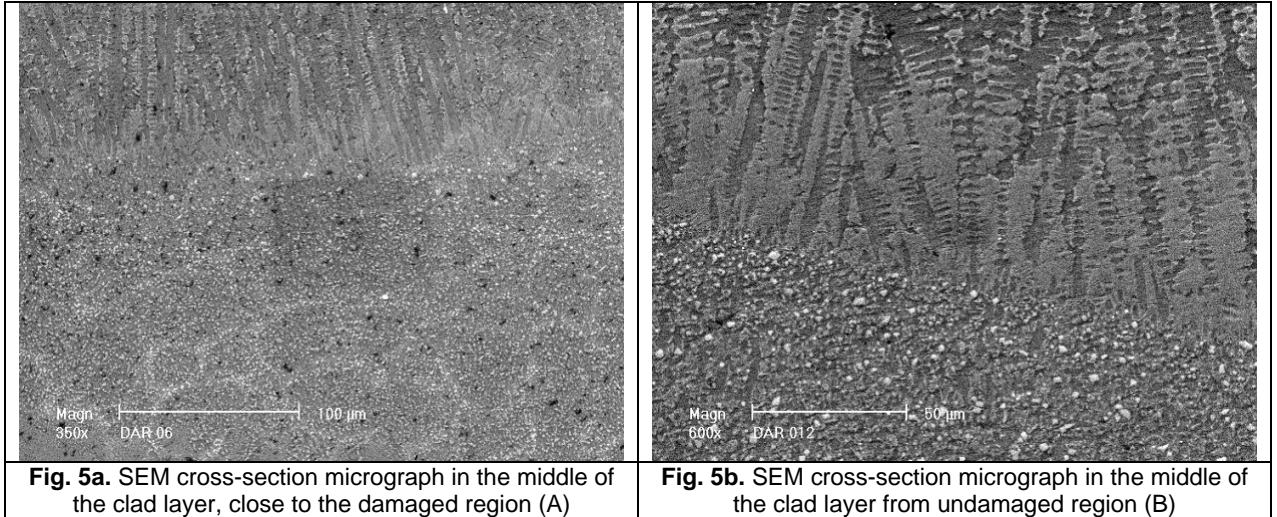
Metallurgical observation of the part of the clad situated deeper from the surface provided rather surprised picture of the microstructure. In the middle region of the clad both dendritic and globular structures are observed. Such a dual microstructure was similar for all region of the valve (Fig. 5a and 5b). Also chemical composition of these regions is different how ever for undamaged part of the valve those differences are less dramatic. Fig. 6 and 7 presents the results of the analysis.

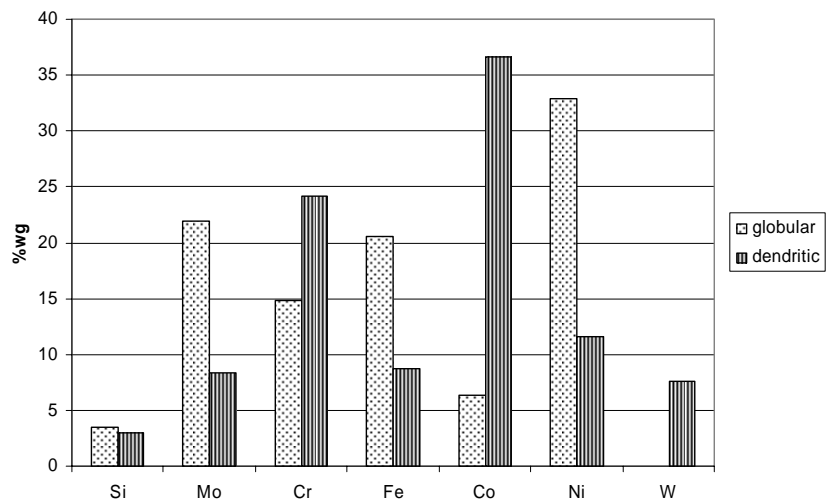
Fig. 6. Chemical analysis from the micro region situated in the middle of the clad, close to the damaged part (A) of the valve face, for globular and dendritic regions from the fig. 5a

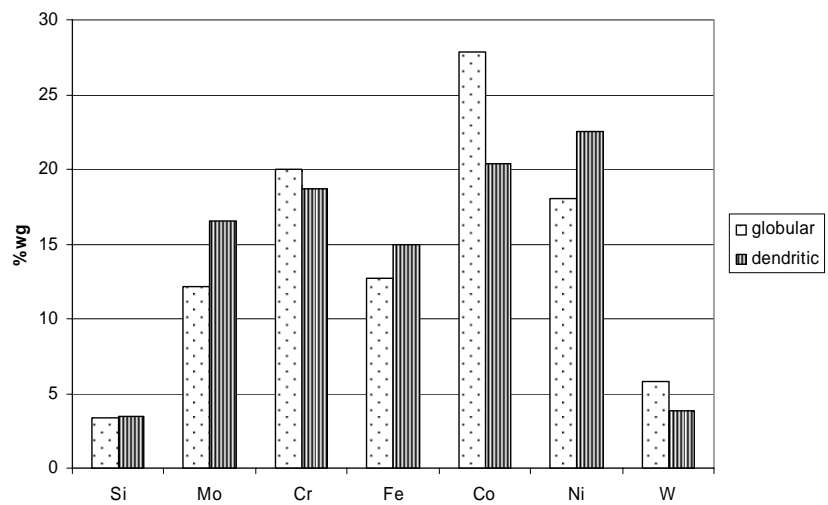
Fig. 7. Chemical analysis from the micro region situated in the middle of the clad, undamaged part (B) of the valve face for globular and dendritic regions from the fig. 5b
