J. Hucińska, G. Gajowiec

Gdansk University of Technology, Mechanical Engineering Faculty, Gdansk, Poland

ASSESSMENT OF FITNESS FOR SERVICE OF Cr-Mo STEEL TUBES IN CATALYTIC REFORMING CHARGE HEATERS

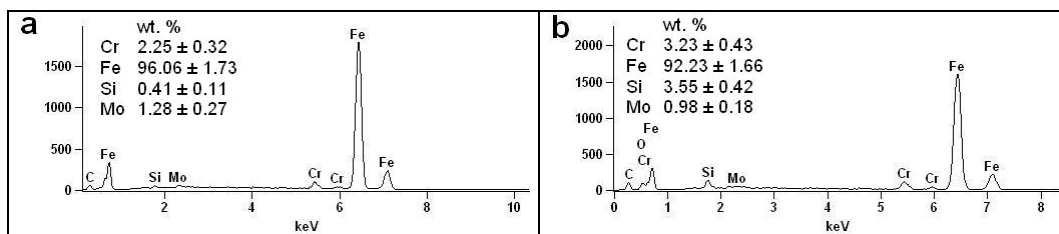
Fig. 2(a), (b). Results of SEM/EDS analyses of carbides in 2.25Cr-1Mo steel: (a) at point 2 indicated in Fig. 1(a), (b) at point 3 in Fig. 1(b)
