Case study of masts damage of the sail training vessel POGORIA.

1. Introduction.

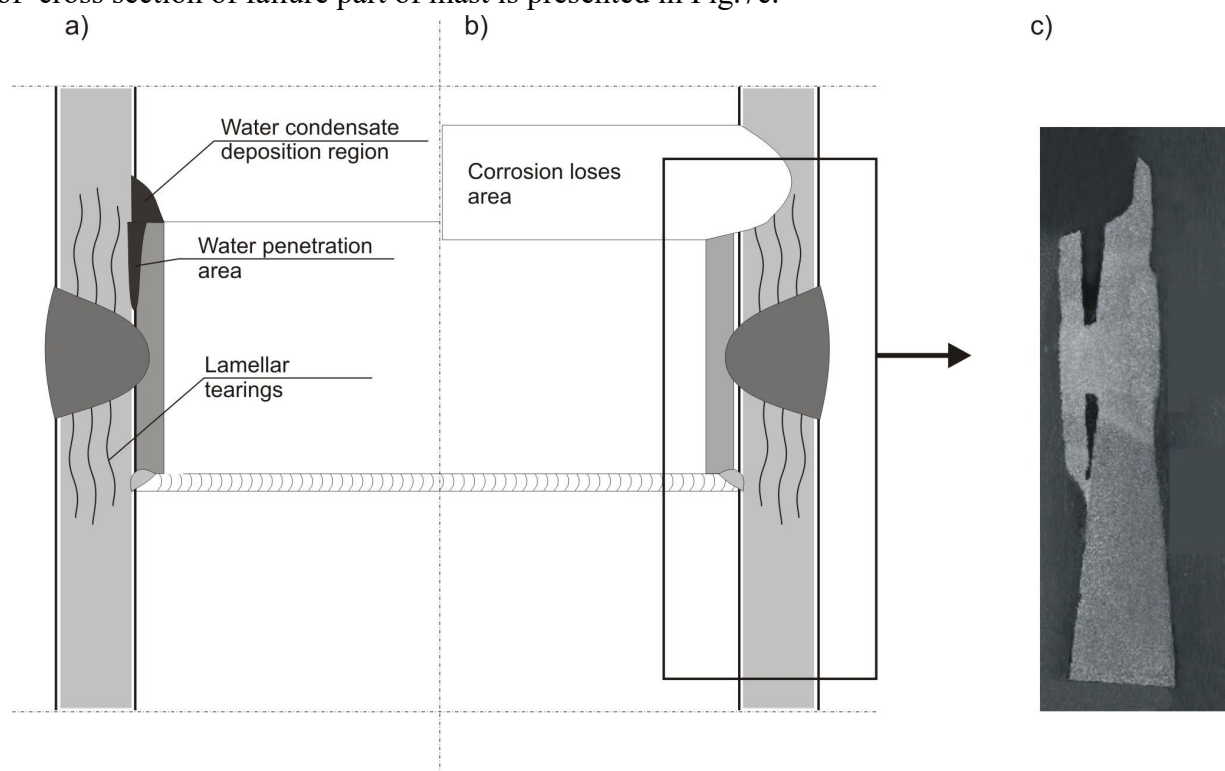
The design factor is just related with a use of the mentioned sleeves. Such a joint design caused to accumulate of water at the upper part of sleeves (fig. 7a). It appeared as the result of water steam condensation due to air temperature decreasing especially at nights. Such a phenomenon have been observed and confirmed by Pogoria crew. Designers of masts also knew about such a phenomenon because they foresaw the special ventilating openings in the upper parts of masts. Nevertheless, the accumulated water penetrated places between tubes and sleeves what contributed to accelerate corrosion of the mast skin material. (fig. 7b). Picture of phractography of cross section of failure part of mast is presented in Fig.7c.

Fig. 7. Way of destruction of the segment connection of mast tubes: a) the places of water penetration and lamellar tearing; b) places of mast skin weakening; c) fractography of corroded joint region

Analysis of the fractography of corroded region (Fig.7c) reveals, that local depth of corrosion centers is relatively high. Such type of corrosion can be described as deep local pitting corrosion. Moreover – the same picture evidences that corrosion processes developed only internally and not penetrated through whole thickness of tube wall.
