Case study of masts damage of the sail training vessel POGORIA.

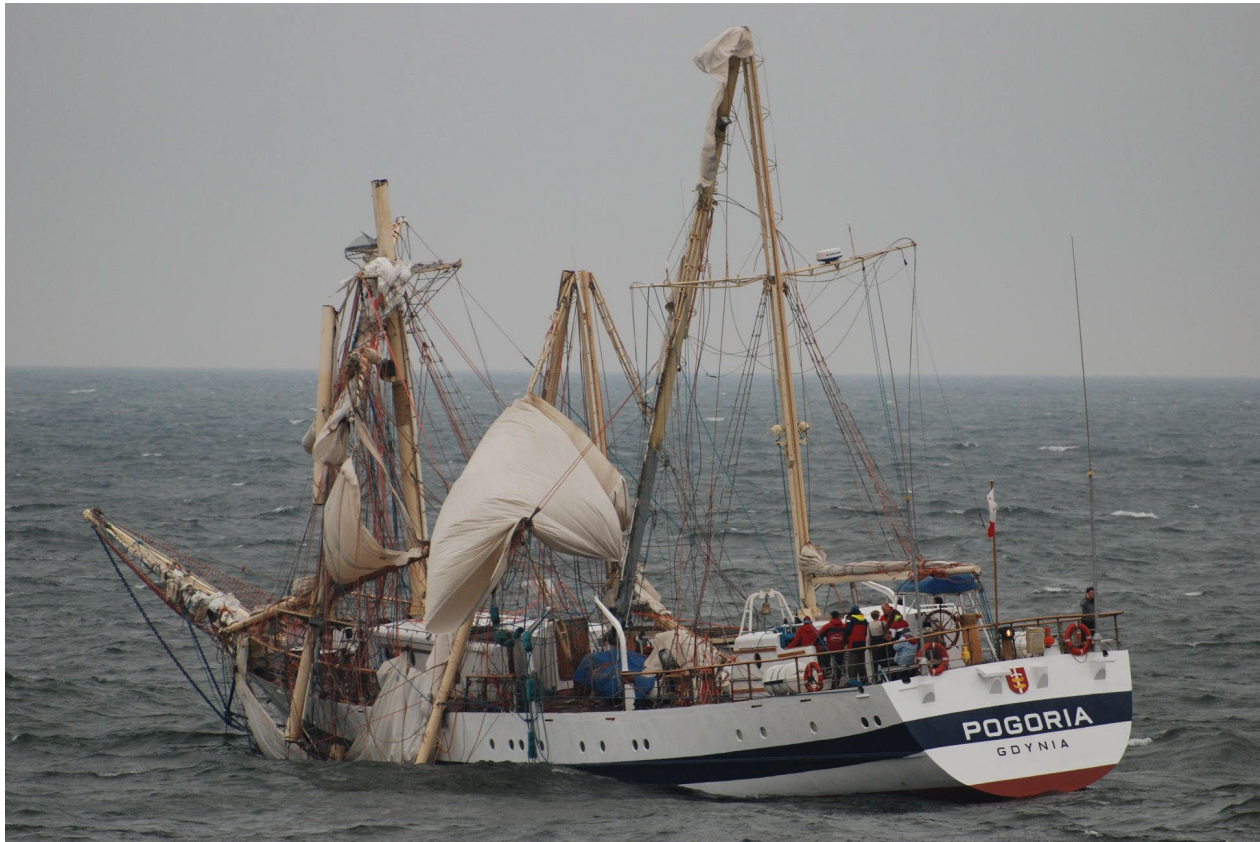
At the entrance to the Gulf of Finland (Baltic Sea), Polish barquentine Pogoria with 50 crewmembers onboard had an accident during Tall Ships Race in the first half of July 2009. All three masts were broken and destroyed both the running and standing riggings (fig. 1). Any significant consequences for the crewmembers did not come into existence.

Fig. 1. The snapshot of Pogoria made just after accident

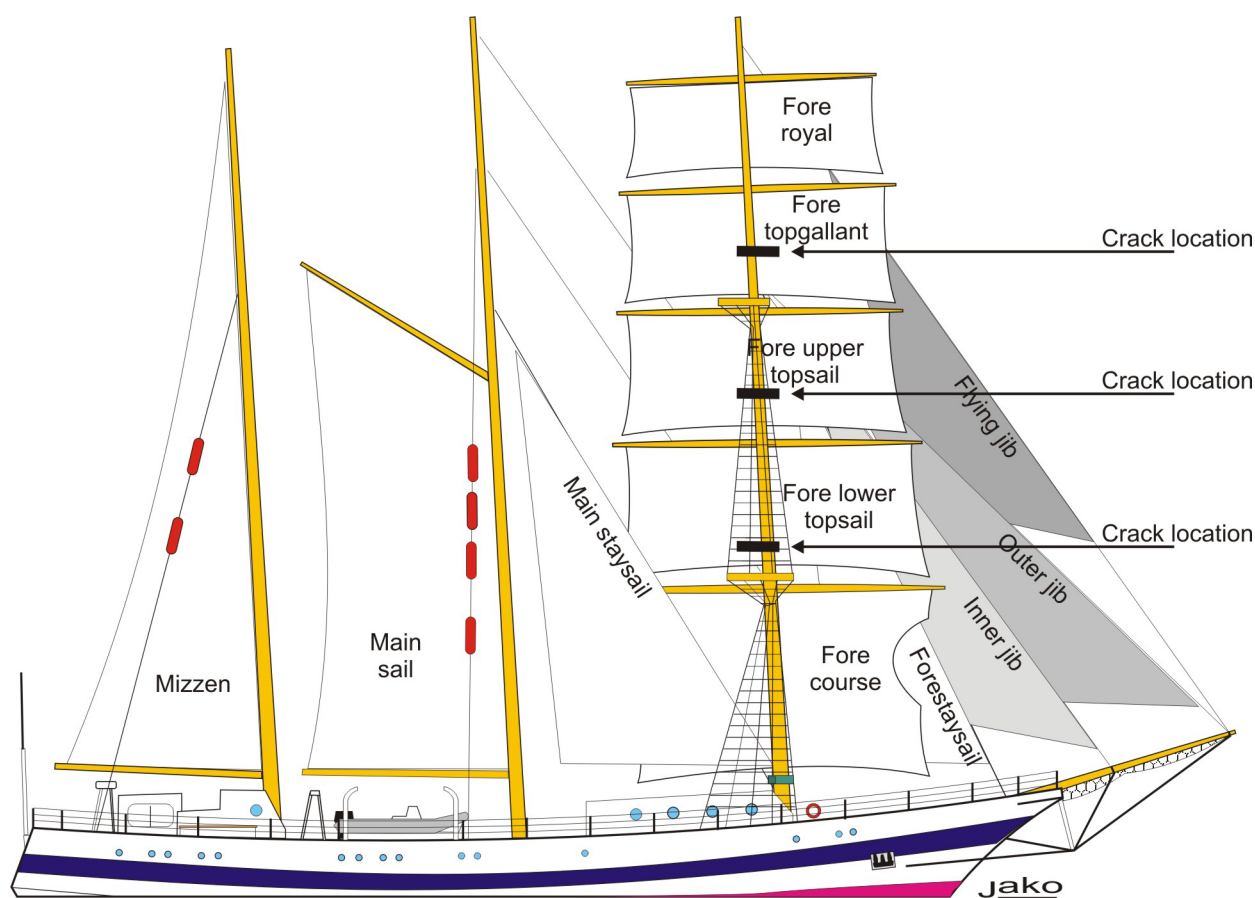
Fig.2. Pogoria sails set and foremast crack location in the moment of the accident

In our opinion, cooperation of two main factors was the direct cause of the fracture of foremast in its upper part:

- substantial weakness of the mast skin material in the determined cross-section,
- periodical action of dynamic strength triggered off by upper foremast sails called flying and outer jibs respectively.

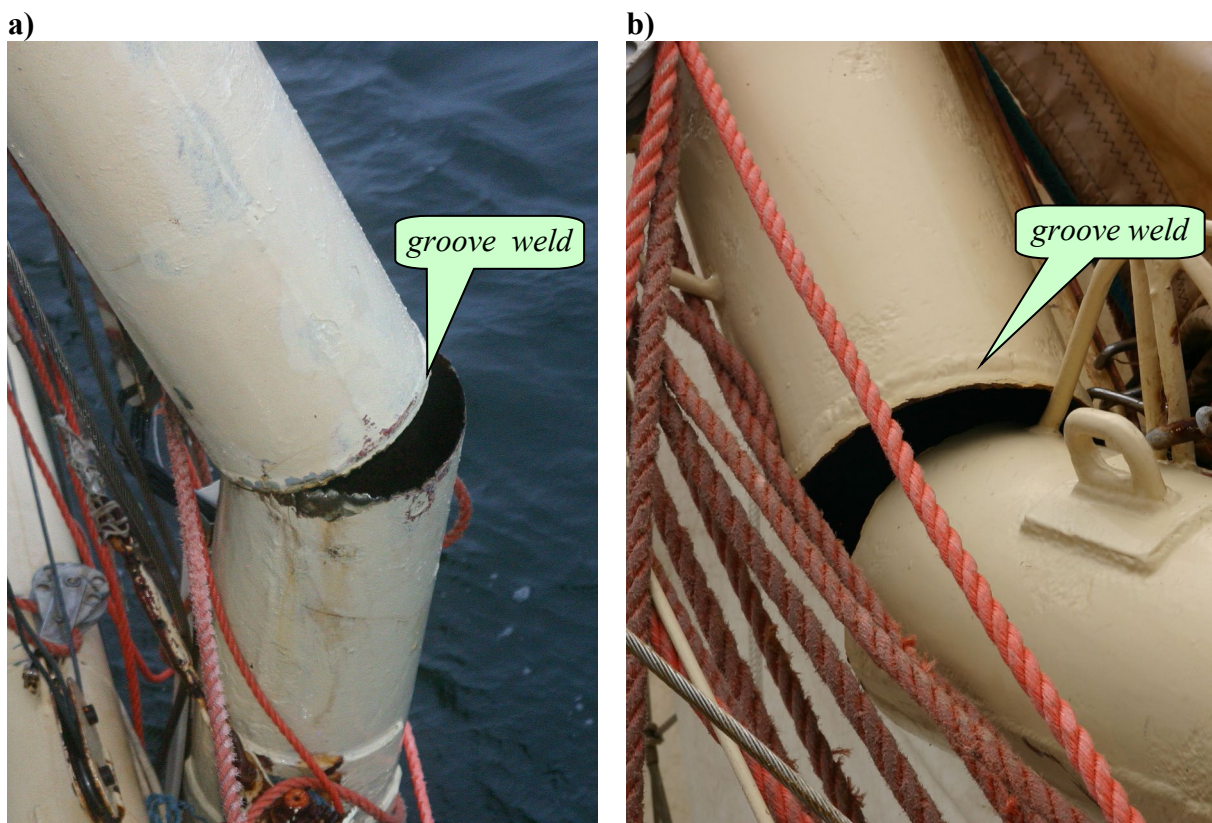
Fig. 3. Fracture examples of with marked butt welds: a) the foremast; b) mainmast.

- the material coherence of standing and running rigging was not violated, excepting a crack of the mounting eye welded to the top mizzenmast which kept the right after-back-stay,
- all weakening places were situated beneath the fusion welds connecting the individual parts of the foremast and mainmast (fig. 3a,b),
- fractures had the clear wedge sharpness at bottom parts of the broken tubes (fig. 4),
- fractures show signs of the characteristic stratification at upper parts of the broken tubes (fig. 5).

As it was already mentioned, all weakening places were situated beneath the welded connections joining the separated parts of the foremast and mainmast (fig.3). In our opinion, the accelerated corrosion of the skin material in heat-affected zones of weld joints was the main cause of the foremast and mainmast destruction. This kind of corrosion resulted from the synergic co-operation of two factors which had both the design and the technological nature.

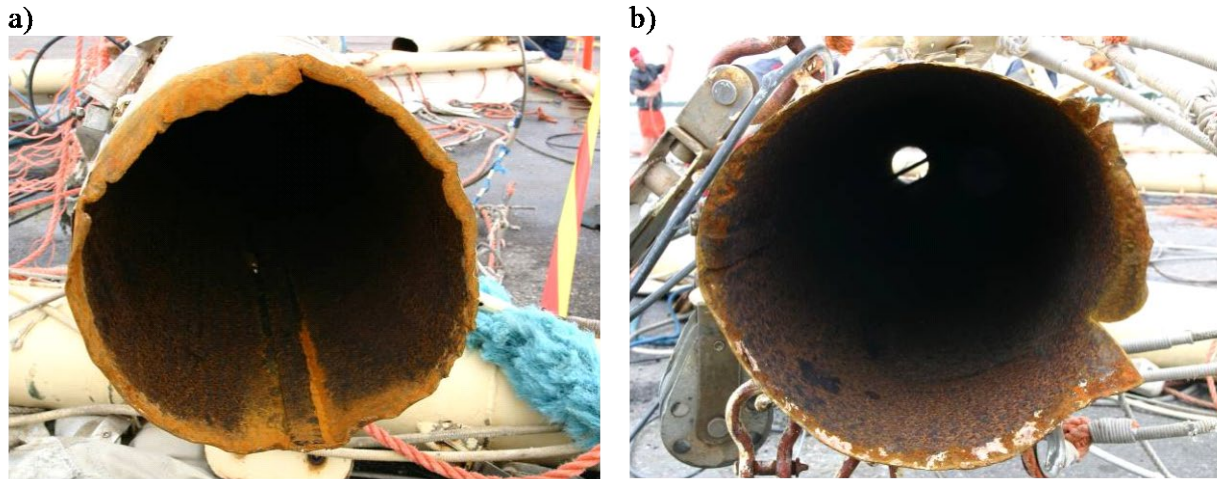
Fig. 4. Examples of the clear sharpness at the bottom parts of the broken tubes: a) foremast; b) mainmast.

Undoubtedly, the synergic cooperation both **the design and technological factors** caused to acceleration of the skin material corrosion of Pogoria masts (Fig. 6b). Such phenomenon has been proved by analysis carried out directly after the accident. It allowed us to unambiguously affirm that all mast fractures had the clear wedge sharpness at their bottom parts (Fig. 4) and the characteristic stratification at their upper parts (Fig. 5).

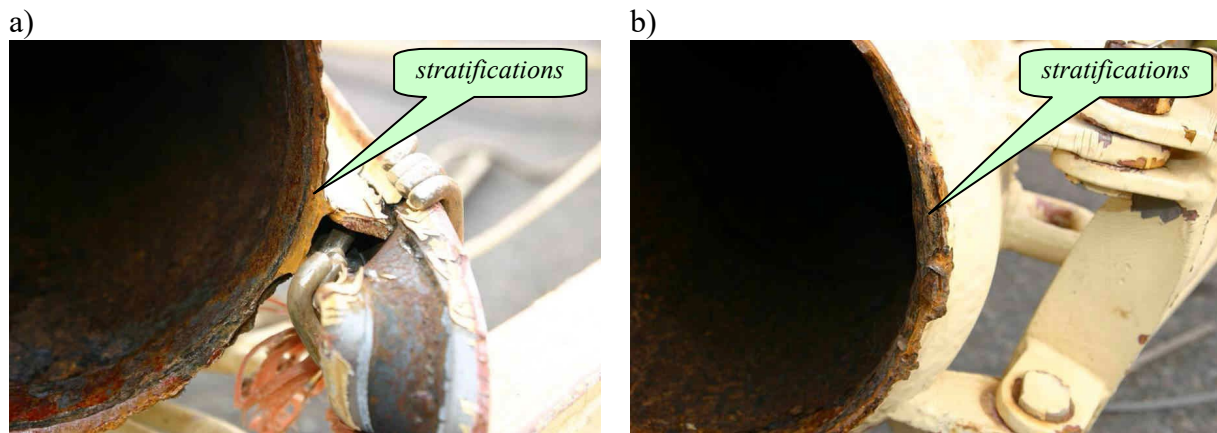
Fig. 5. Examples of the characteristic stratifications at the upper parts of the broken tubes: a) foremast; b) mainmast.

In our opinion, due to both the high transverse strain and the mast skin poor ductility in the through-thickness direction such situations occurred in welded joints of Pogoria masts because the surface of the fracture was fibrous and 'woody' with long parallel sections (Fig. 5). The orientation of the tears in butt welds of Pogoria masts are presented in Figure 6a.

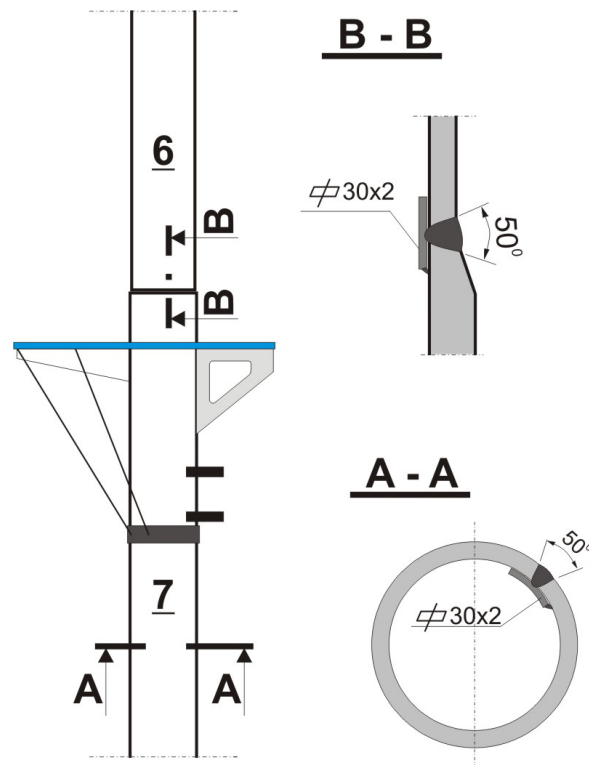
Fig.6. Mast structure and details of the joints

Individual segments of mast tubes were connected together by the butt joints with the groove weld (Fig. 6). In order to prevent various discontinuities in fusion welds (for example incomplete or lack penetrations), inside all of tubes connections were applied the special welding pads fixed by the fillet weld (Fig. 6).

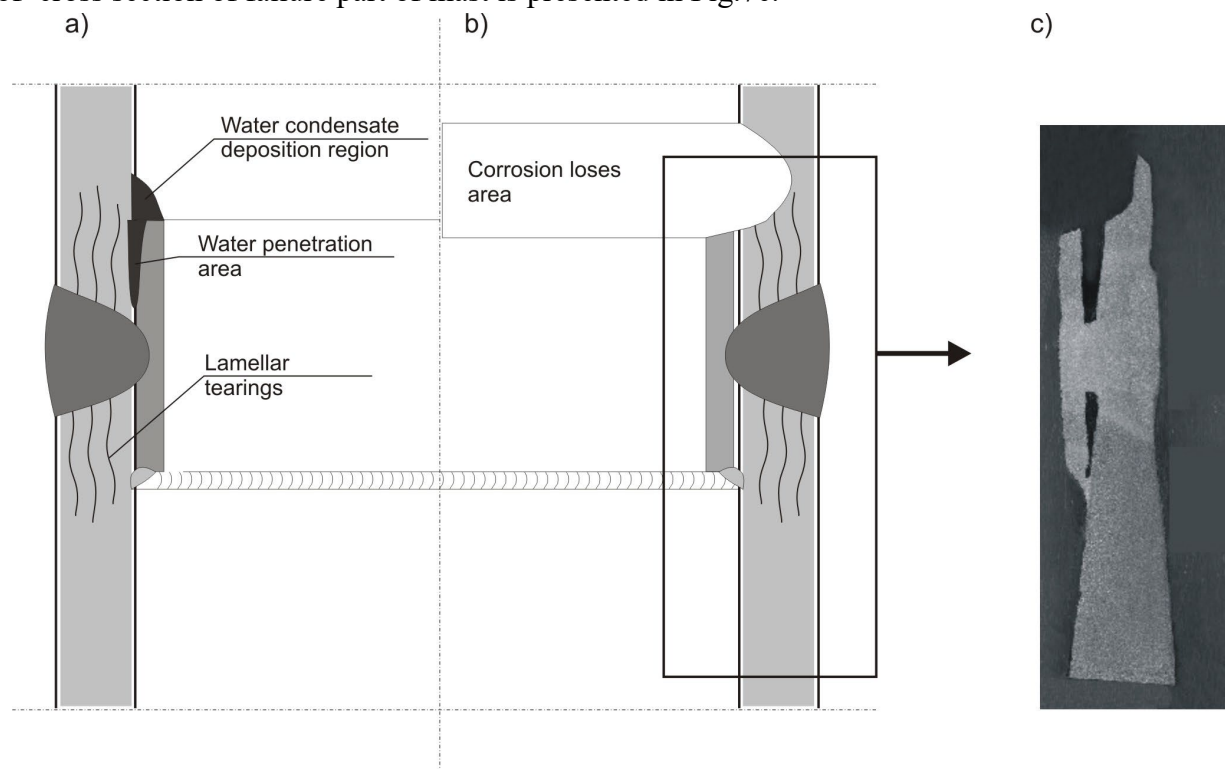
The design factor is just related with a use of the mentioned sleeves. Such a joint design caused to accumulate of water at the upper part of sleeves (fig. 7a). It appeared as the result of water steam condensation due to air temperature decreasing especially at nights. Such a phenomenon have been observed and confirmed by Pogoria crew. Designers of masts also knew about such a phenomenon because they foresaw the special ventilating openings in the upper parts of masts. Nevertheless, the accumulated water penetrated places between tubes and sleeves what contributed to accelerate corrosion of the mast skin material. (fig. 7b). Picture of phractography of cross section of failure part of mast is presented in Fig.7c.

Fig. 7. Way of destruction of the segment connection of mast tubes: a) the places of water penetration and lamellar tearing; b) places of mast skin weakening; c) fractography of corroded joint region

Analysis of the fractography of corroded region (Fig.7c) reveals, that local depth of corrosion centers is relatively high. Such type of corrosion can be described as deep local pitting corrosion. Moreover – the same picture evidences that corrosion processes developed only internally and not penetrated through whole thickness of tube wall.

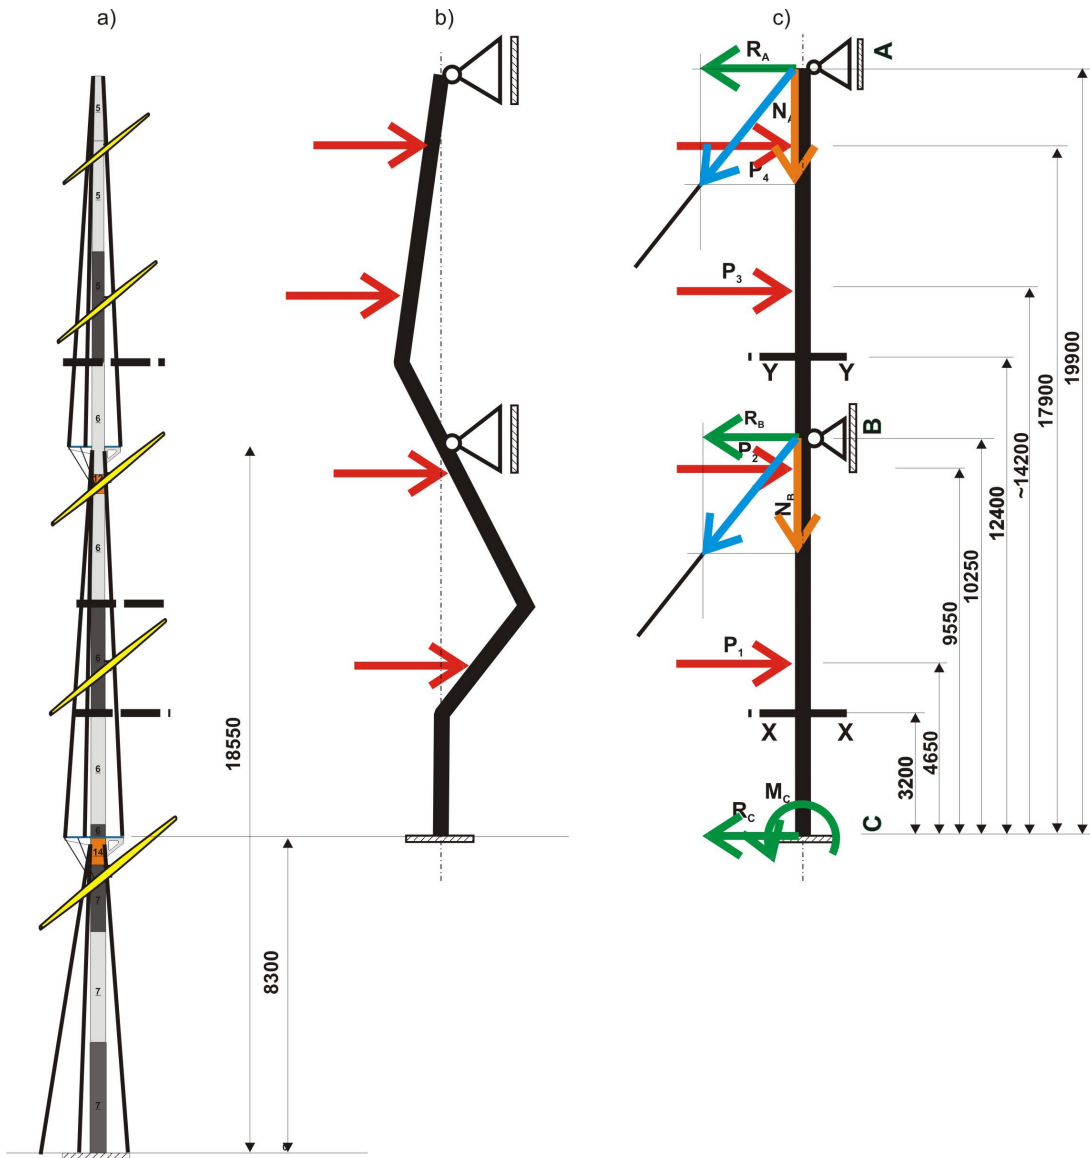
During of analyze of the pictures made just after damage (Fig.1) one can found, that beside of remained on the deck part of the foremast, rest was broken into three parts – as it marked in Fig.2 and Fig.8.b. It was certified, that during the accident, all ropes and hooks worked properly. Taking above mentioned into account, one can assumed expected model of the foremast damage – as it is presented in Fig.8.b. For the calculation, cantilever beam model semi-supported in places of platforms was applied – presented in Fig.8.c.

Fig. 8: Failure of the foremast: a) location of failures, b) model of damage, c) substitute model for calculation.

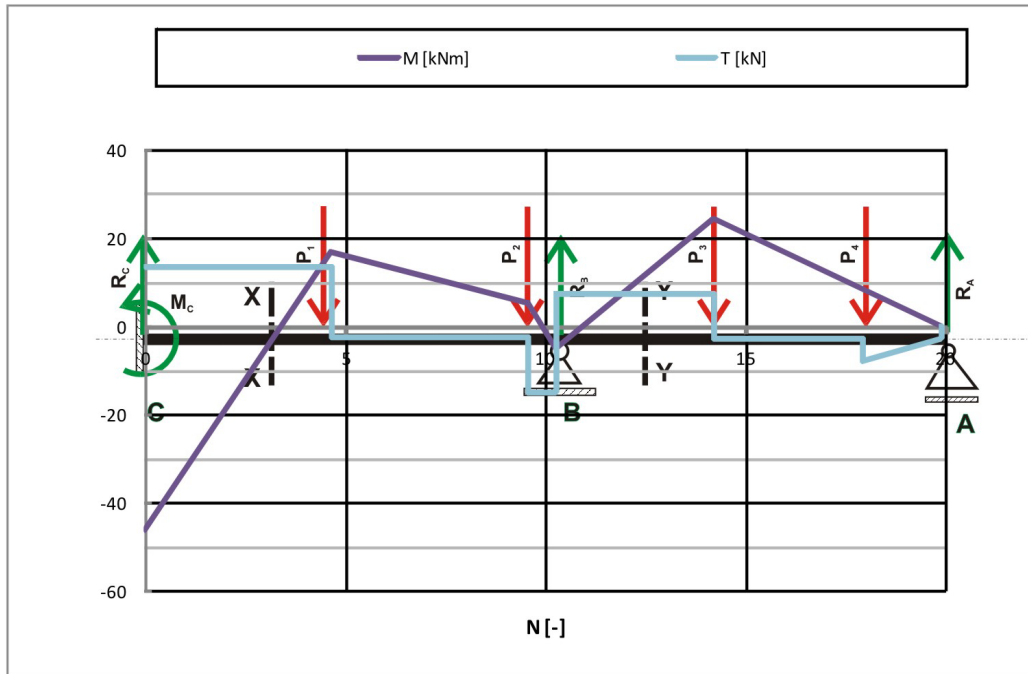
Fig. 9. Calculated distribution of the bending moment (M) and shear force (T)

For nominal design cross section parameters: section X-X: 23 [MPa], section Y-Y 32 [MPa].

For real shell thickness measured for section X-X equal 0,5 [mm]: section X-X 268 [MPa] and 308 [MPa] for section Y-Y. One can see that safety margin for non-corroded structure was about 8. Analysis of calculations shows that such corrosion like presented reduced safety margin to zero.

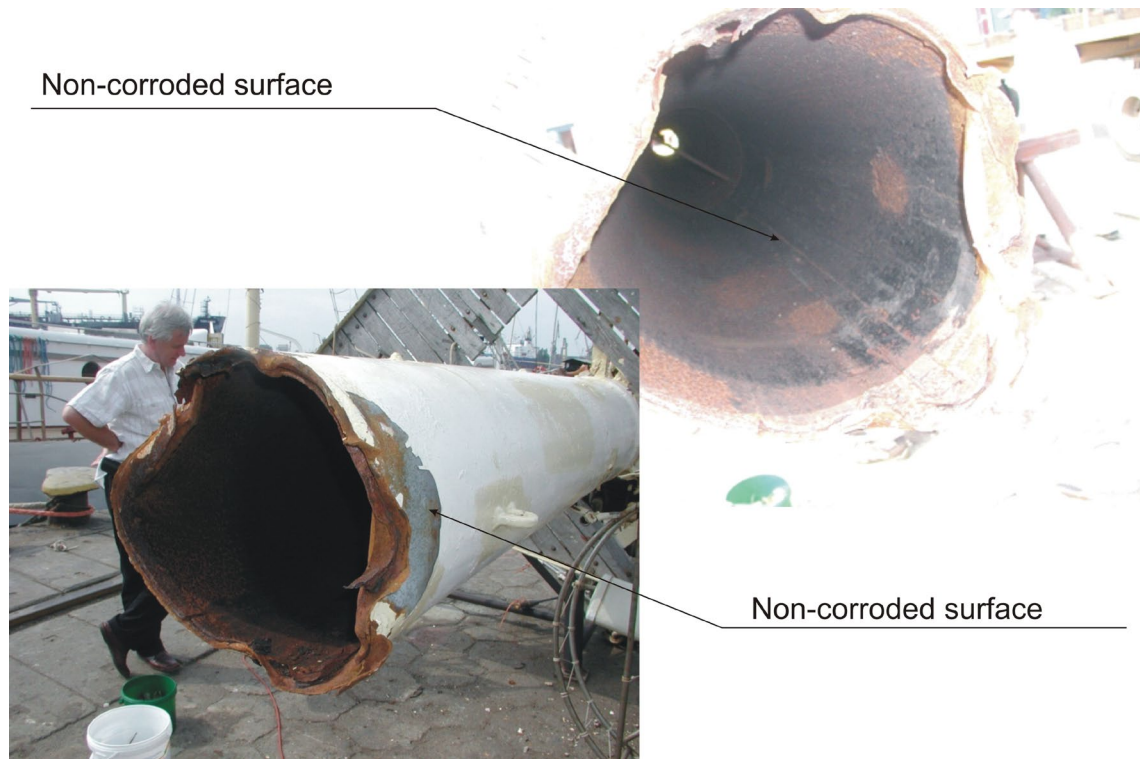
Analysis of pictures of parts of destroyed masts reveals (Fig. 10) that corroded area cover limited part of mast volume – region close adjacent to circumferential welds. Rest of the surface is steel covered – from inside by original protected coating, - from outside – by zinc layer – Fig. 10.

Fig.10. Location of the corroded area in the foremast segments

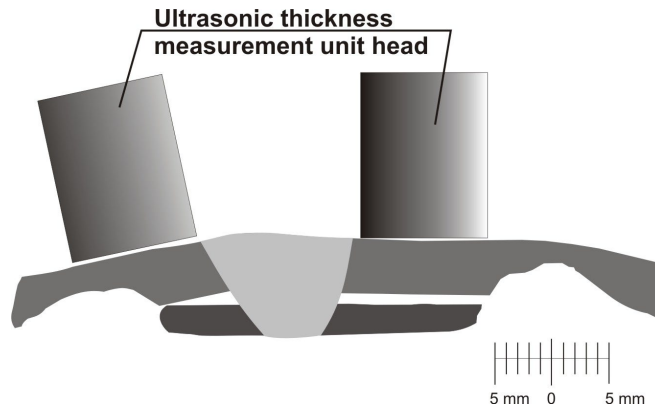
This fact means, that even after total removing of external paintings by sand blasting, it was not possible to find out of the existence of such deep corrosion loses area. From the other side application of the most common steel thickness method – ultrasonic measurement – also can bring not quite clear data due to specific of the internal joint geometry. As one can see in Fig. 11 location of the corroded regions is strictly connected with position of the welding pad in relation to butt weld centre: for one case this is region located closely to the weld fusion area, for other case – in the some distance of it. If one compare size of the typical measurement unit of ultrasonic thickness meter with size of corrosion losses, one can see that for some cases typical measurement process conducted closely to the root of the weld will not detect of the such type of corrosion losses.

Fig.11. Size of the typical ultrasonic thickness meter measurement unit on the background of contour of corrosion losses.

So during standard periodic surveying procedures, probability of detecting of such type of corrosion effects is relatively low. The last conclusion presents risk factor for such type of structure – only very careful systematic thickness measurement procedure with internal thickness profile analysis can indicate potential loosing of the safety margin.

- the possibility to predict of results of all adopted design solutions not always exists, especially with reference to a prototype unit like Pogoria,
- such a kind of event will occur in not long time maybe as a result of gravity loading,
- it is necessary to check the technical conditions on board of all sailing vessels with similar design of masts,
- it should be developed new technologies providing the high quality of welded joints in such types connections of individual segments of sailing vessel masts.
- it should be introduced new surveying standards related to the steel welded sailing vessel masts.
