# The effect of long-term service at elevated temperatures on structure and mechanical properties of Cr-Mo-V steel

**Design/methodology/approach:** Examinations were conducted on 273 mm diameter, 32 mm wall thickness tube made of 13HMF (14MoV6-3) steel. The tube was a segment of stem pipeline used in power plant at 540°C. The service time is 168,000 hours. Microstructure of the material has been examined with the use of light optical microscopy and scanning electron microscopy (SEM). The energy dispersive X-ray spectrometry (EDS) analysis was used for phase chemical composition identification. Transmission electron microscopy (TEM) of thin foils was used for carbides structure identification. The mechanical properties of the tube material were evaluated in static tensile tests at room temperature, hardness tests and impact Charpy U tests.

Examinations were conducted on one segment of  $\varnothing 237 \times 32.0$  mm fresh steam pipeline connecting the steam boiler with turbine. Tube was made of 13HMF according to PN-75/H-84024 (14MoV6-3 according to PN-EN10216-2) steel grade and was operated for approximately 168 000 hours at  $540^\circ\text{C}$  under 14 MPa pressure. The che

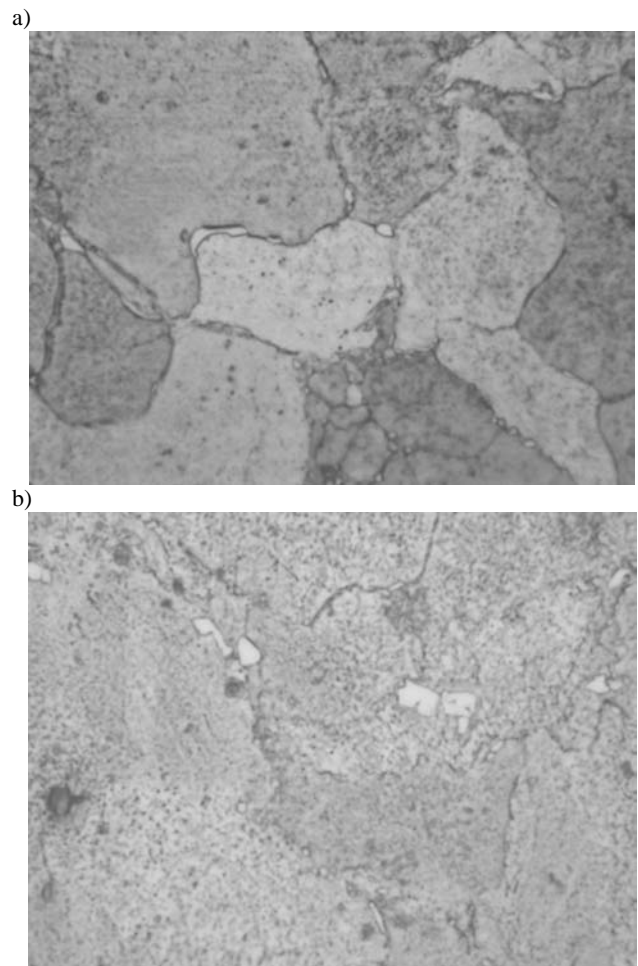
Fig. 1. Microstructure of 13HMF steel tube  $\varnothing 273 \times 32$  mm, Magn. 1000x

The structure of the tube material has an advanced degree of degradation. On Fig. 1 it can be seen separate coagulated cementite particles and carbides at the grain boundaries of ferrite and bainite areas. Visible are large single precipitates and precipitates occurring in the form of strings deployed along the grain borders. Assessment of structure degradation according to the criteria [10] corresponds to the model of SIII. There were no decohesion changes in the tube steel microstructure.

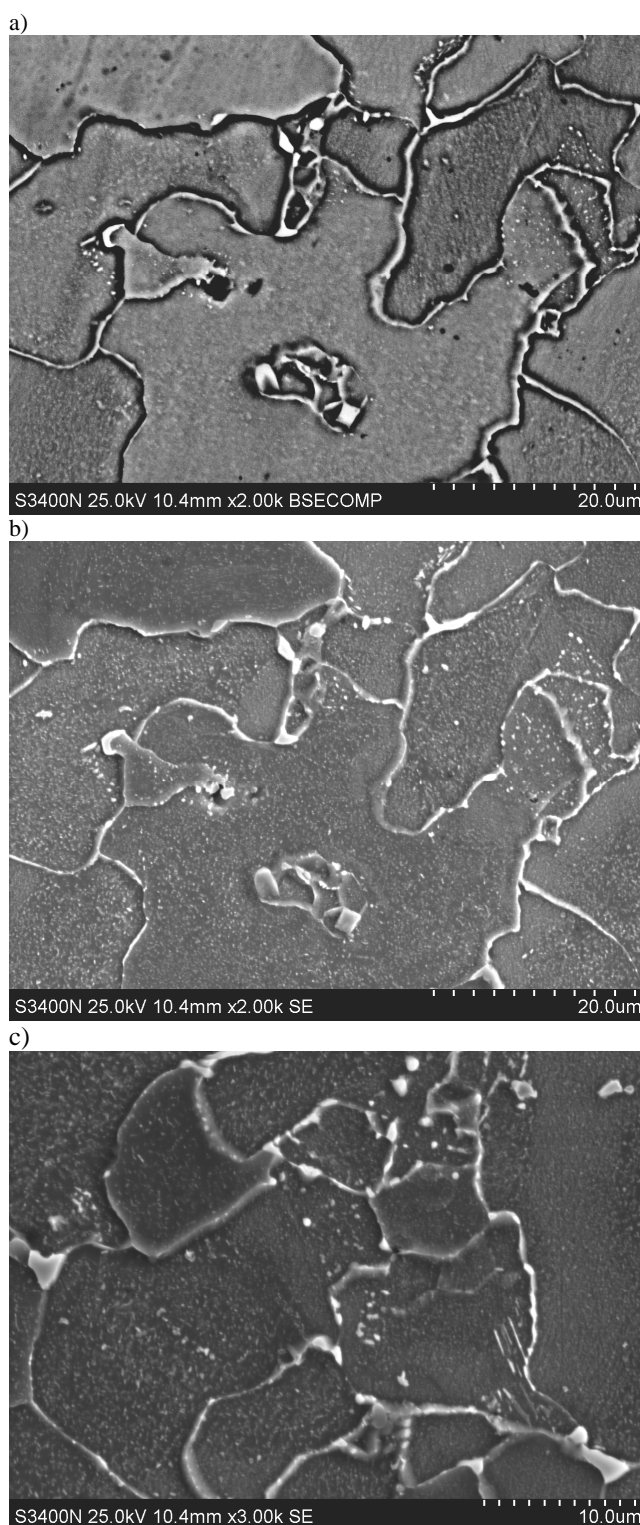
Fig. 2. Carbides morphology in 13HMF steel, tube Ø 273 × 32 mm. Observations performed at metallographical samples SEM, detector: a) BSE, b), c) SE

Morphology of carbides observed on metallographic samples is shown in Fig. 2. Many small carbides are visible - dispersed inside the degraded bainite grains and relatively large carbides at grain boundaries, which often form a continuous net.

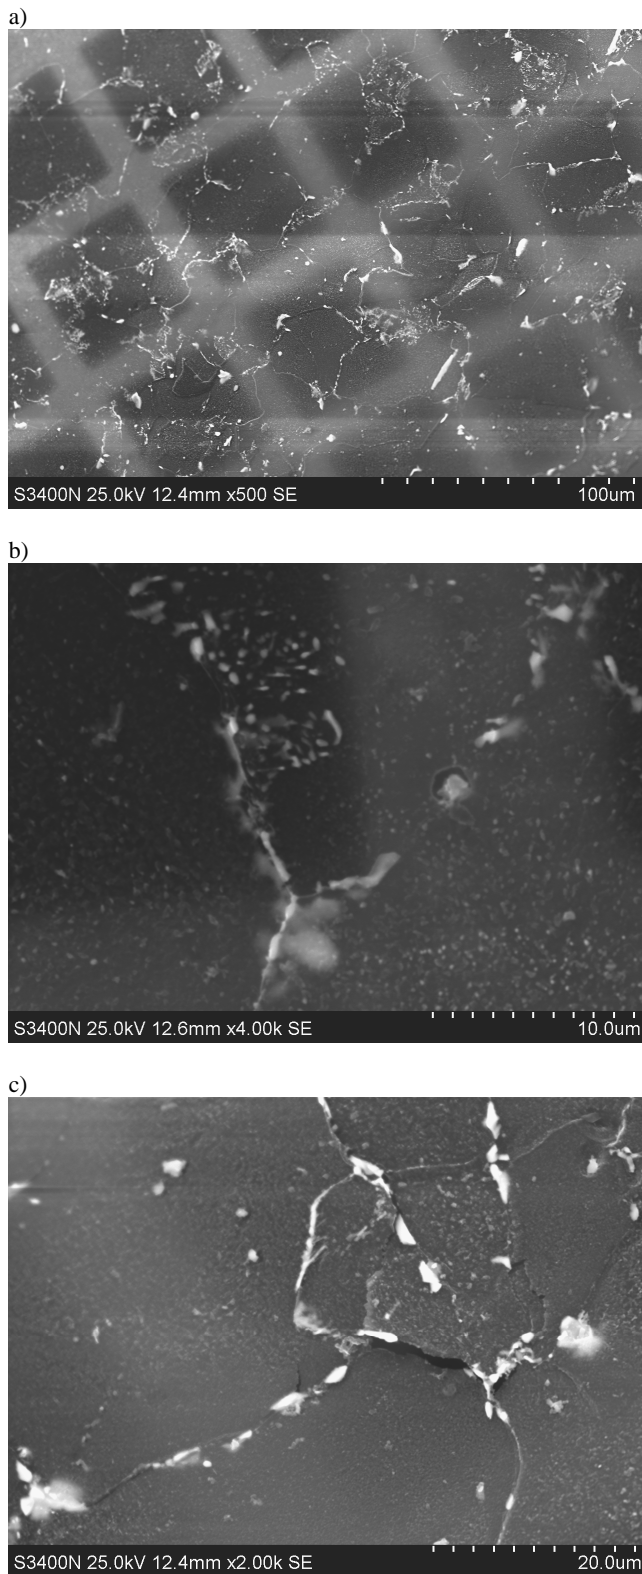
Fig. 3. Carbides morphology in 13HMF steel, tube  $\varnothing 273 \times 32$  mm. Extraction replica, SEM, detector SE

Carbides morphology disclosed on a replica is shown in Figs. 3,4.

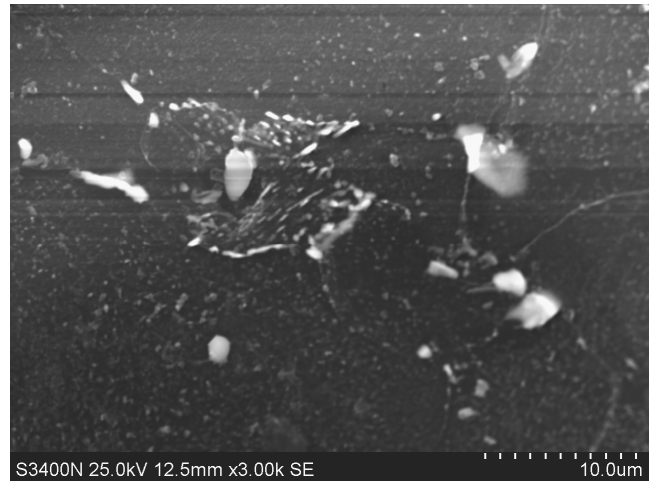
Fig. 4. Carbides morphology in 13HMF steel microstructure, tube  $\varnothing 273 \times 32$  mm. Extraction replica, SEM, detector SE

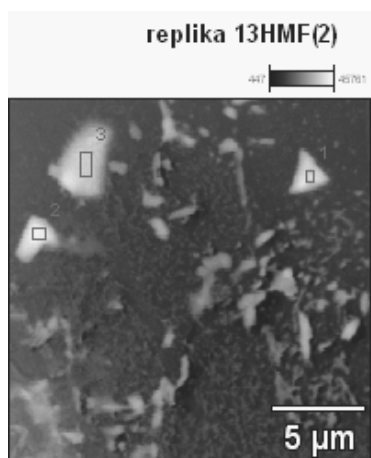
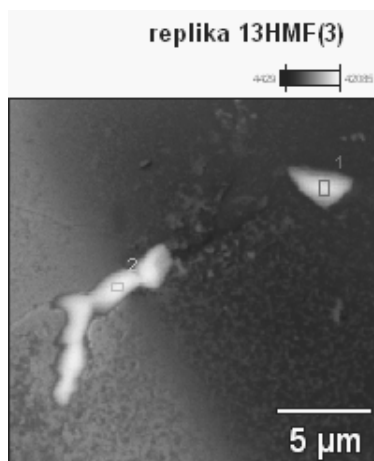
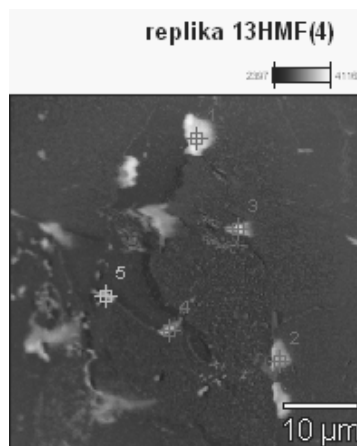
Fig. 5. EDS chemical microanalysis and morphology of carbides in 13HMF steel, tube  $\varnothing 273 \times 32$  mm. Extraction replica, SEM, detector SE

Example results of chemical composition investigations of carbides are presented in Fig. 5. It was found that carbide content by weight is about: 14% Mo, 8% Mn, 7% Cr and 1% V. It should be noted that the EDS analysis of low volume carbide precipitates is a qualitative analysis and does not give the exact chemical composition of the phase only by informing the elements are present.

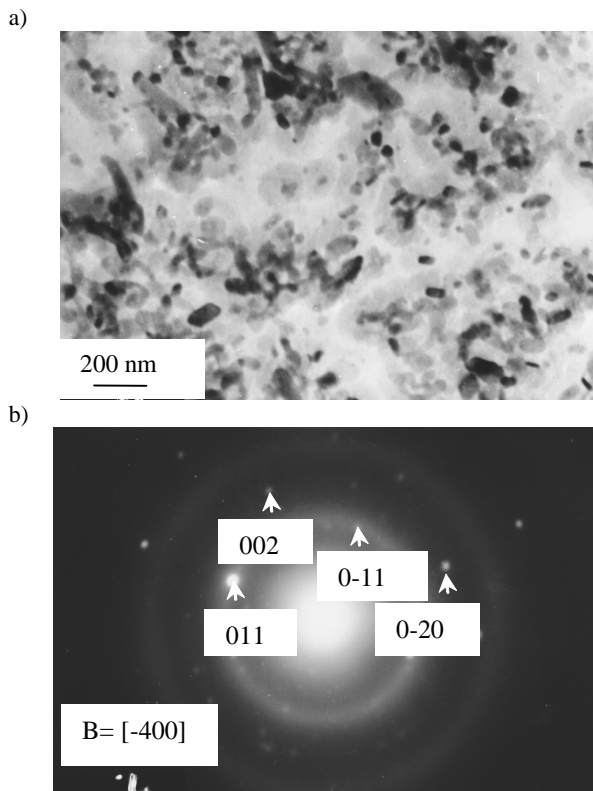
Fig. 5. a) Dispersed MC precipitates, TEM image b) Diffraction pattern of MC precipitates

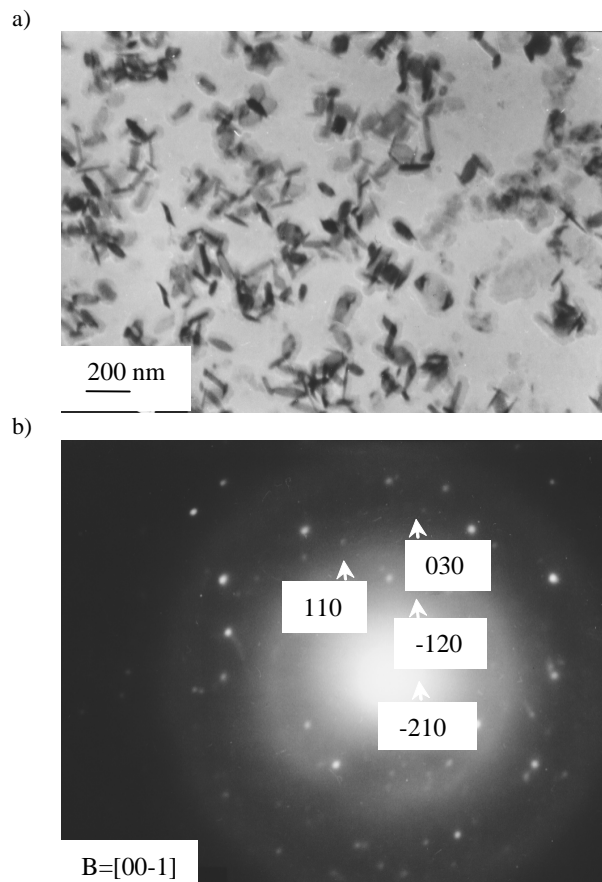
Fig. 6. a) Dispersed  $M_2C$  precipitates, TEM image b) Diffraction pattern of  $M_2C$  precipitates

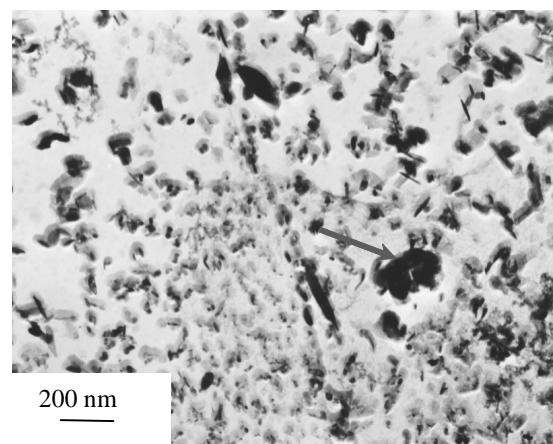
Fig. 7. The diverse morphology of the precipitates. Arrow marked the precipitation where the diffraction was performed

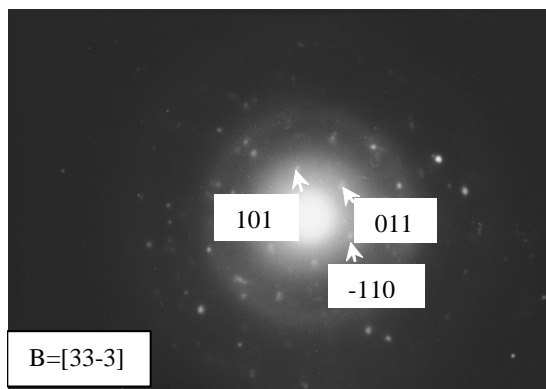
Fig. 8. Diffraction pattern of particle shown by arrow in Fig. 7,  $M_{23}C_6$  precipitate

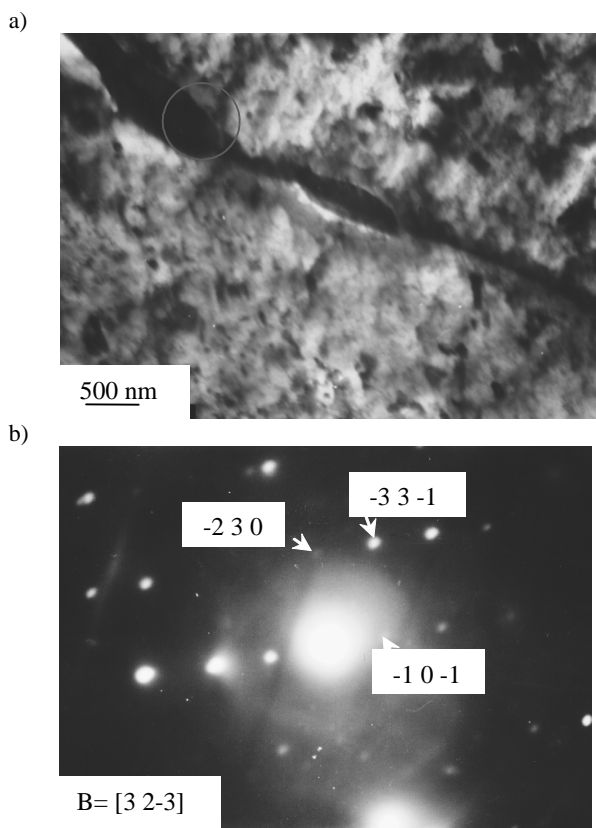
Fig. 9. a) Dispersed  $M_7C_3$  precipitates, TEM image b) Diffraction pattern of  $M_7C_3$  precipitates
