The effect of long-term service at elevated temperatures on structure and mechanical properties of Cr-Mo-V steel

Purpose: of this paper is to reveal the microstructural changes in 13HMF steel exposed to long-term service at elevated temperatures. The degradation of bainite structure was determined and carbides morphology has been examined. The influence of carbides evolution was discussed in dependence of creep rupture strength and mechanical properties of the steel.

Design/methodology/approach: Examinations were conducted on 273 mm diameter, 32 mm wall thickness tube made of 13HMF (14MoV6-3) steel. The tube was a segment of stem pipeline used in power plant at 540°C. The service time is 168,000 hours. Microstructure of the material has been examined with the use of light optical microscopy and scanning electron microscopy (SEM). The energy dispersive X-ray spectrometry (EDS) analysis was used for phase chemical composition identification. Transmission electron microscopy (TEM) of thin foils was used for carbides structure identification. The mechanical properties of the tube material were evaluated in static tensile tests at room temperature, hardness tests and impact Charpy U t

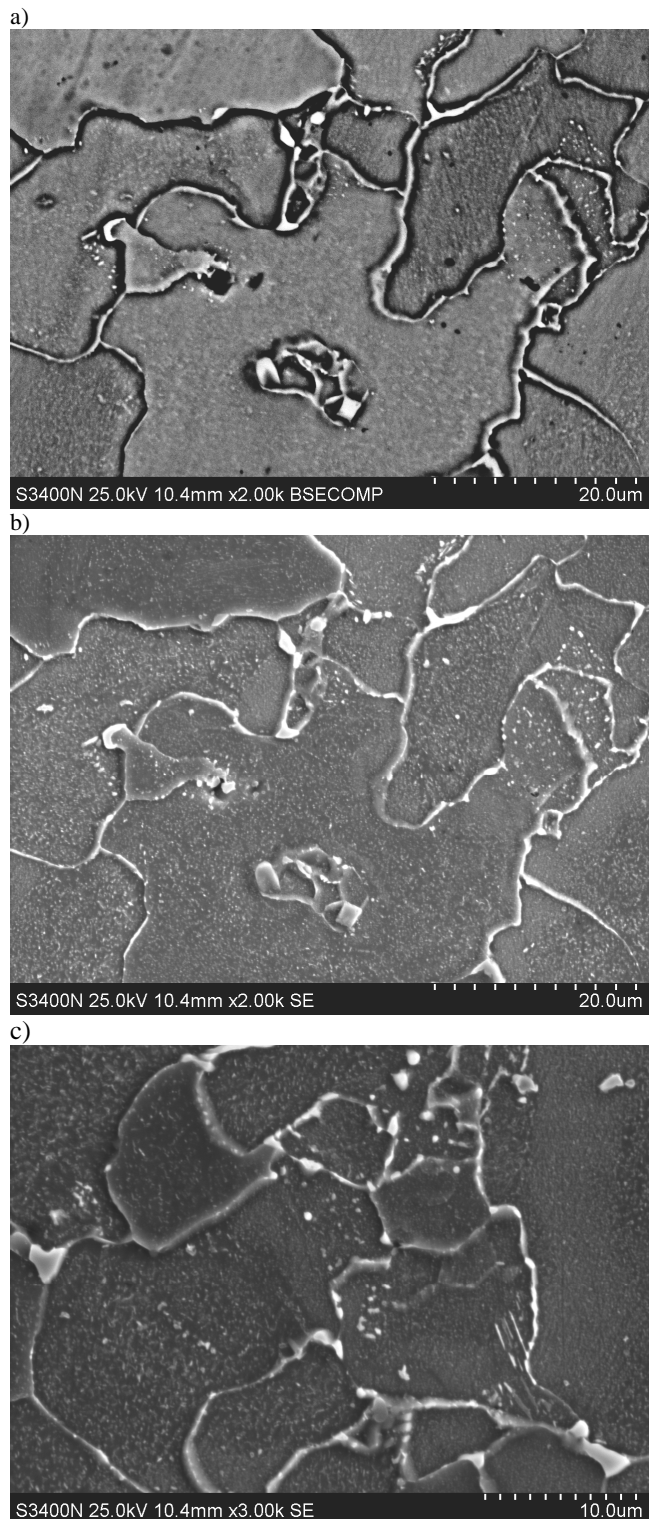
Fig. 2. Carbides morphology in 13HMF steel, tube $\varnothing 273 \times 32$ mm. Observations performed at metallographical samples SEM, detector: a) BSE, b), c) SE

Morphology of carbides observed on metallographic samples is shown in Fig. 2. Many small carbides are visible - dispersed inside the degraded bainite grains and relatively large carbides at grain boundaries, which often form a continuous net.

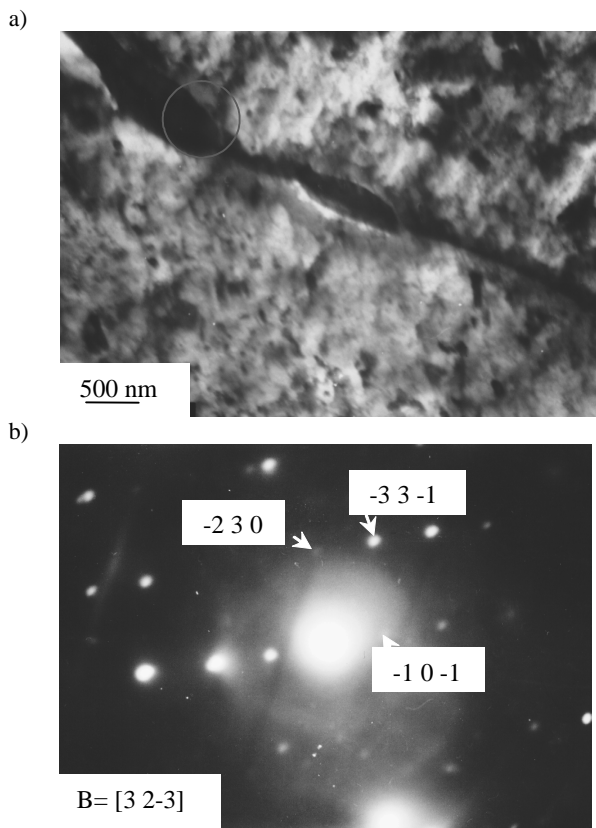
Fig. 9. a) Dispersed M_7C_3 precipitates, TEM image b) Diffraction pattern of M_7C_3 precipitates
