## ENDOSCOPIC IMAGE PROCESSING AND ANALYSIS OF PISTONS' SERVICE FAILURES OF MARINE DIESEL ENGINES

**Zbigniew Korczewski**

*Gdansk University of Technology  
Faculty of Ocean Engineering & Ship Technology  
Department of Ship Power Plants  
tel. (+48 58) 347-21-81  
e-mail: [z.korczewski@gmail.com](mailto:z.korczewski@gmail.com)*

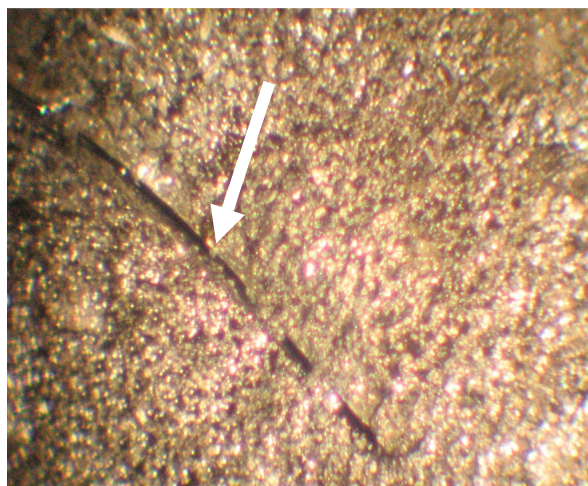
A low-cycle fatigue of the piston's head up to cracks' occurrence, connected with cyclic squeezing and spreading tensions of the constructional material represents a different consequence of this phenomenon - Fig. 2b. They result from cyclic, respectively: the material overheating and widening as well as its cooling down and shrinking, during the engine's work cycle realization.

b) piston head – a crack fatigue

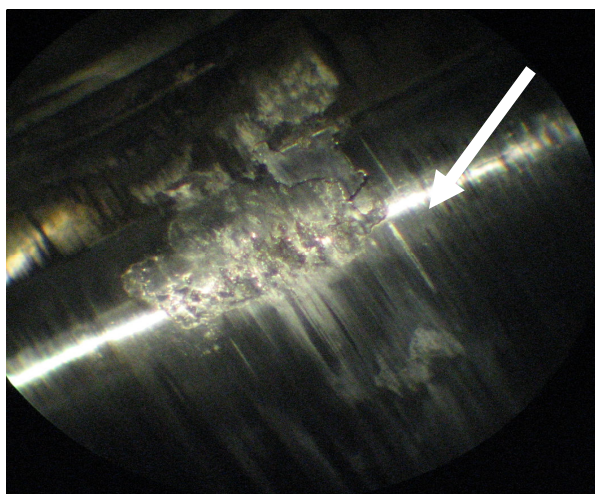
c) cylinder bearing surface – smearing traces of the piston material's layer (aluminum alloy)

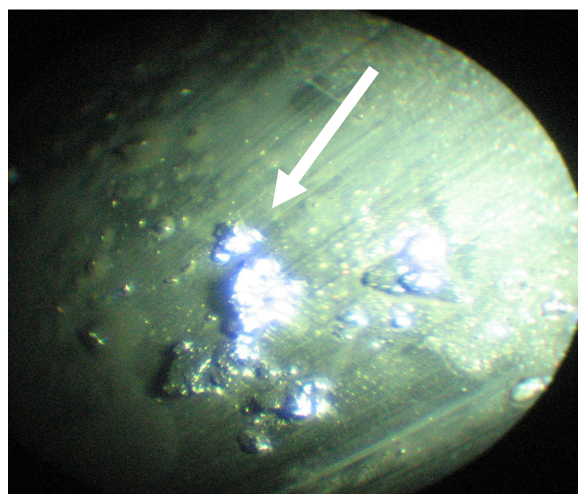
the piston head's temperature when the lubricating conditions get better. Unfortunately, it usually produces undesirable results - an intensive growth of the aluminum particles quantity in the engine's lube oil system - Fig. 2d.

d) cylinder bearing surface – metal fillings (aluminum alloy)

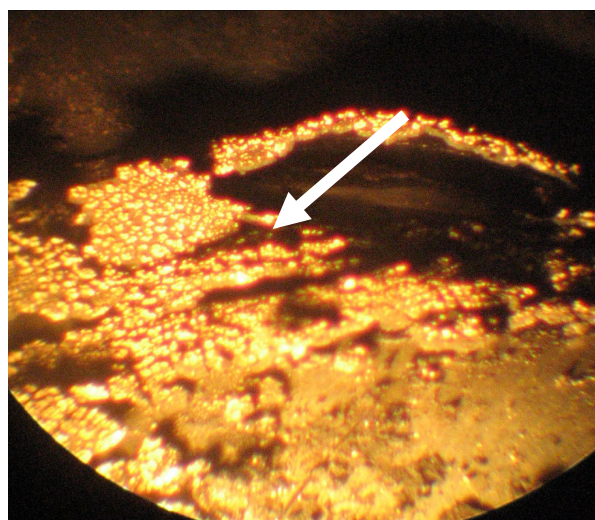
e) piston head – a thick layer of the carbon deposit

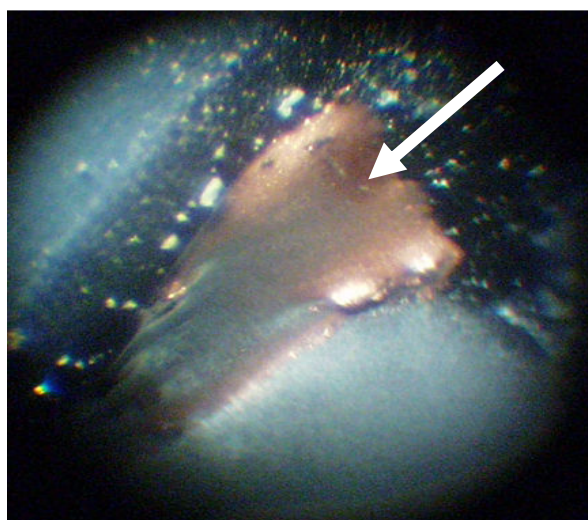
Very often, a self-ignition's time decay takes place along with detonating fuel combustion. In case of shifting the fuel burning beyond TDC an intensive temperature's growth of all the combustion chamber elements occurs (particularly the piston). A transfer of the combustion process on the expansion stroke (work), at an incomplete and imperfect character of this process, produces undesirable results with a quantity enlargement of carbon deposits settled on the surfaces that restrict the combustion chamber. A thick layer of the carbon deposit on the piston's head (Fig. 2e), coming into existence particularly intensely during the engine work on partial loads while it is maladjustment, worsens significantly the warmth flow conditions and consequently drives to the piston head's overheating - Fig. 2f.

f) piston head – a local overheating of the constructional material

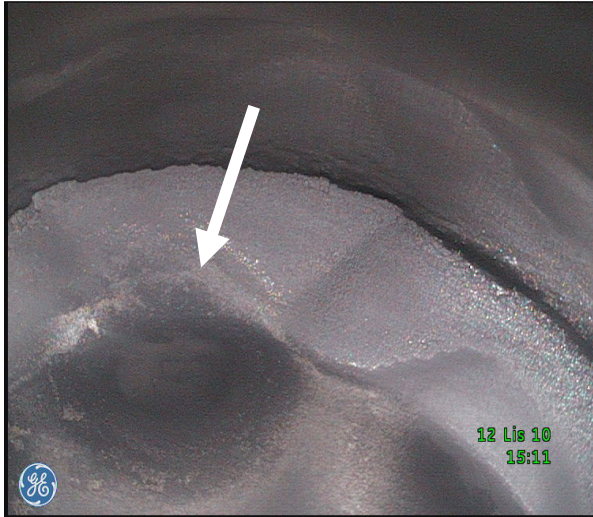
piston crown, at the correctly functioning injector, widens uniformly and the waste area on piston's surface is also proportionate on its whole circuit. Moreover, a whole phenomenon of the adhesive waste proceeds at the considerably lower temperature. In such a situation grooves and rollings both on the piston and cylinder bearing surface are clearly visible. However, because of injectors' disfunctioning e.g. in result of losses of the sprayer's tightness or its spraying holes patency, a chronic fuel burning along with piston's overheating is possible. Traces of the fuel after-burning occur on the piston head's surface (fig. 3a), and in the extreme case - even the constructional material's burn out until a total piston melting.

a) piston head – traces of the fuel after-burning

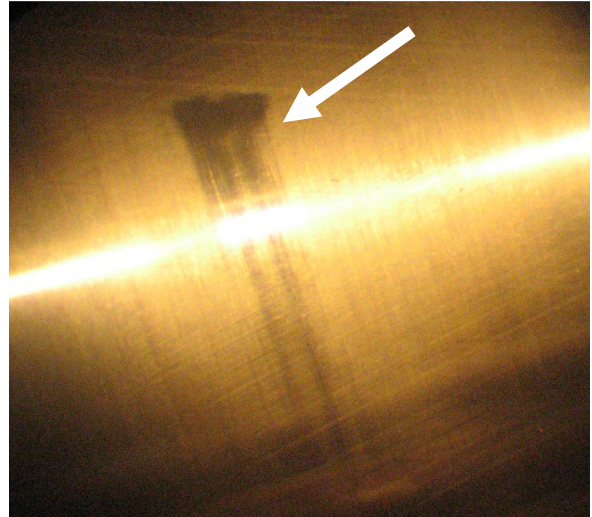
b) cylinder bearing surface – traces of the piston ring's seizing

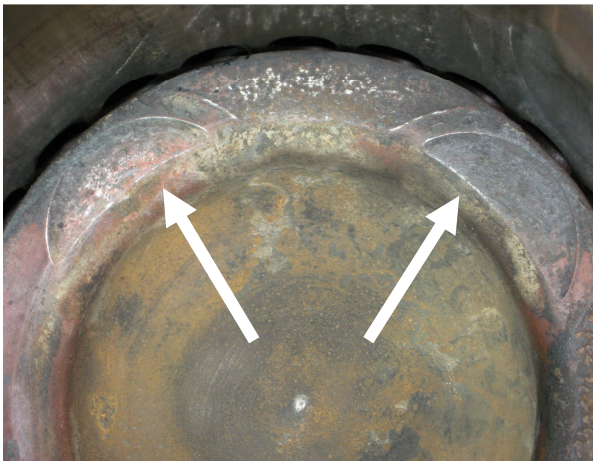
c) piston head – traces of the piston strokes over the valves (a state after the “water hammer”)

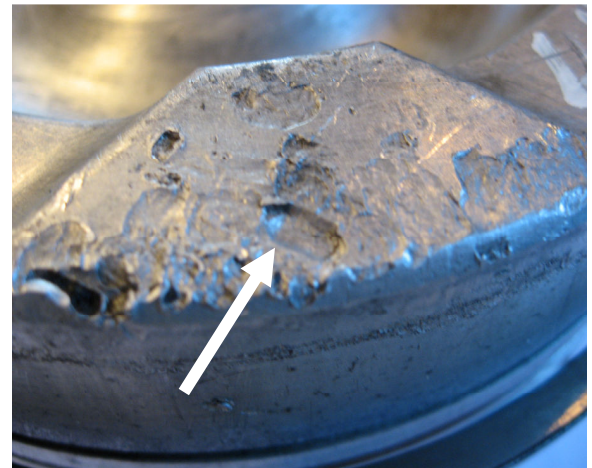
Piston mechanical deformations represent its relatively often occurred damages. They are usually caused by the valve's part (the exhaust valve generally) e.g. a broken off valve's head, which has fallen into the combustion chamber - fig. 3d. During its operation the cylinder valve is forced to move along its spindle in the guide which undergoes irreversible friction wear. The process goes at high temperature of the spindle whose additional task is to absorb heat from the valve head. As a result an excessive increase of radial clearance is produced between the guide and spindle, which, in all the cases, leads to an undesirable skew of the valve especially, that it is loaded with transverse component from the pressure of the timing lever or cam. Consequently, a loss of cylinder tightness (compression pressure drop), gas eruption, returnable flows, lubricant leakage from the spindle – guide precision pair until an

d) piston head's crown – traces of the strokes made by the broken-off part of the valve head

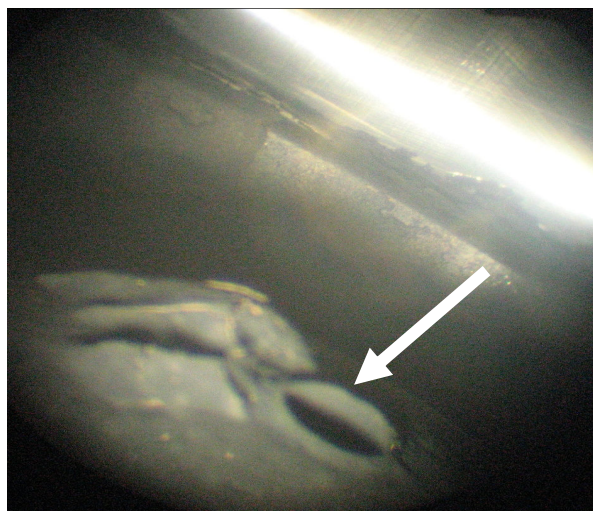
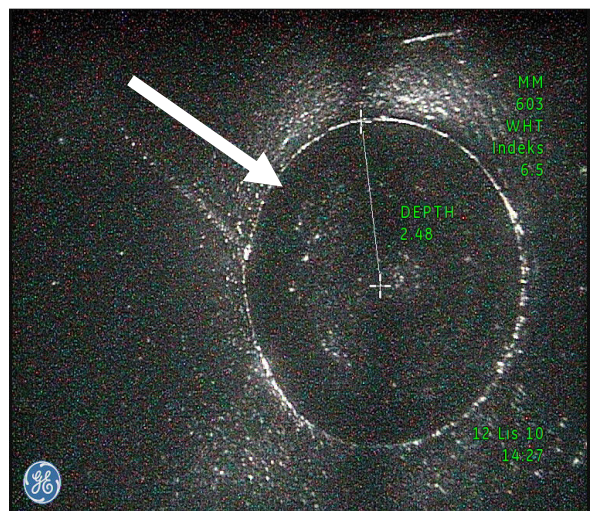
A presence of the punctual dent on the piston head, that is placed in an injector's axis (fig. 3e,f) testifies about the piston's mechanical strokes over the injector resulting from e.g. the elongated piston stroke (for some high- speed engines, a distance between the piston head and injector's ending at TDC is not more than 3-4 mm [11]). Such a situation might represent a consequence of excessive clearances in an assembly of crank-shaft or intensive wear and tear of bearing pans.

An excessive injector's lowering which is mounted in the head stands for different probable reason of this type dents' formation, caused by the inappropriate-chosen washer under the injector. It in such a situation was one should explain the prime causes of the dent's presence, and independently - the injector has to be definitely exchanged. Further operation in such state usually drives to cracks and even breaking-off the injector's ending. Moreover, an intensive fuel leakage to cylindrical spaces and thinning the lubricative oil with fuel might occur until to development of the extensive secondary damages in cylindrical sets, threatening with the engine's breakdown.

e) piston head – a dent after the piston stroke over the injection sprayer

f) piston head – a measurement of the dent's depth by means of the „Shadow” method (2,48 mm)
