Failure of austenitic stainless steel tubes during steam generator operation

Purpose: of this study is to analyze the causes of premature failure of steam generator coil made of austenitic stainless steel. Special attention is paid to corrosion damage processes within the welded joints.

The steam generator studied worked with a nominal pressure of 12-16 bar, under outlet steam temperature 160°C. The working time of the device was 6 months, with numerous intermissions in service. The reason for the withdrawal of the generator from the operation was leaks in the coil tube caused by corrosion damage.

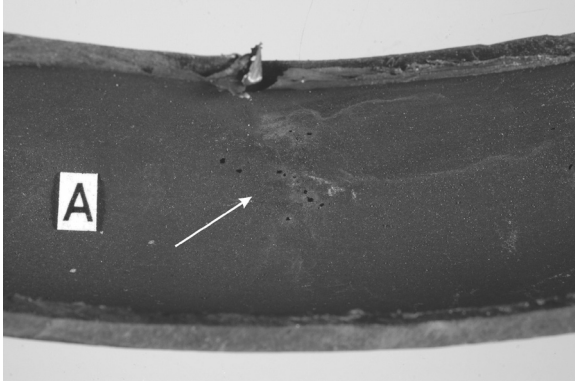
The high concentration of Mg and Ca ions in the deposits indicates that water quality monitoring and its treatment was insufficient. Sparingly soluble carbonates and sulphates of calcium and magnesium formed a hard and porous layer called boiler scale. Excessive deposition of minerals, due to disorders of the boiler water composition has a significant influence on the temperature of the pipe wall, which can be overheated (up to 500-600°C) and can deform, which accelerates the initiation of cracks and corrosion processes [2,19]. Corrosion processes are accelerated by water penetrating into the sediment and producing superheated steam. In such conditions all salts can evolve out of the water, even these very soluble, then react with the metal ground and form corrosion products [11,12]. Examples of deposit corrosion as deep pits in the tube wall are shown in Fig. 3.

The cause of corrosion attack in the crevices (in place of welding defects), or under adjacent to the pipe surface sediment is reduced oxygen access, and thus insufficient surface passivity.

Fig. 3. Pitting corrosion on the inner surface of the tube

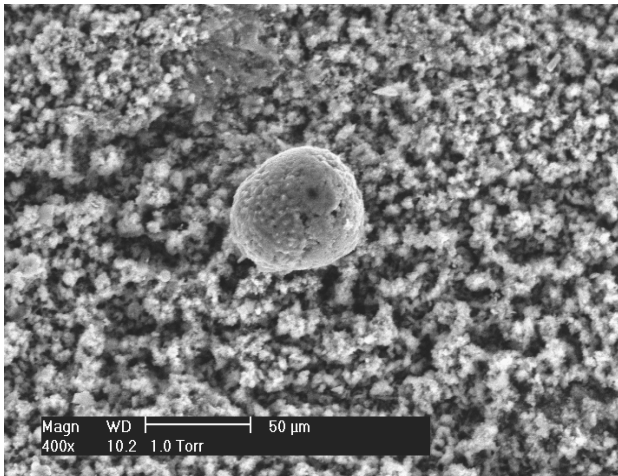
Fig. 4. View of the inner surface of the pipe. The spherical particle of different morphology than the rest of the surface sediment

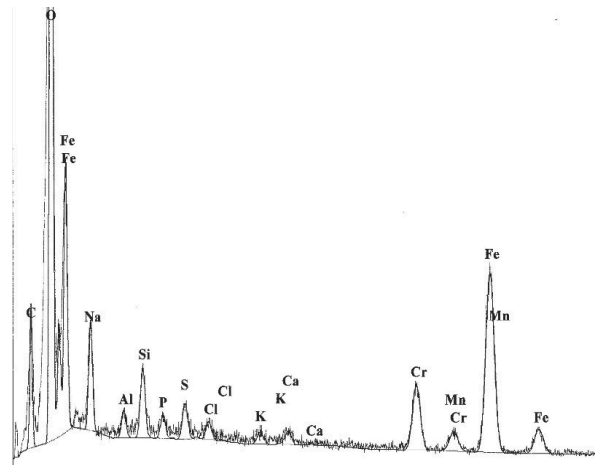
spherical particles also contain Cl ions, Fig. 5, which shows selective adsorption of this element and the local increase in concentration.

Aggressive effect of sediments against austenitic stainless steel surface increases particularly strongly with increasing alkali metals chlorides content, which presence in high concentrations were detected. Under such conditions, the rapid progress of local corrosion leads to perforation of the pipe walls and destruction of structural elements what was proven by attempts to repair of perforated pipe walls by welding which ended in failure Fig. 6 a. Application of padding welds on the outer tube side (without whole penetration), caused warm-up to the inner tube's surface and its oxidation. These oxide layers are rich in chromium, which is taken from the steel matrix adjacent to the oxide layer. This process depletes the chromium in metal surface and consequently reduces the corrosion resistance [16].

Fig. 5. The results of microanalysis of sediments in the form of spherical particles with a higher concentration of chlorine, as shown in Fig. 4

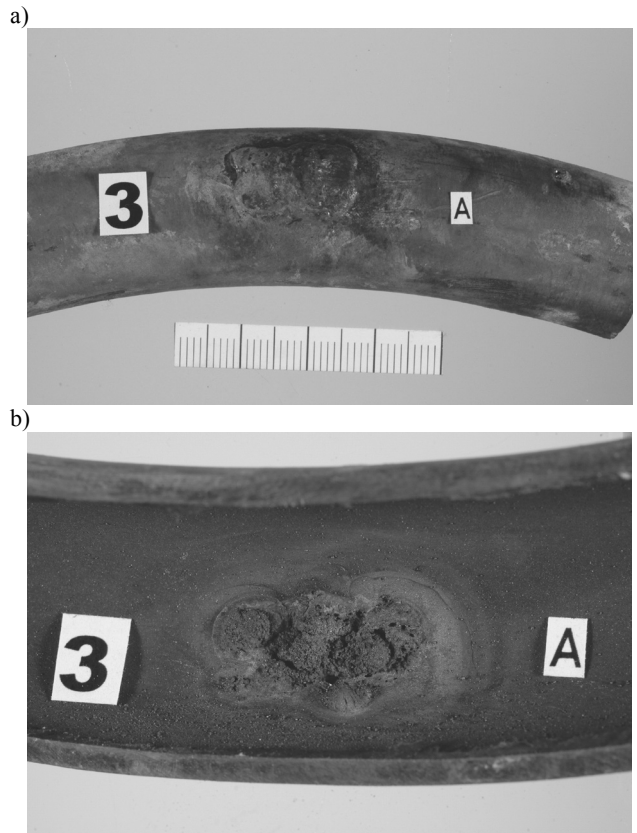
The rapid progress of corrosion on the inner tube surface under padding welds was detected, Fig. 6 b. Probably padding welds were performed without the simultaneous protection of internal surfaces of tubes with an inert gas.

Fig. 6. a) The padding weld on the outer tube surface; b) the view from the inside - the progress of corrosion processes

- Strictly use the backing inert gases for welding. The use of welding in the test case without forming gases resulted in oxidation of the inner surface of pipes and abnormal

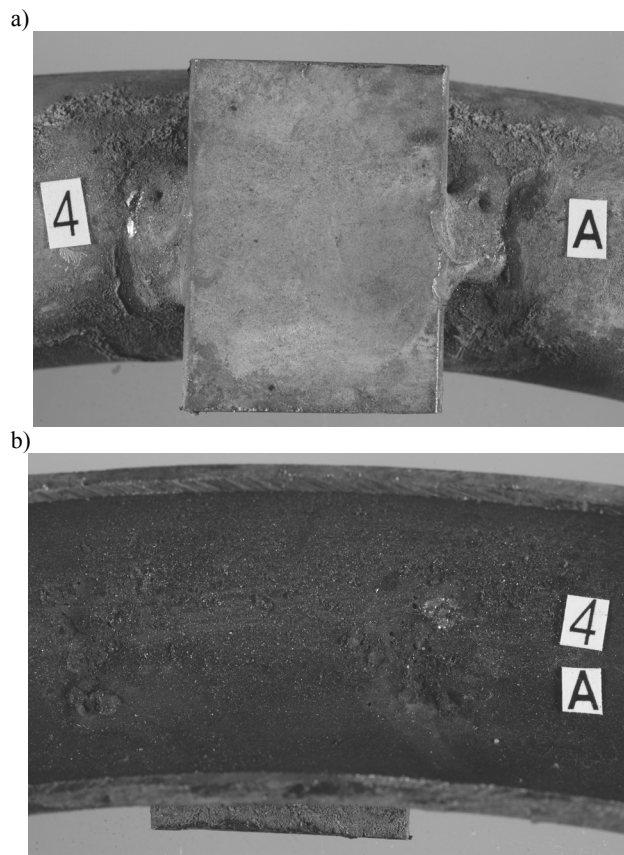
Intense pitting corrosion was also found on the inner surface of pipes under welds connecting coil stiffeners. Figure 7 b clearly shows two pitted areas under the welded joints where the inner surface of the pipe is heated to high temperatures.

Fig. 7. Stiffener welded to the pipe coil, a) outer surface, b) the inner surface attacked by pitting corrosion

- Avoid excessive stiffening of the tubes. Welding of the coils stiffeners should be performed with minimal heat input.
- It is advised to apply stress relief annealing after cold bending of the tubes to remove internal stresses.
- Cleaning the inner surfaces of the coil tube surface passivation of the surface should be performed after welding.
- Water quality monitoring. Keep the feed water pollution at the appropriate level.
- Flooding of the evaporator tubes with water or completely remove water and drain installation at each stopping installation.
- Procedures for the periodic removal of scale in the coils should be supplemented by passivation of the pipe.

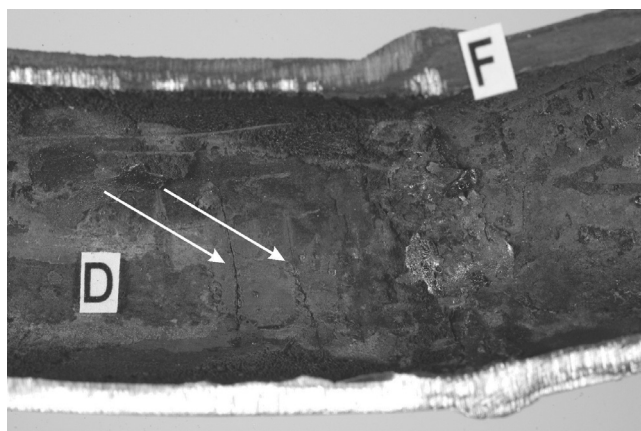
Many cracks were observed in the welded joints area. These cracks propagated parallel to the joints at heat affected zone Fig. 8.

Fig. 8. Cracks in the HAZ of the circumferential weld

Initiation of cracks come from the inside of the pipe. Metallographic examination of pipe wall sections showed that crack initiated in the HAZ propagate in different directions and the development of cracks in some cases has been blocked and changed direction at the fusion line. Figure 9 shows crack of considerable thickness, it is associated with subsequent reactions inside the crevices and electrochemical dissolution of cracks walls.

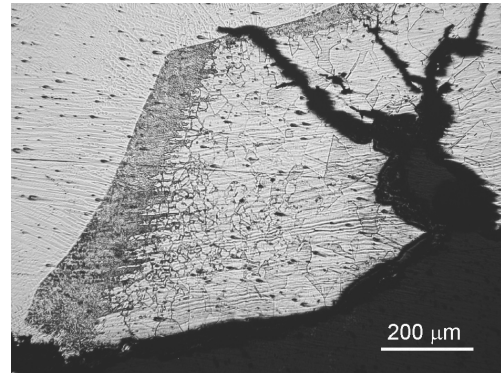
Fig. 9. The propagation of cracks initiated by intergranular corrosion

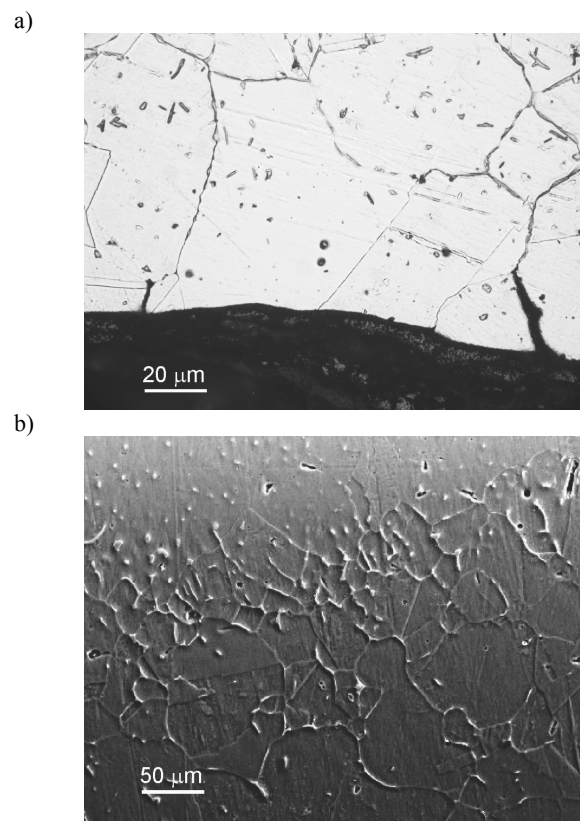
Fig. 10. The structure of sensitized zone of austenitic stainless steel, a) light microscope image, b) SEM image - visible carbides net at grain boundaries of austenite

A detailed analysis of cracks showed their intergranular propagation along the austenite grain boundaries which were decorated by chromium carbide precipitates. Figure 10 shows the microstructure of sensitized HAZ zone, with clearly visible coagulated carbides located mainly at the austenite grain boundaries, forming an almost continuous net. Such a distribution of carbides in the HAZ was also observed by scanning electron microscope, Fig.10 b. This was confirmed by EDX field qualitative analysis of the chromium distribution and is direct evidence of steel sensitization in the HAZ area where the temperature reached 500 to 800°C.

- In order to avoid intergranular corrosion austenitic steels with a carbon content below 0.02% should be selected instead of steel stabilized with Ti or Nb, which does not fully protect against such corrosion.
