Failure of austenitic stainless steel tubes during steam generator operation

Purpose: of this study is to analyze the causes of premature failure of steam generator coil made of austenitic stainless steel. Special attention is paid to corrosion damage processes within the welded joints.

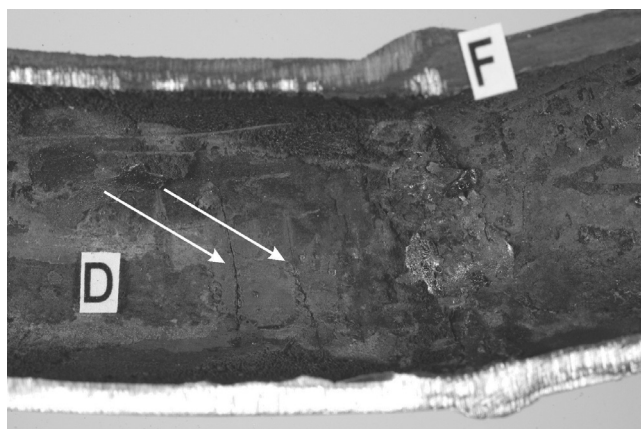
Many cracks were observed in the welded joints area. These cracks propagated parallel to the joints at heat affected zone Fig. 8.

Fig. 8. Cracks in the HAZ of the circumferential weld

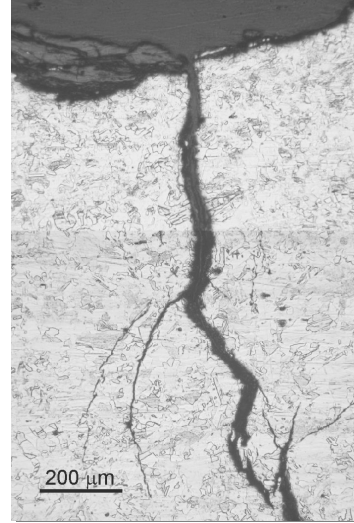
Many cracks were revealed in the parent material of the coil. The cracks were located perpendicular to the tube axis passing through the entire thickness of the pipe wall and causing leaks. The places of crack initiation were pits on the inner surface covered with a dense sludge of corrosion products. Cracks have characteristic branching shape and transgranular propagation typical for stress corrosion. Figure 12 shows the fissure of stress corrosion cracking filled with corrosion products. The results of microanalysis of corrosion products and deposits are shown in Table 2 and as EDS spectra as Fig. 13.

concentration of chloride ions in certain areas of the environment, high temperature, the presence of oxygen ions in the feedwater, high level of tensile stresses received from welding, cold bending and stresses generated during the operation, create conditions for the development of stress corrosion cracking.

Fig. 12. Transgranular propagation of stress corrosion crack through the pipe wall with characteristic branching

- Avoid excessive stiffening of the tubes. Welding of the coils stiffeners should be performed with minimal heat input.
- It is advised to apply stress relief annealing after cold bending of the tubes to remove internal stresses.
- Cleaning the inner surfaces of the coil tube surface passivation of the surface should be performed after welding.
- Water quality monitoring. Keep the feed water pollution at the appropriate level.
- Flooding of the evaporator tubes with water or completely remove water and drain installation at each stopping installation.
- Procedures for the periodic removal of scale in the coils should be supplemented by passivation of the pipe.
