Failure of austenitic stainless steel tubes during steam generator operation

S. Topolska ^{a,*}, J. Łabanowski ^b, M. Głowacka ^b

Purpose: of this study is to analyze the causes of premature failure of steam generator coil made of austenitic stainless steel. Special attention is paid to corrosion damage processes within the welded joints.

The steam generator studied worked with a nominal pressure of 12-16 bar, under outlet steam temperature 160°C. The working time of the device was 6 months, with numerous intermissions in service. The reason for the withdrawal of the generator from the operation was leaks in the coil tube caused by corrosion damage.

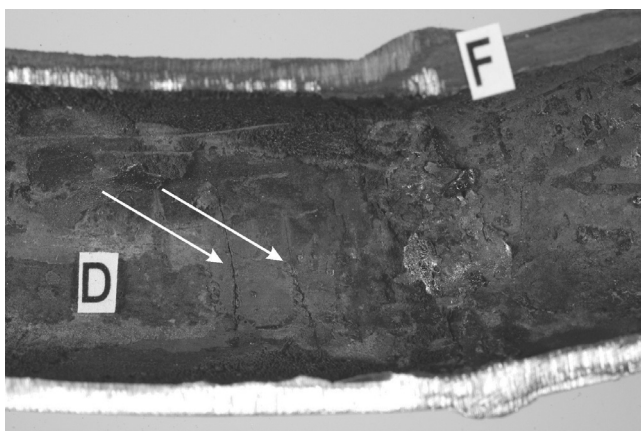
Many cracks were observed in the welded joints area. These cracks propagated parallel to the joints at heat affected zone Fig. 8.

Fig. 8. Cracks in the HAZ of the circumferential weld

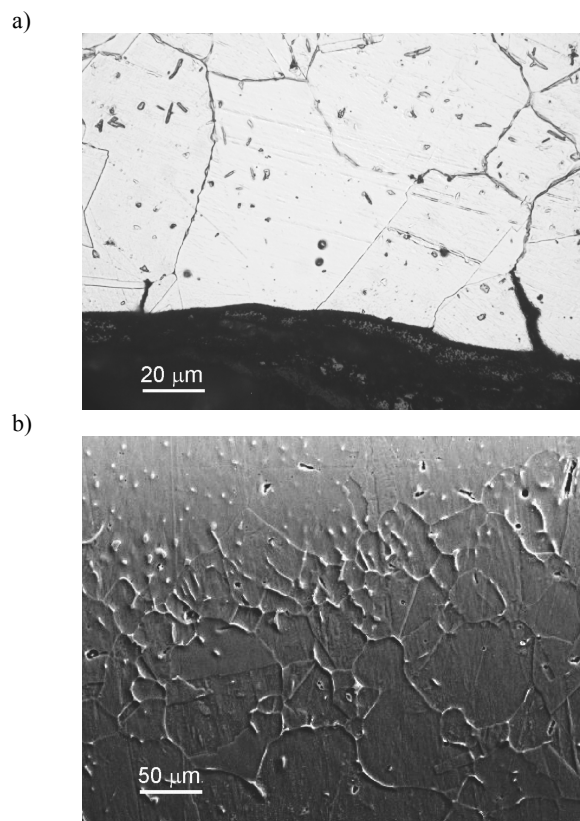
Fig. 10. The structure of sensitized zone of austenitic stainless steel, a) light microscope image, b) SEM image - visible carbides net at grain boundaries of austenite

A detailed analysis of cracks showed their intergranular propagation along the austenite grain boundaries which were decorated by chromium carbide precipitates. Figure 10 shows the microstructure of sensitized HAZ zone, with clearly visible coagulated carbides located mainly at the austenite grain boundaries, forming an almost continuous net. Such a distribution of carbides in the HAZ was also observed by scanning electron microscope, Fig.10 b. This was confirmed by EDX field qualitative analysis of the chromium distribution and is direct evidence of steel sensitization in the HAZ area where the temperature reached 500 to 800°C.

- In order to avoid intergranular corrosion austenitic steels with a carbon content below 0.02% should be selected instead of steel stabilized with Ti or Nb, which does not fully protect against such corrosion.
