DYNAMIC STATE ASSESSMENT OF THE WATER TURBINE WITH THE POWER OF 600 kW

Grzegorz ŻYWICA, Paweł BAGIŃSKI, Łukasz BREŃKACZ

Institute of Fluid-Flow Machinery, Polish Academy of Sciences
80-231 Gdansk, Fiszerka 14 str., gzywica@imp.gda.pl

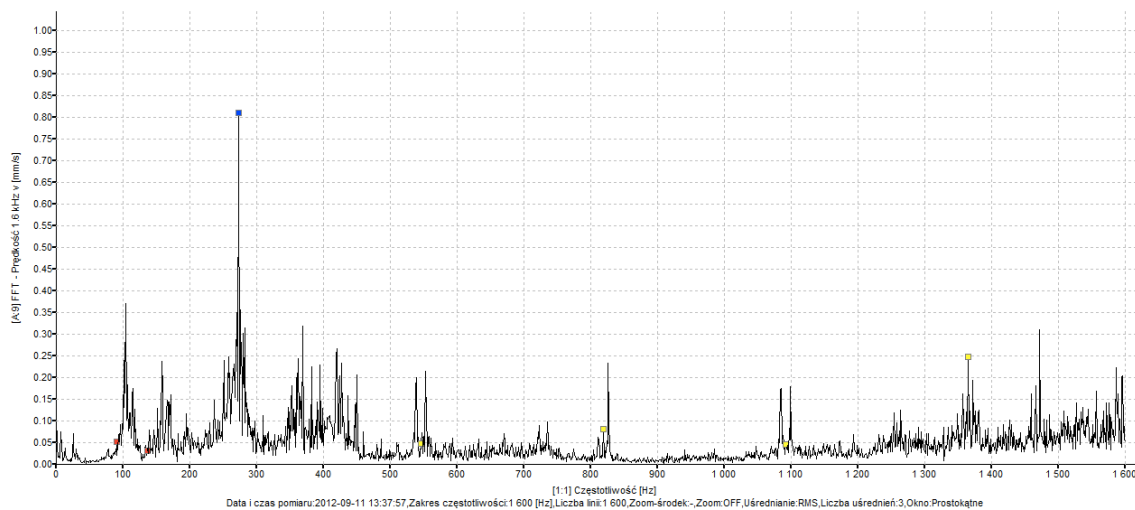
At higher frequencies, for all the measuring nodes similar vibration spectra were recorded. Characteristics shown in Figure 5 was determined for the measured signal at node II in the direction of the Y axis (on the flange connecting the generator with the transmission gear). The recorded vibration signal allowed to draw the following conclusions. The dominant component (272 Hz frequency) of the resulting characteristics relates to the toothed ring's meshing frequency (it was marked by a blue point and its harmonics by yellow and red points). The origin of the vibrations of toothed gear also testified clear sidebands. Elevated levels of vibration can also be observed in successive harmonic frequencies of toothed ring's meshing: 544, 816, 1088, 1360 Hz. At the frequency of 103 Hz a component occurred resulting from the frequency of meshing the satellite wheels with the toothed ring. Under the frequencies within the range of 170 Hz appeared increased vibration levels that could be associated with the co-operation of the satellite wheels with the central wheel of the planetary gear. Other areas of high vibration levels were difficult to clearly interpret.

Fig. 5. Frequency spectrum of the vibration velocity measured at measuring node II in the Y direction with the marked frequency of toothed ring meshing with the planetary cage at 272 Hz (blue dot) and its harmonics (red and yellow dots)

The study clearly showed that the cause of elevated levels of rms values of vibration velocity was the operation of planetary gear, and more specifically the lack of smooth cooperation of gears. Since the vibration of the machine was measured on the housing, the registered signal was dominated by vibrations coming from the toothed ring cooperation with the planetary gear. This ring was permanently connected to the gear's body, resulting in the direct transfer of vibrations to the housing.

The analysis conducted of vibrations therefore clearly indicated the source of high level of vibrations, which impacted directly on the acceptable level of vibration (for new objects which are ready for use). The cause of the elevated vibration level was due to the planetary toothed gear. Since this was a new gear, it was unlikely that such quick wearing or damage could have occurred, so this evidenced by low accuracy performance of toothed wheels.
