# Determination of causes of accelerated local corrosion of austenitic steels in water supply systems

## Abstract

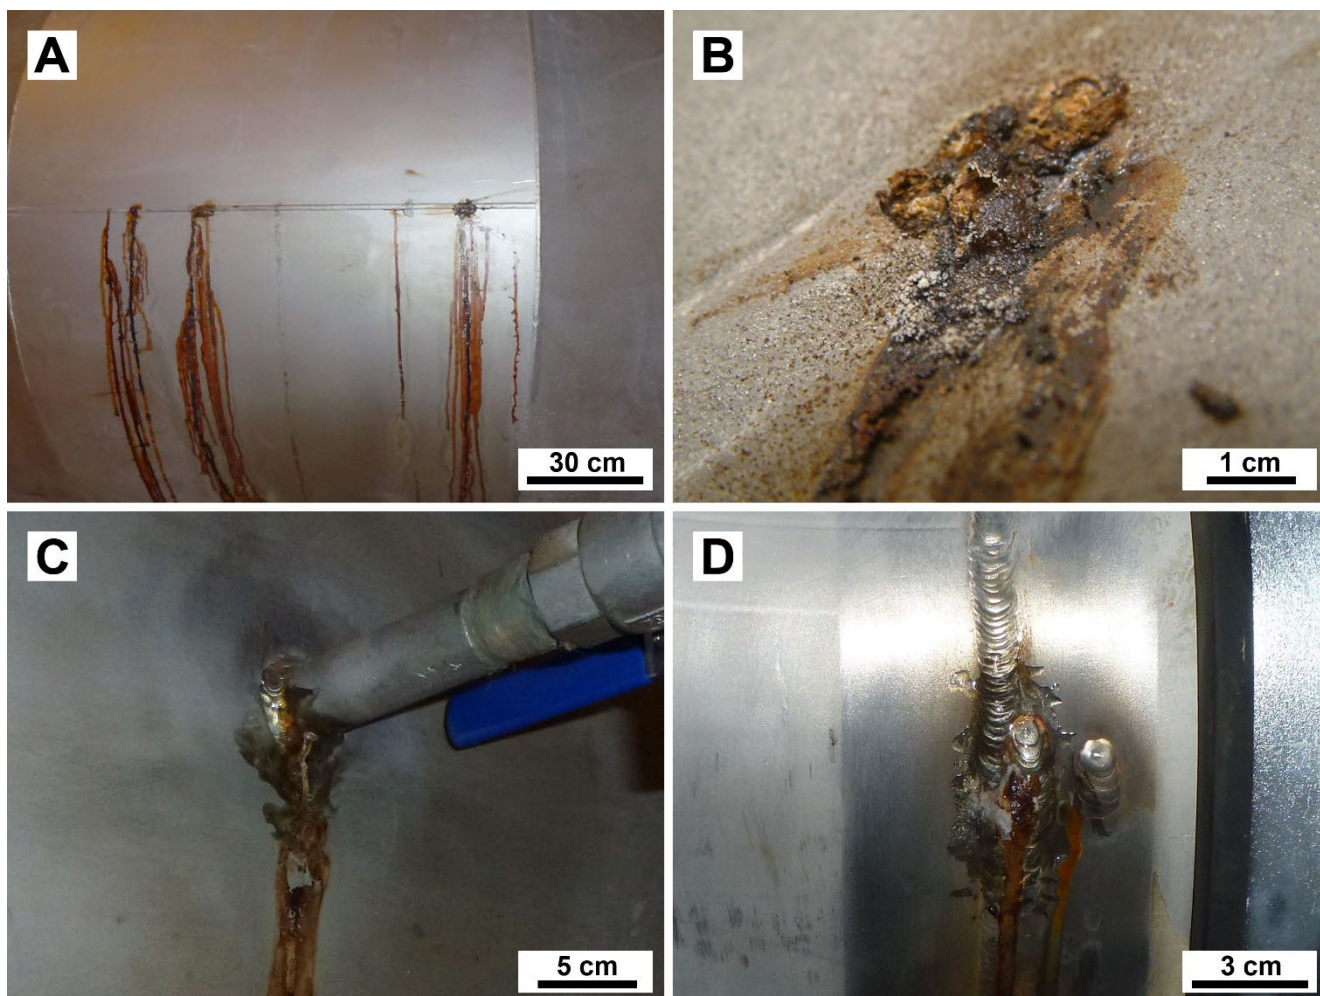
Various areas of the system were inspected, corrosion had the same character and origin for every element of the pipeline. Most often corrosion occurred just at the weld or in its vicinity, not further than 3 cm away from the weld. Washed-away corrosion products flow slowly out of the perforation areas. The photos in Fig. 1 illustrate corrosion damage of different pipelines within the water supply system, in particular: pumping station (Fig. 1a-b), rinsing water system (Fig. 1c), water filtration system (Fig. 1d). In addition, it was found that there were attempts to remove perforation due to corrosion by pad welding (Fig. 1d).

Figure 1 – Inspection of pipeline system, at: a,b) pumping station pipeline, c) rinsing water system pipeline, d) water filtration system pipeline.

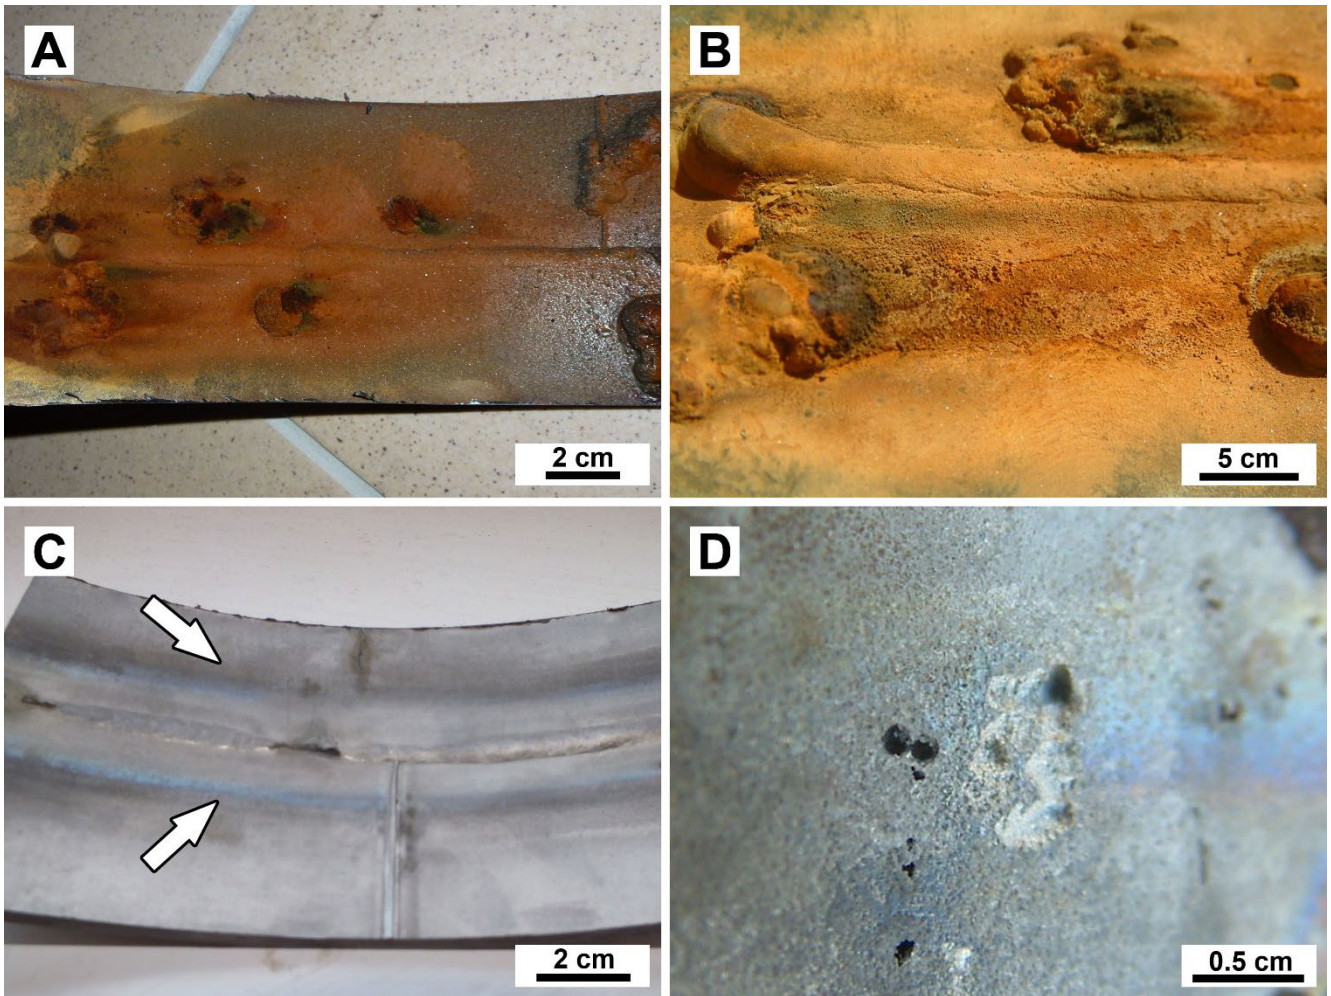
A preliminary visual inspection of the pipeline showed that compacted corrosion products were accumulated on its inner side (Fig. 2a-b). The areas correspond to the spots where stains on the outer side were located. Moreover, in the vicinity of the weld, the entire area was covered with a thin layer of rust. Its presence indicates that there was no protective passive layer on the steel surface and iron corrosion occurred as a result. Once the section was cleaned, dark line located about 1 cm from the

weld was found (pointed out with arrows on Fig. 2c). In this area, macroscopic pits were revealed under the agglomeration of corrosion products (Fig. 2d).

Figure 2 – Pipeline element taken for further analysis. a) specimen, b) a view of corrosion products on the inner side, c) the sample after immersing in inhibitors, d) corrosion pits
