# Determination of causes of accelerated local corrosion of austenitic steels in water supply systems

J. Ryl<sup>a,\*</sup>, J. Wysocka<sup>a</sup>, K. Darowicki<sup>a</sup>

<sup>a</sup>Department of Electrochemistry, Corrosion and Materials Engineering,

## Abstract

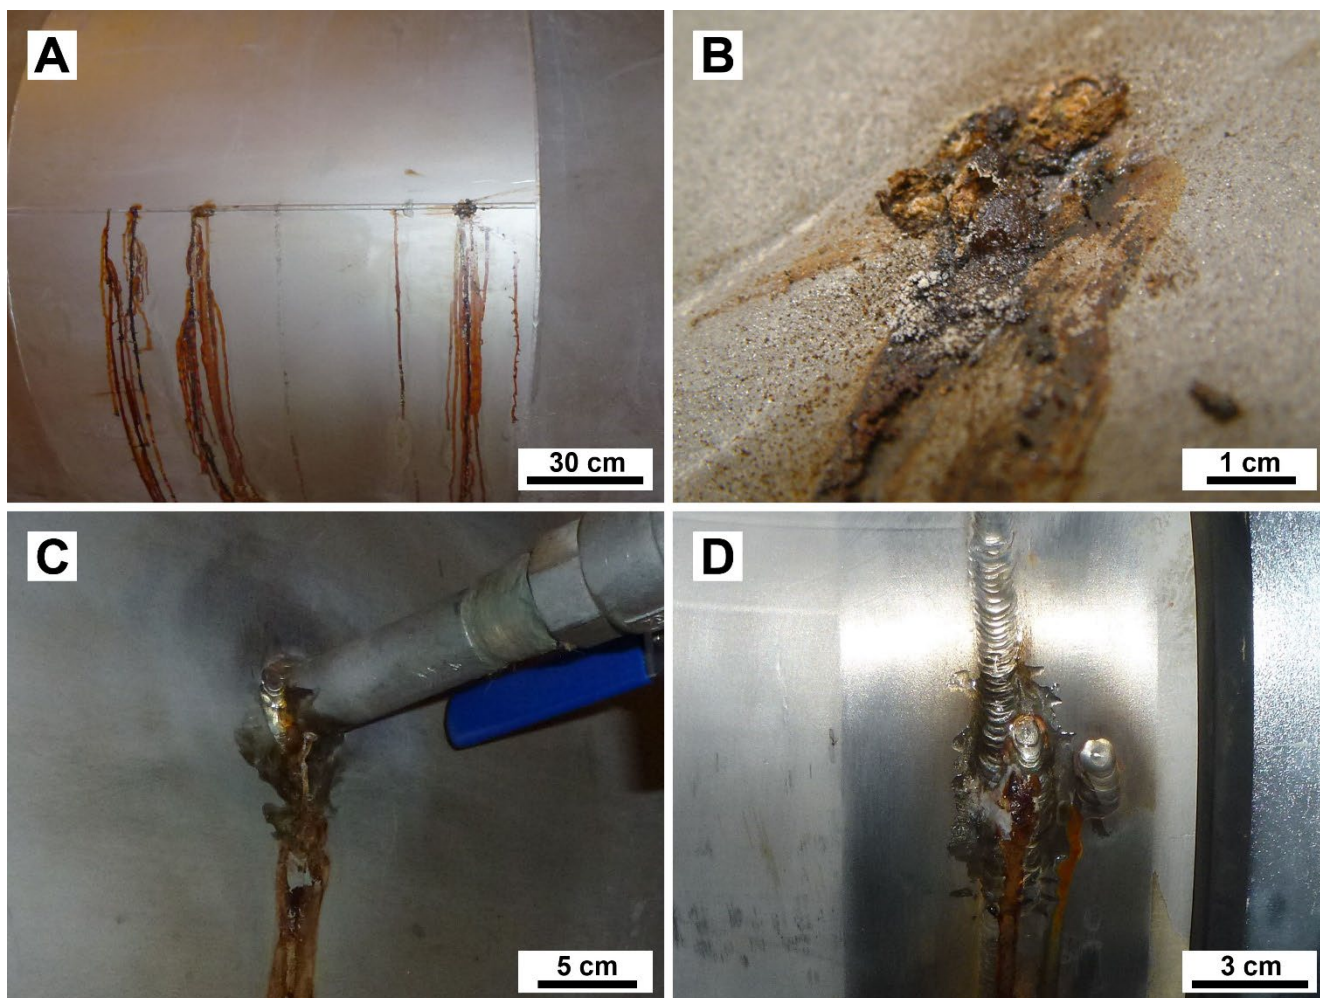
Various areas of the system were inspected, corrosion had the same character and origin for every element of the pipeline. Most often corrosion occurred just at the weld or in its vicinity, not further than 3 cm away from the weld. Washed-away corrosion products flow slowly out of the perforation areas. The photos in Fig. 1 illustrate corrosion damage of different pipelines within the water supply system, in particular: pumping station (Fig. 1a-b), rinsing water system (Fig. 1c), water filtration system (Fig. 1d). In addition, it was found that there were attempts to remove perforation due to corrosion by pad welding (Fig. 1d).

Figure 1 – Inspection of pipeline system, at: a,b) pumping station pipeline, c) rinsing water system pipeline, d) water filtration system pipeline.

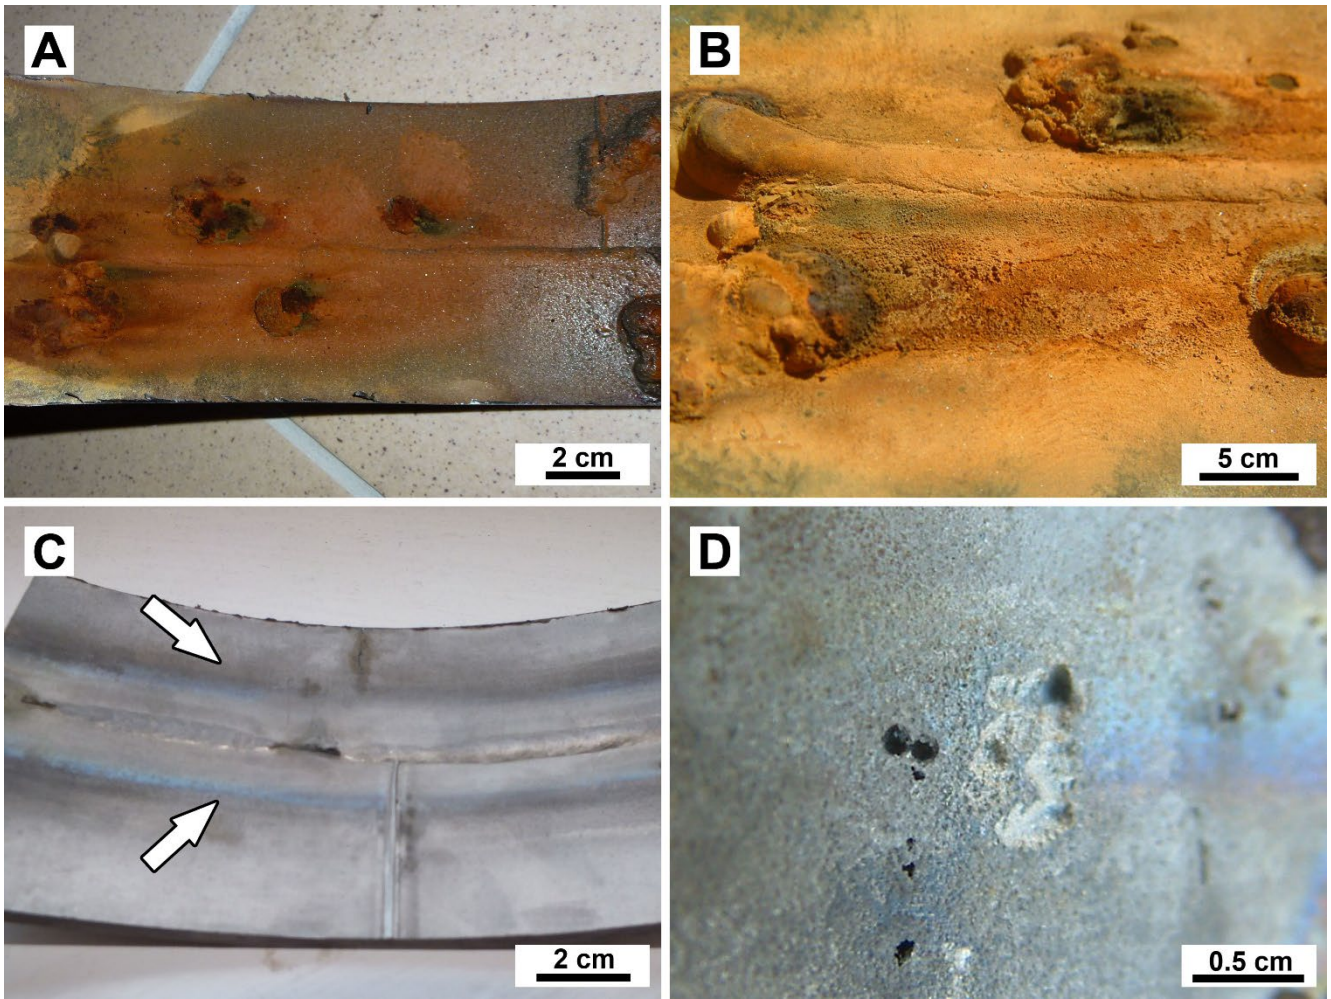
A preliminary visual inspection of the pipeline showed that compacted corrosion products were accumulated on its inner side (Fig. 2a-b). The areas correspond to the spots where stains on the outer side were located. Moreover, in the vicinity of the weld, the entire area was covered with a thin layer of rust. Its presence indicates that there was no protective passive layer on the steel surface and iron corrosion occurred as a result. Once the section was cleaned, dark line located about 1 cm from the

weld was found (pointed out with arrows on Fig. 2c). In this area, macroscopic pits were revealed under the agglomeration of corrosion products (Fig. 2d).

Figure 2 – Pipeline element taken for further analysis. a) specimen, b) a view of corrosion products on the inner side, c) the sample after immersing in inhibitors, d) corrosion pits

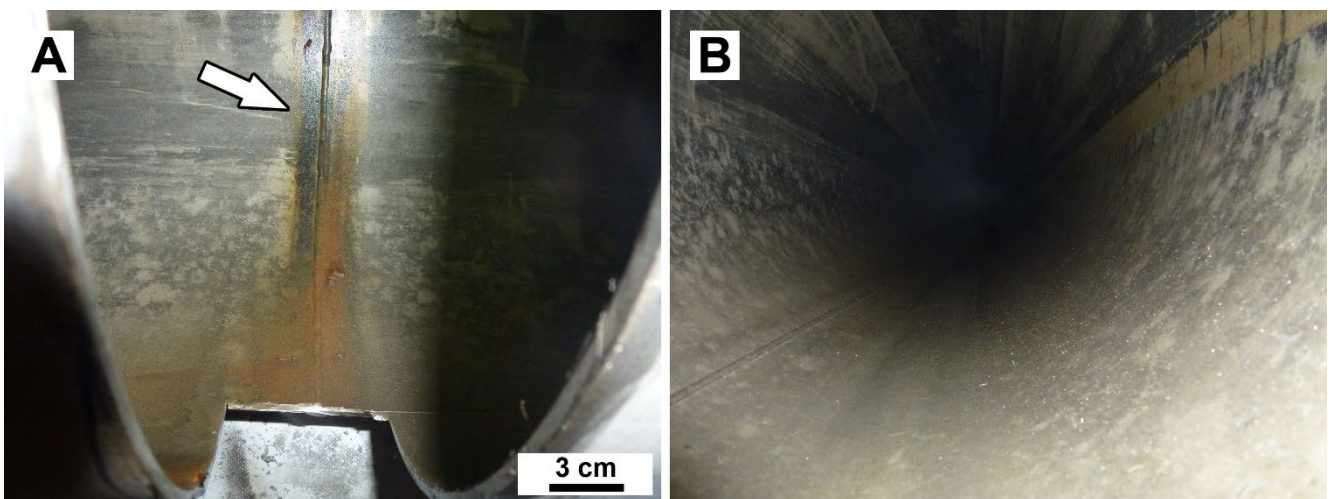
An internal inspection of the pipeline carried out upon collecting the specimen showed that there were no such corrosion products further away from the weld. The photo in Fig. 3 reveals the same dark line within a direct distance from the weld. Its presence indicates an area of a thick layer of chromium oxides; the layer was formed as a result of overheating during the welding process [17].

Figure 3. – A photo taken inside the pipeline at the specimen collection site.

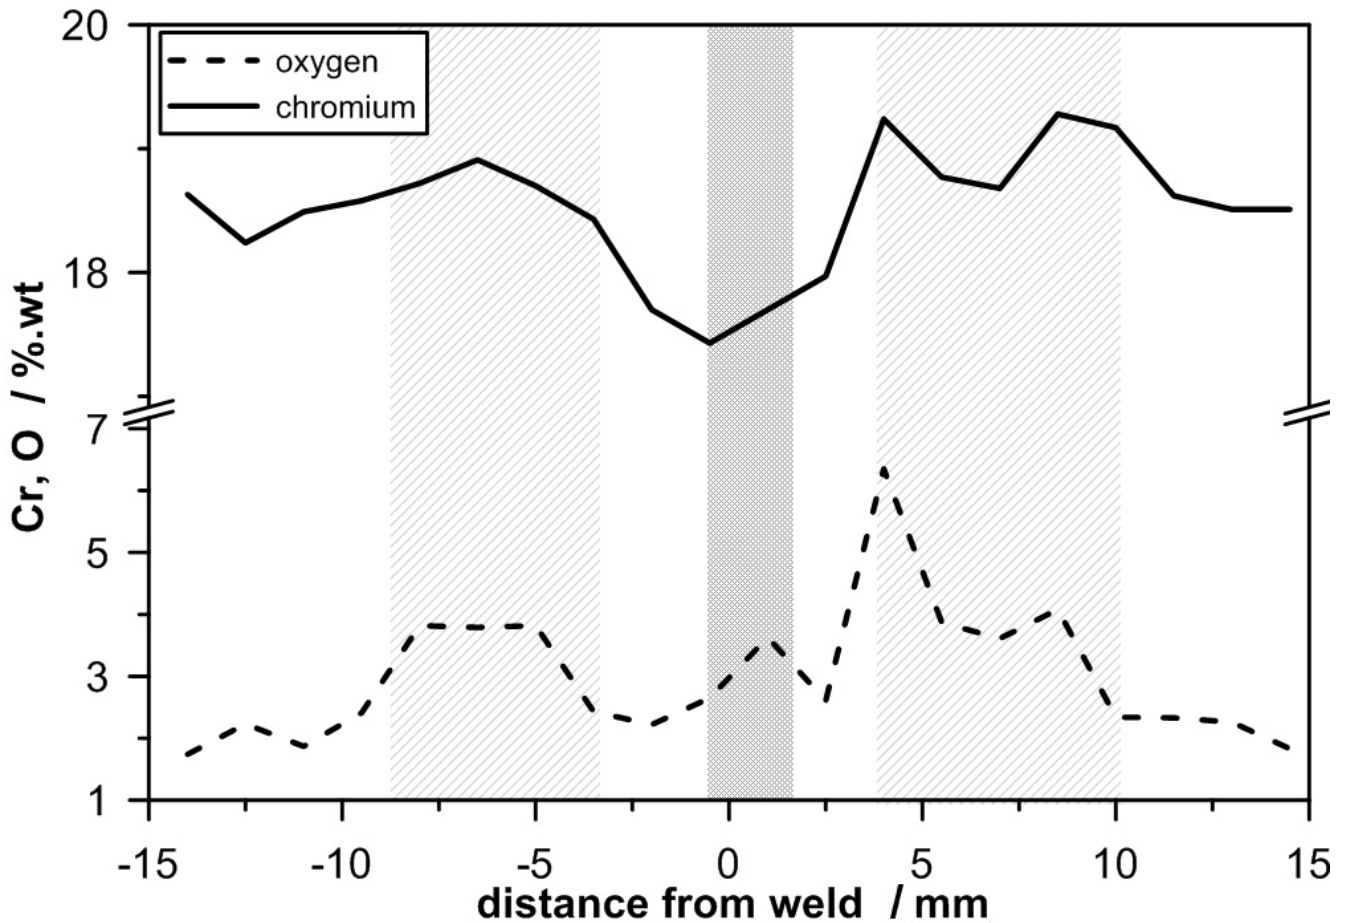
An analysis of chemical composition of the sample in a direct vicinity of the weld, within oxidized area (as presented in Fig. 2c) , was carried out. The oxidized area width is up to 1 cm. Fig. 4 presents relative information on the surface gradient of chromium and oxygen concentration with the use of Energy Dispersive X-ray Spectrometry (EDX). The obtained results prove an increased content of chromium and oxygen within the oxidized area, as compared to the weld and the area of the parent material (on the outer sides of the diagram). However, the results obtained with the help

of the EDX method with reference to thin films should be regarded as demonstrative because the area subject to the analysis is greater than the thickness of the passive layer; therefore just a part of the signal corresponds to it, whereas the rest corresponds to the bulk of the material. Still, the diagrams illustrate changes in the analysed parameters accurately.

Figure 4 – Results of the EDX analysis concerning the content of chromium and oxide on the inner surface of the pipeline section. The shaded area corresponds respectively to (▨) the weld and (▧) the blue layer of chromium oxides.

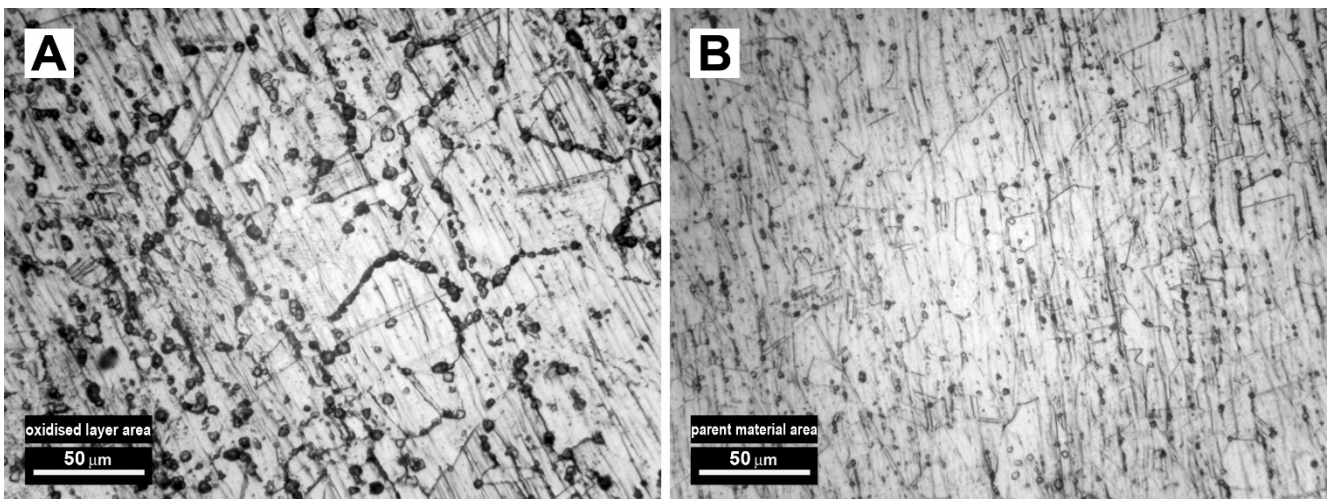
While welding high-alloy steels, areas with a higher risk of local corrosion are often created. In order to determine steel susceptibility to intergranular corrosion, metallographic pictures were taken at the specimen cross-section for the area of the parent material and underneath the oxidised layer. Earlier, the samples were subjected to chemical etching with Adler's reagent in order to uncover the metallographic structure of the steel. Pictures taken by a metallurgical microscope are presented in Fig. 5. Welded joint area, presented on Fig. 5a, is of completely different structure than heat-affected zone or base metal (Fig. 5b-c), wherein the sample has an austenitic structure. In the area beneath

oxidised layer, etching points at grain boundaries indicating the occurrence of intergranular corrosion are well visible. Also, the grains within this area are more coarse. Such degradation is not visible within the parent material. Susceptibility of the oxidised area to intergranular corrosion proves the presence of broad heat-affected zone underneath it.

Figure 5 – Pictures of steel cross-sections taken by a metallurgical microscope: a) weld and heat-affected zone (magnification x100), b) heat-affected zone within the oxidized layer area (magnification x400), c) parent material (magnification x400).

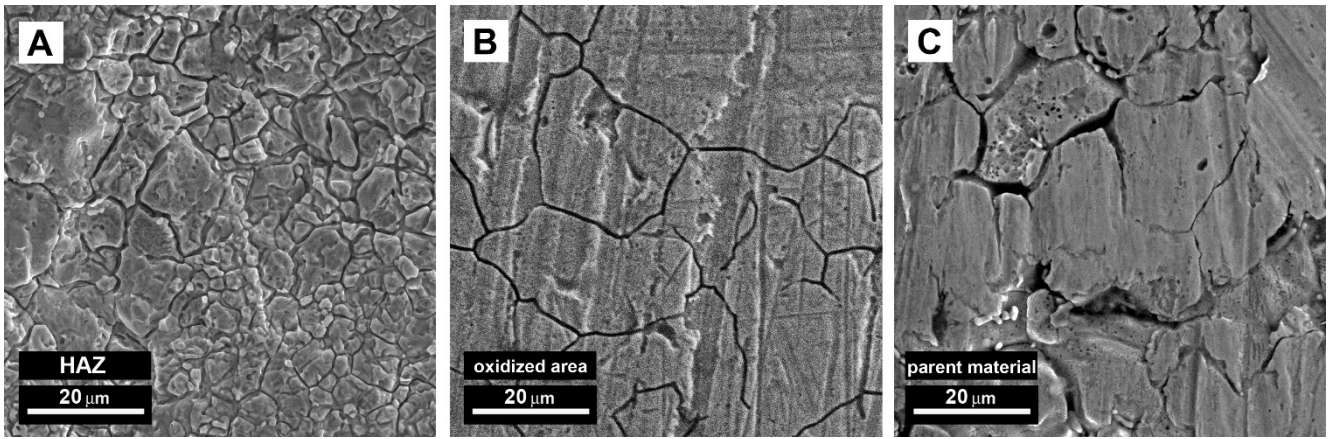
In addition, a Strauss test was carried out, i.e. a test carried out with the use of 18% sulphuric acid and copper(II) sulphate [18]. The Strauss test revealed that steel in the section of the pipeline is prone to intergranular corrosion both in the broad area underneath oxides and heat-affected zone as well as in the parent material. Steel susceptibility to intergranular corrosion is proven by lost resonant sound of metal when hit as well as the photos taken by the scanning electron microscope (SEM) presented in Fig. 6.

Corrosion attack typical of intergranular corrosion is visible both in the heat-affected zone in a direct vicinity of the weld and further away in the parent material, up to a few centimetres from the weld. Intergranular attack revealed the structure within HAZ to be of smaller grain sizes. With the distance from the weld, the depth of the intergranular attack raise as well as the grain sizes. The cracks are most dominant in the oxidized area, around 1 cm from the weld, where susceptibility to intergranular corrosion increased considerably due to sensitization. The weld face was the only area where intergranular corrosion was not found. This area also maintained its resonant property. Additionally, SEM image taken in the oxidized area (Fig. 7) show joint intergranular and pitting corrosion, as is in case of the weld decay.

Figure 6 – SEM micrographs taken after Strauss test: a) heat-affected zone b) area of the parent material. Magnification x1000

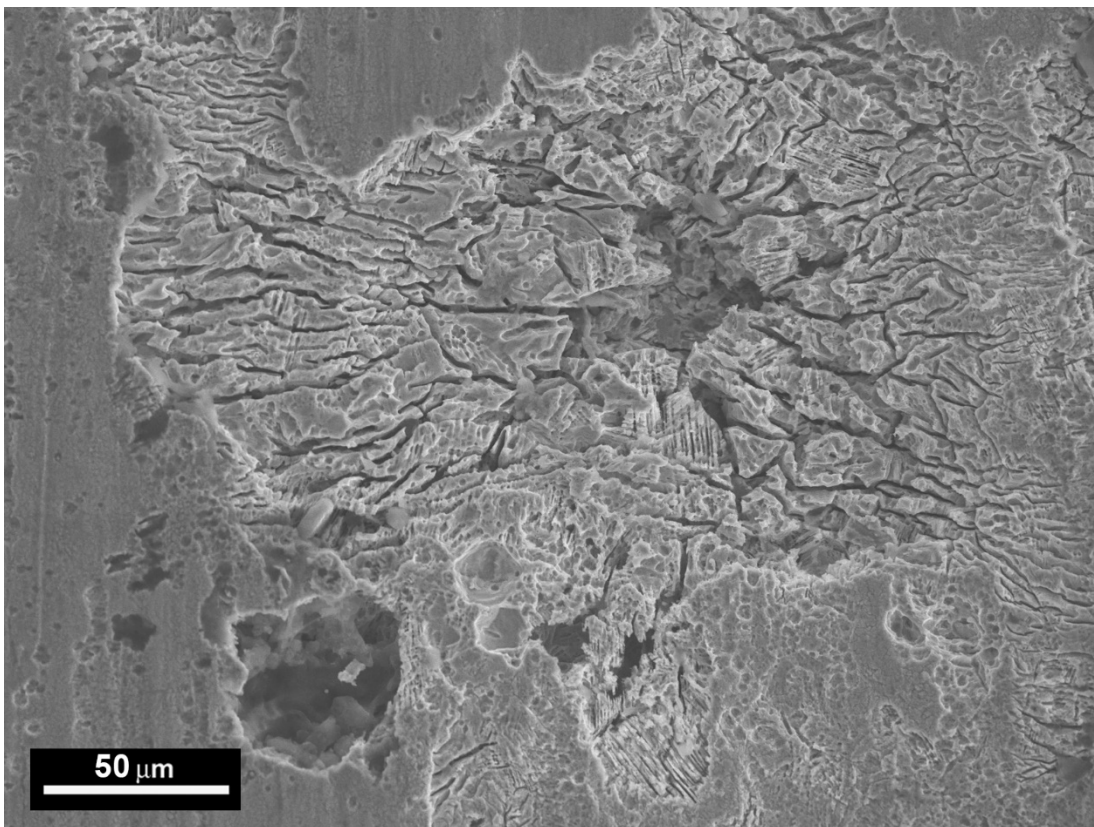
Figure 7 – SEM micrographs of a joint pitting and intergranular corrosion within the heat-affected zone, proving weld decay presence. Picture taken after Strauss test. Magnification x500.

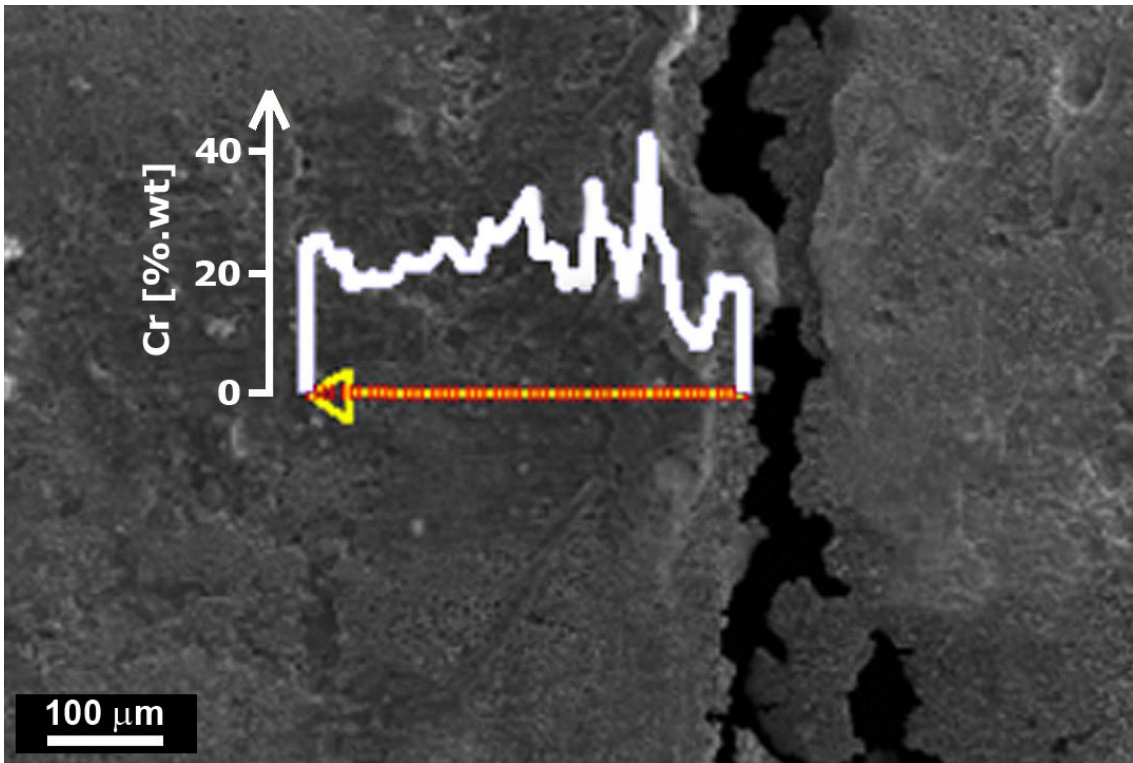
Fig. 8 presents a SEM micrograph of an area surrounding corrosion pits connected in a crack. Similar to Fig. 7, the picture was taken within the oxidized area. The image was overlaid with a local analysis of chromium in steel, carried out by the EDX technique.

A chemical analysis proved micro-segregation of chromium in the vicinity of the corrosion pit and confirmed that steel sensitization occurred. The chromium content along a section of about 100  $\mu\text{m}$  ranges from about 4.5% to even 40%. Such considerable local variations of the chemical element lead to the creation of concentration cells that intensify the rate of local corrosion, whereas a locally lower content of chromium below 12% results in disappearance of the passive layer, and as such protective properties of high-alloy steel as well. Even if chromium content is not below 12%, local galvanic cells can form which can lead to pitting. Such corrosion is caused by degradation of the thin passive layer that protects the metal [20,21].

Figure 8 – SEM micrograph of a pit connected into cracks, with an overlaid profile of local variation in chromium concentration, based on the EDX technique. Magnification x200

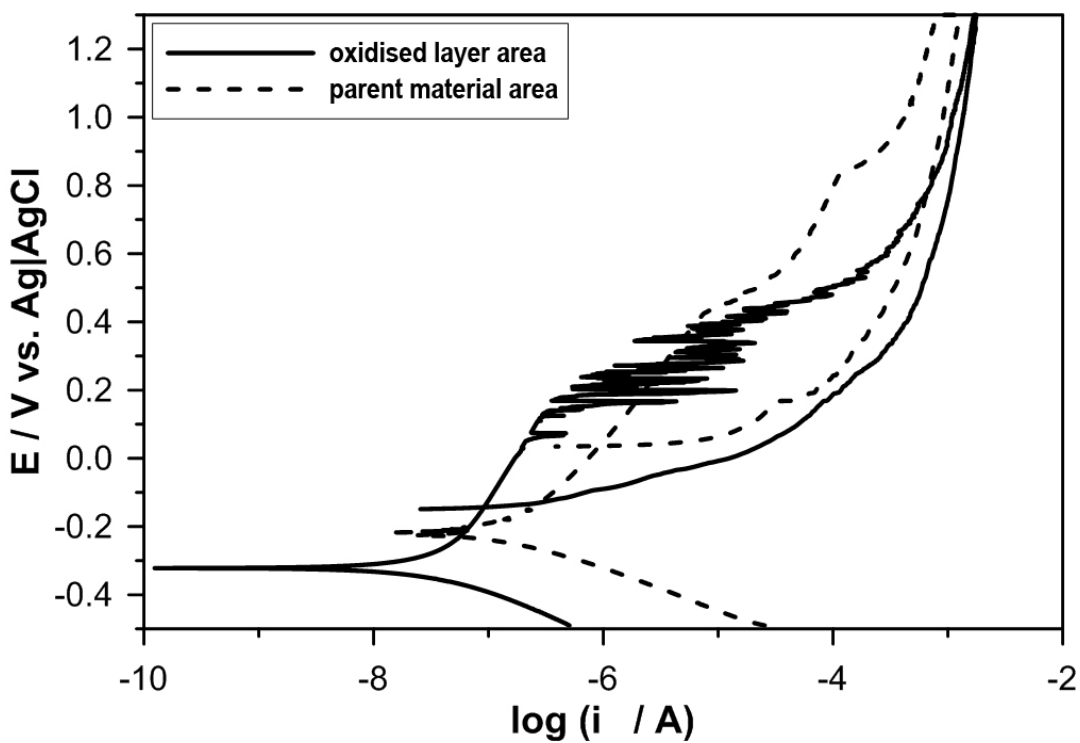
The polarisation curves indicate steel susceptibility to pitting corrosion in both cases (Fig. 9); a hysteresis loop is visible. Pitting potential for both cases is about +0.5 V with reference to the silver chloride electrode. Re-passivation potential in the area of the parent material is 0.1 V and is higher than for the oxidised film area by about 0.2 V. In addition, the polarisation curve plotted for the area in the vicinity of the weld is characterised by rapid fluctuations in the current within the range before

the pitting potential. It is typical of steel undergoing pitting corrosion and is characteristic of the creation of metastable pits on the sample surface. The analysis of water revealed a high content of chlorides. As shown by the polarisation curves, the presence of chlorides causes pitting corrosion also in the area of steel parent material. Therefore, steel AISI type 304 is not an optimal choice in terms of corrosion resistance, and in particular, in the case of additional factors such as heat treatment after welding, it can be susceptible to local corrosion to a significant extent.

Figure 9 – A polarisation curve for (—) steel AISI 304 in the area of oxidised passive film, and (...) within the area of the parent material.
