# Problem of Clogging in Drainage Systems in the Examples of the Żur and Podgaje Dams

Witold Sterpejkowicz-Wersocki

**Key words:** drainage, clogging, hydraulic engineering

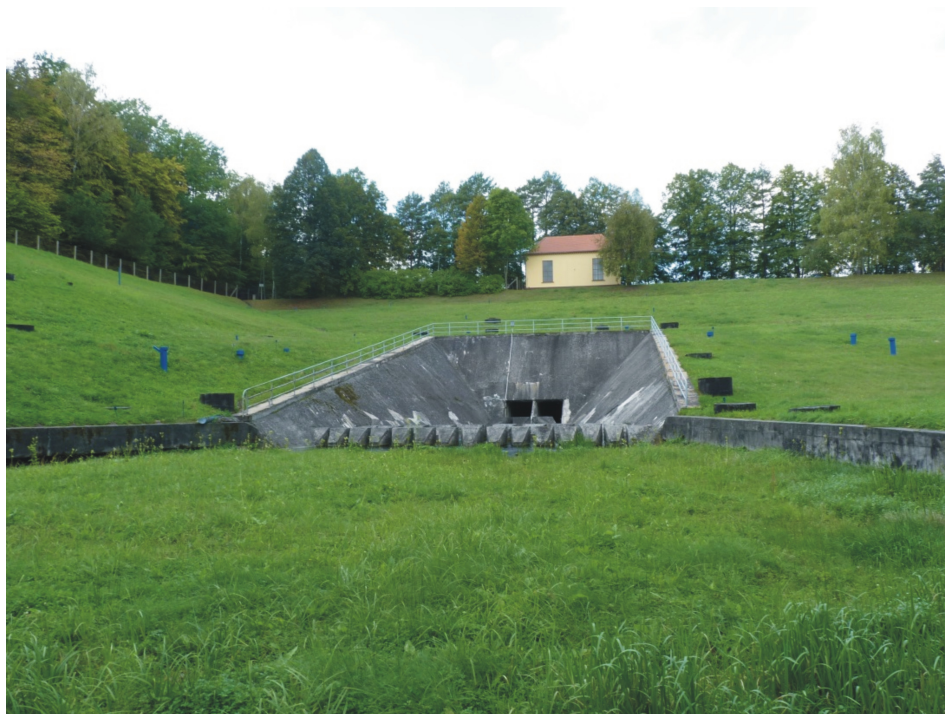
In the mid 1970s, a decision was made to build a new drainage system, as the rock toe filter had been clogged, and it was pointless to renovate the filtration capacity

**Fig. 1.** General view of the Zur earth dam and the bottom outlet

of the rip-rap that had worked since the beginning of the construction. There is no further information about the type of clogging. It was probably related to the development of vegetation, with layers of soil and root, and the consequent reduction in the permeability of the drainage prism at the base of the downstream slope of the dam.

A new drainage system with a total length of approx. 170 m and a diameter of 300 mm was constructed in place of the rock toe filter, that had an area equal to about 1400 m<sup>2</sup>. The drainage system was likely to eliminate the impact of surface factors, which had led to the clogging of the original rock toe filter.

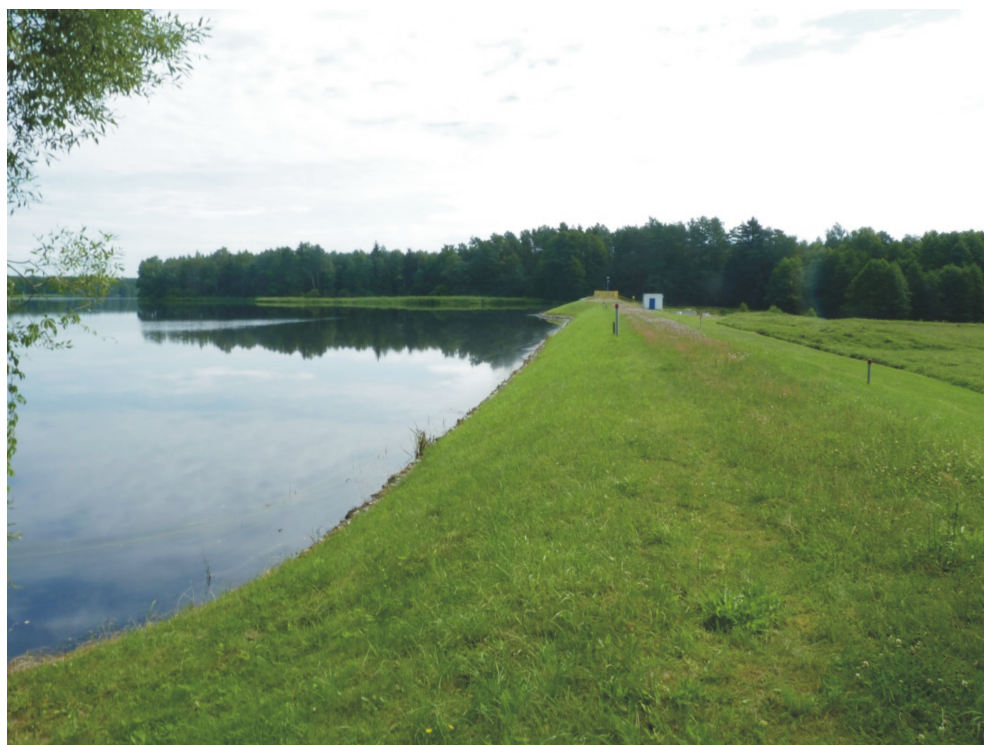
**Fig. 2.** General view of the Podgaje earth dam

This earth dam is also afflicted with cyclical drainage dysfunctions caused by clogging with iron compounds. Its present drainage system was constructed in 1991. It consists of ceramic drainage pipes, a sand filter, and a geotextile.

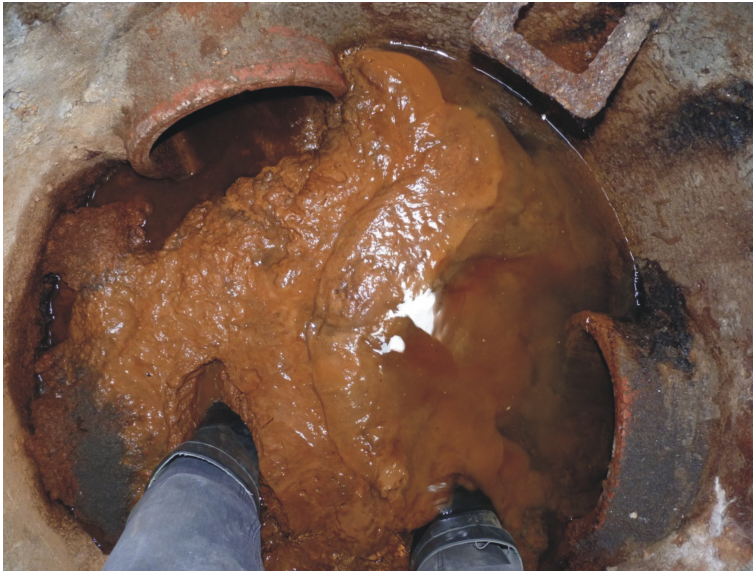
During operation, a slow but steady increase in pressure filtration can be observed. Inside wells and drainage pipes, clogging is caused by iron oxide in the form of fer-

**Fig. 3.** Ferruginous substance in a well

ruginous deposits, which reappear within a few months after being removed (Fig. 3 and Fig. 4).

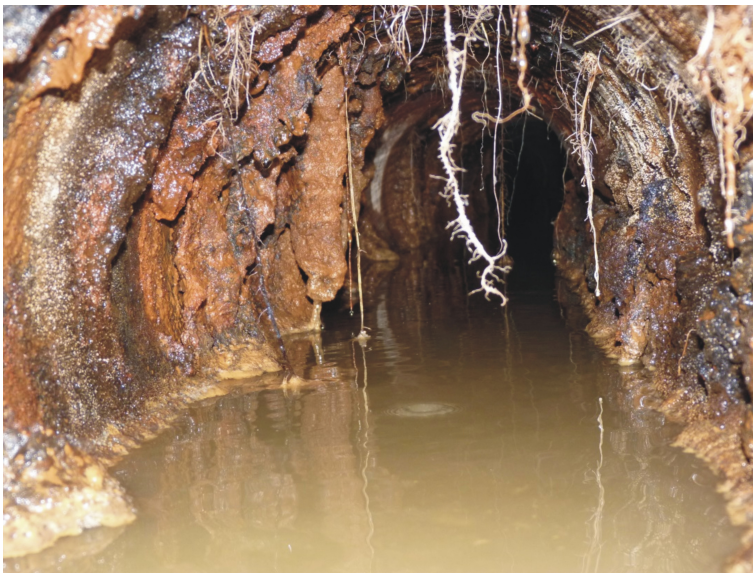
**Fig. 4.** Ferruginous substance in a pipe

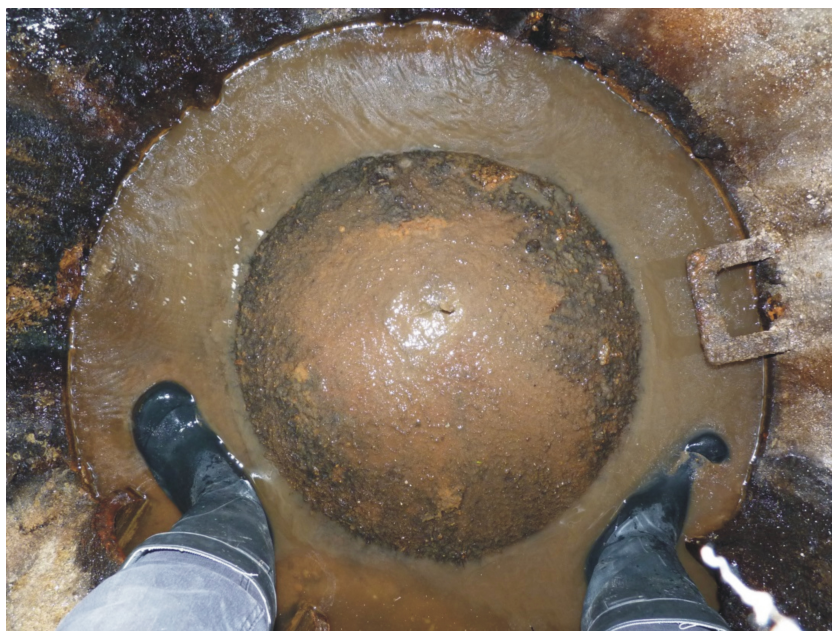
Some of the drainage wells have been mounted only on a geotextile (without a concrete plug). Inside the wells, a severe clogging of the geotextile can be observed, which

results in a bulge of the material (Fig. 5) caused by groundwater pressure, which is stabilized at a height of about 2 m above the bottom of the well.

**Fig. 5.** A bulge caused by groundwater pressure in geotextile at the bottom of a well

The technical condition of the drain and the observed upward trend of the phreatic curve clearly demonstrate the need to restore the drainage system. Under the existing conditions, it is impossible to protect the drain effectively against the precipitation of iron oxide, but measures should be taken to delay the consequences of progressive clogging.

These measures include the replacement of the geotextile as a drainage layer with classic mineral inverted filters. The author's experiences (Bolt, Sterpejkowicz-Wersocki 2006; Sterpejkowicz-Wersocki Szudek 2011, 2013; Sterpejkowicz-Wersocki 2013) regarding the effectiveness of geotextiles in filtration and drainage solutions indicate that the presence of ferruginous groundwater results in the formation of an impermeable film on the surface of geosynthetics. In other cases, geotextiles retain their function, acting effectively as filters.
