Problem of Clogging in Drainage Systems in the Examples of the Żur and Podgaje Dams

Witold Sterpejkowicz-Wersocki

Gdańsk University of Technology, Faculty of Civil and Environmental Engineering,
ul. G. Narutowicza 11/12, 80-233 Gdańsk, Poland, e-mail: wste@pg.gda.pl

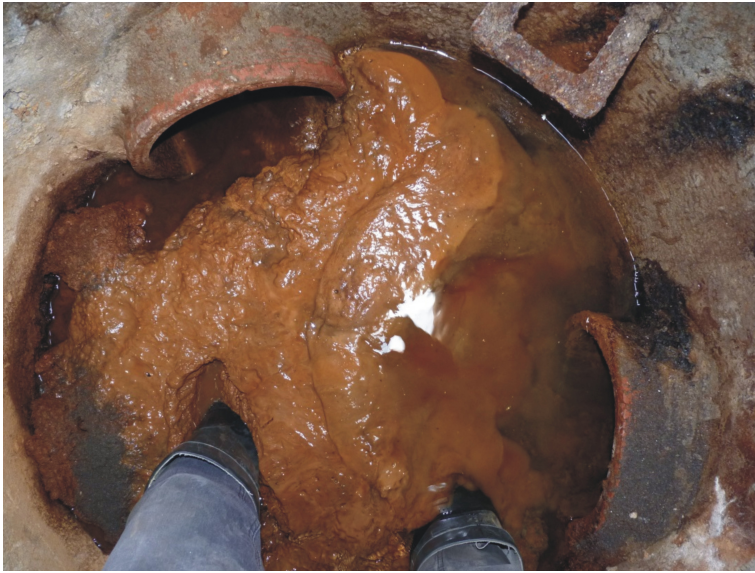
During operation, a slow but steady increase in pressure filtration can be observed. Inside wells and drainage pipes, clogging is caused by iron oxide in the form of fer-

Fig. 3. Ferruginous substance in a well

ruginous deposits, which reappear within a few months after being removed (Fig. 3 and Fig. 4).

The technical condition of the drain and the observed upward trend of the phreatic curve clearly demonstrate the need to restore the drainage system. Under the existing conditions, it is impossible to protect the drain effectively against the precipitation of iron oxide, but measures should be taken to delay the consequences of progressive clogging.

These measures include the replacement of the geotextile as a drainage layer with classic mineral inverted filters. The author's experiences (Bolt, Sterpejkowicz-Wersocki 2006; Sterpejkowicz-Wersocki Szudek 2011, 2013; Sterpejkowicz-Wersocki 2013) regarding the effectiveness of geotextiles in filtration and drainage solutions indicate that the presence of ferruginous groundwater results in the formation of an impermeable film on the surface of geosynthetics. In other cases, geotextiles retain their function, acting effectively as filters.

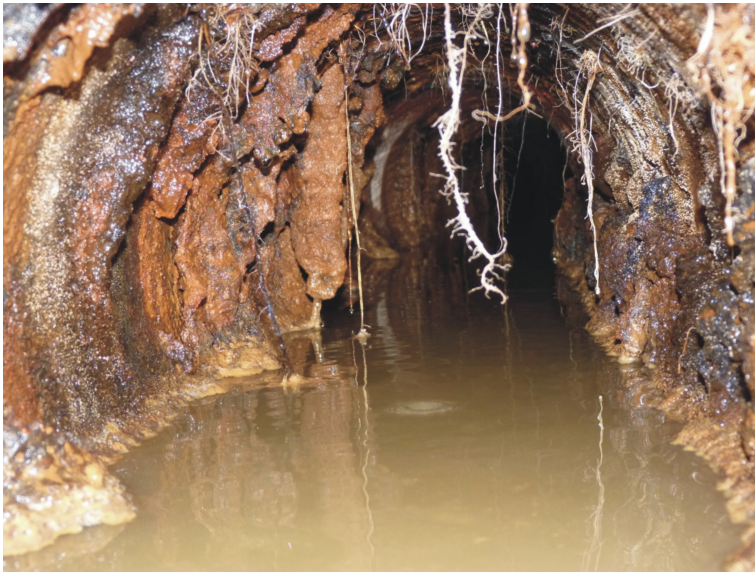
Fig. 4. Ferruginous substance in a pipe
