Studies of the mechanism of metal dusting of 10CrMo9-10 steel after 10 years of operation in the semi-regenerative catalytic reformer

The purpose of this paper is to present a metal dusting mechanism for 10CrMo9-10 steel operated for 10 years in the semi-regenerative catalytic reformer.

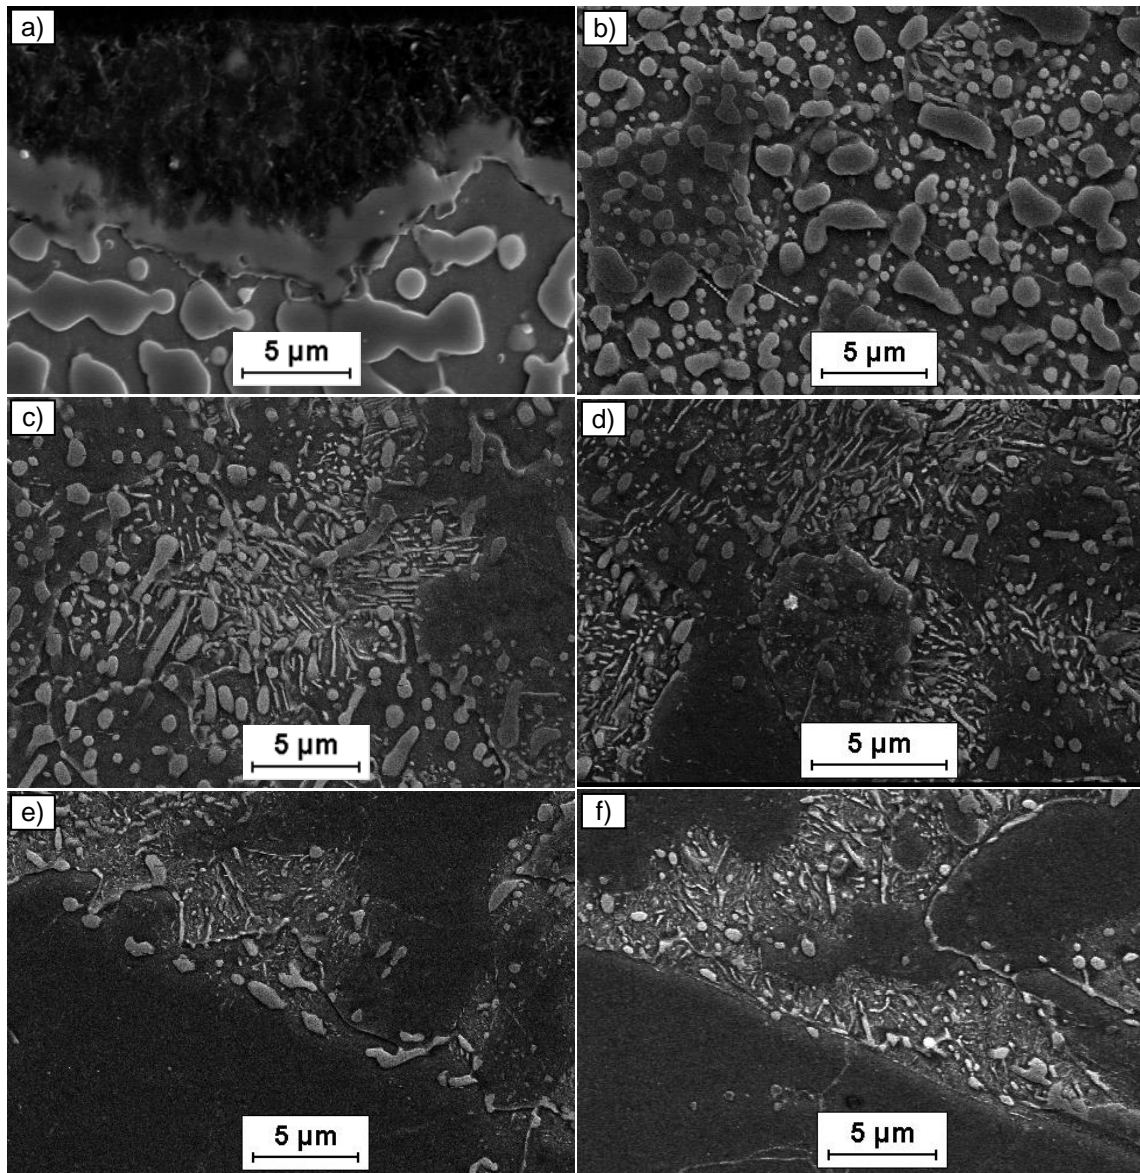
Fig. 4 shows the microstructures of the steel made at different distances from the inner surface of the pipe. Under inner surface of the pipe there are visible numerous, large spheroidal carbides evenly distributed in the ferritic matrix (Fig. 4a, b). With increasing distance from the inner surface of

the pipe, carbides contribution in the microstructure of the steel and their size are reduced. Also their structure changes - already at a depth of 150 μm lamellar carbides can be observed (Fig. 4b), which part increases with the distance from the inner surface.

Fig. 4. Images obtained with the cross section of the tube. The inner surface of the pipe with the subsurface layer – Fig. a). Microstructure of the steel approximately 150 μm from the inner surface of the pipe – Fig. b), 500 μm from the surface – Fig. c), 750 μm from the surface – Fig. d), 1 mm from the surface – Fig. e), 3 mm from the surface – Fig. f)

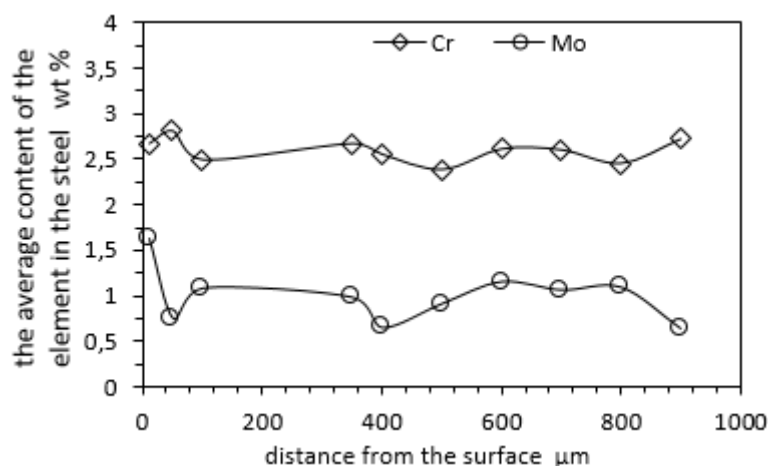
Fig. 5. Average content of the chromium and molybdenum in the steel as a function of distance from the inside surface (IS) of the tube measured by EDS

As is apparent from Fig. 5 the average content of the alloying elements Cr and Mo as a function of distance from the surface of the inner pipe is approximately constant. There is no the outward diffusion of elements forming carbide, i.e. chromium and molybdenum, as it did in the case of steel tubes X11CrMo9-1 furnaces operated in the platformer CCR [19].

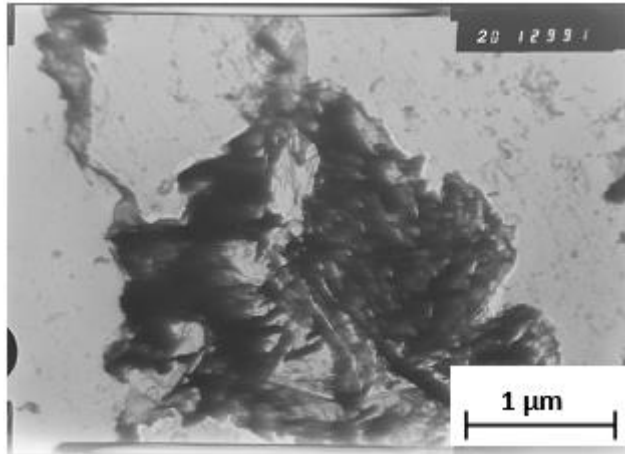
Fig. 9. Small, lamellar precipitations at the bottom of imprints, not extracted spheroidal carbide
