World Multidisciplinary Civil Engineering-Architecture-Urban Planning Symposium 2016,  
WMCAUS 2016

## Cast Iron Staircase in Aleksandrów Kujawski (Poland) - History, Construction, Architectural Form

Michał Kwasek<sup>a,\*</sup>, Aleksander Piwek<sup>a</sup>

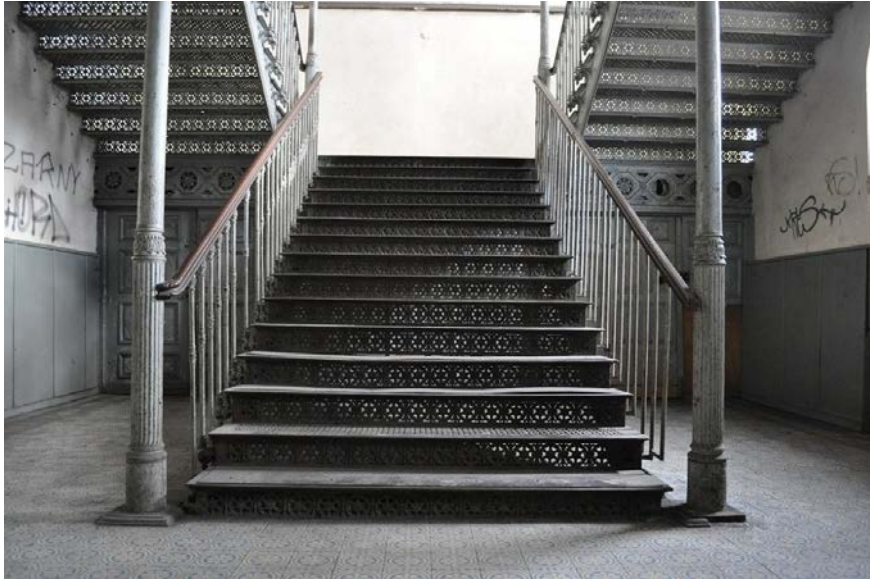
The railway station complex is entered in the register of monuments and remains under the protection of Kujawsko-Pomorskie Voivodship Regional Heritage Conservator. However the current condition of the stairs should be assessed as bad. Most parts of the barriers are damaged. Lack of some vertical bars, cast iron ornaments are broken off, or complete lack of them. The condition of some treads was so poor that, in order to further use of the steps it was necessary to mount on them additional items of flat sheet. Wooden stairs' walls which are partially damaged were repaired temporarily by the residents of the building by placing fibre panels. Interim actions allow to use that vintage construction, but it is still deteriorating (Fig. 1).

Fig. 1. Cast iron staircase: general view.

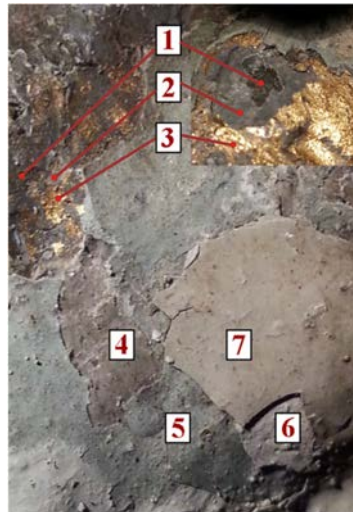
Fig. 7. The surface of decorative metal element of railing bar. The layers of painting coats are numbered consecutively.

The separate issue meriting specific action is painting decoration. The primary colour should be restored if possible. The first author of the article has carried out the stratigraphy examination on decorative, bird-shaped part of the vertical railing bar (Fig. 7). Below the results of the examination are revealed. Based on them it is possible to determine the history of coating. Examination has shown that original colour of the stairs was gold. Till nowadays it has been repainted four times. Current paint coat is grey.

Number of layer	Chronological order	Dating	Characteristic	Colour of layer
1.	I	70's of 19th century	cast iron base	black
2.	I	70's of 19th century	ground coat	grey
3.	I	70's of 19th century	first painting coat	gold
4.	II	20th century	secondary painting coat	grey steel
5.	III	20th century	secondary painting coat	steel blue
6.	IV	20th century	secondary painting coat	Steel sky blue
7.	V	20th century	secondary painting coat	grey
