The application of non-destructive methods in the diagnostics of the approach pavement at the bridges

M Miskiewicz, J Lachowicz, P Tysiac, P Jaskula and K Wilde

Faculty of Civil and Environmental Engineering, Gdansk University of Technology, Gdansk, Poland

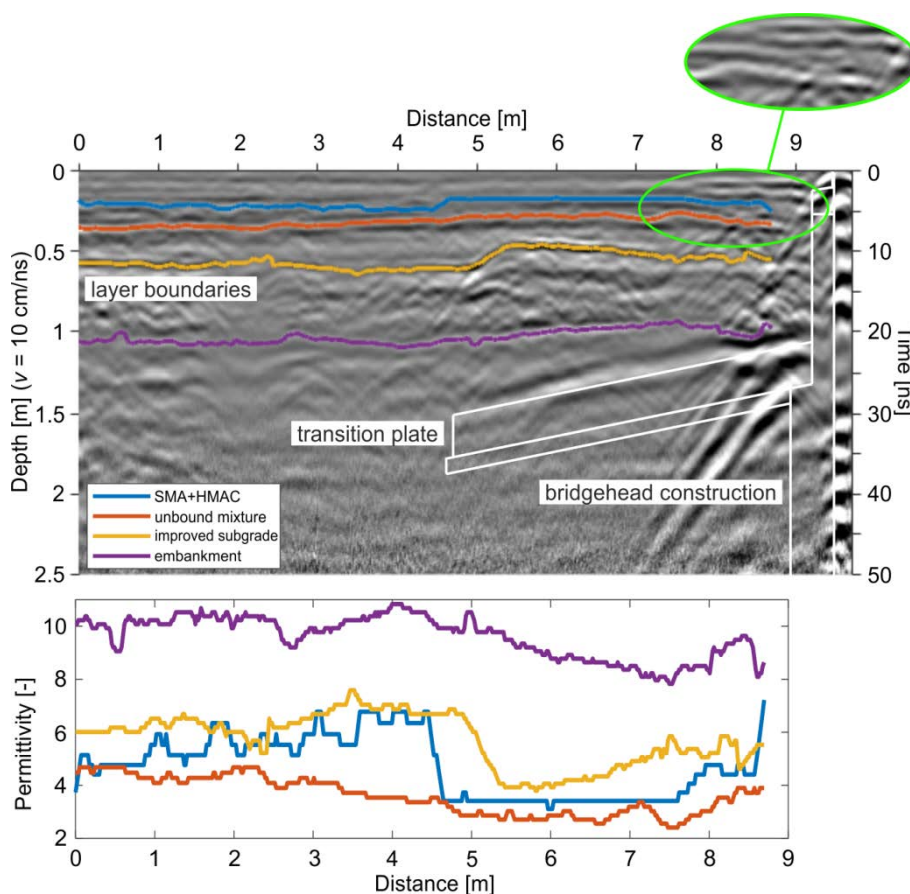
Figure 3. The slow lane (most-loaded lane) longitudinal GPR map.

Anomalies near the bridge joint were observed, i.e.: change of the reflected signal phase, increased reflected signal power and multiple longitudinal reflections (Fig. 3 and Fig. 4a). These anomalies may

indicate structural disturbance, increased humidity or air voids. In order to interpret the observed anomalies correctly, numerical calculations of electromagnetic wave propagation were carried out by means of the finite-difference time-domain method (FDTD). Transverse maps with permittivity diagrams are shown in Fig. 4b. It can be noticed that differences in the dielectric constant occur across the pavement, possibly caused by the low traffic load of the emergency lane.

Diagnostic tests using the GPR method showed changes in the value of permittivity of individual structural layers of the pavement in a zone around the bridge joint. Detected changes in the dielectric constant in the area of four meters from the bridge joint trigger increased porosity or humidity of the tested medium. Moreover, in case of the elevated humidity, the value of permittivity is higher than the average value due to the value of water permittivity ($\epsilon_r = 81$). However, in the case of increased porosity of the material, the permittivity value is lower than the average due to the value of air permittivity ($\epsilon_r = 1$). In conclusion, the occurrence of inhomogeneous compaction zones in the expansion zone is considered highly probable.

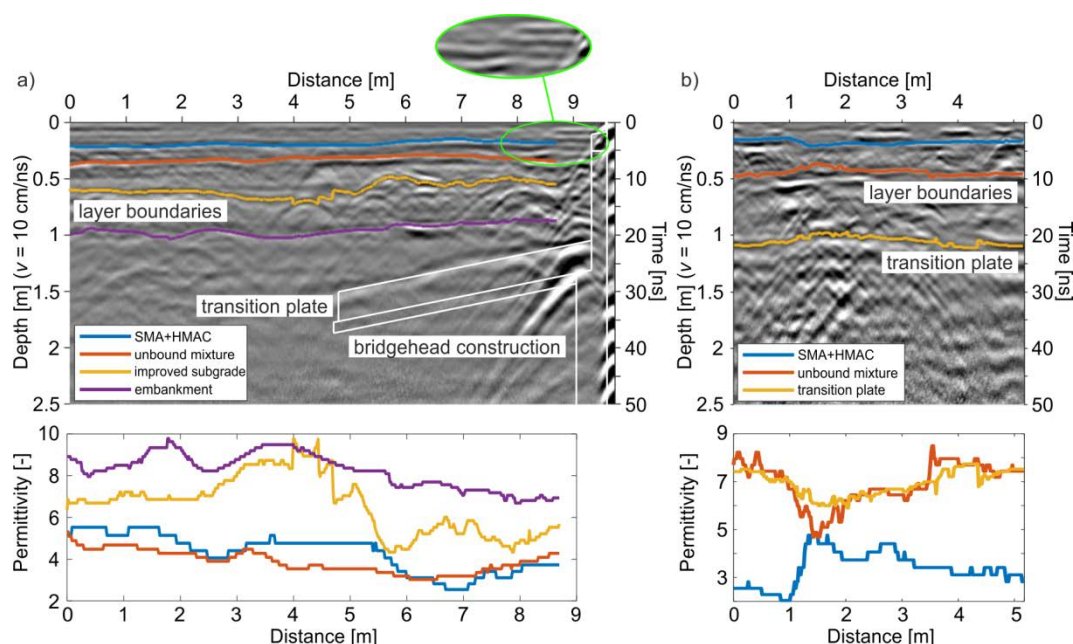
Figure 4. GPR maps a) The emergency lane longitudinal GPR map b) Transversal GPR map of approach pavement at bridge.

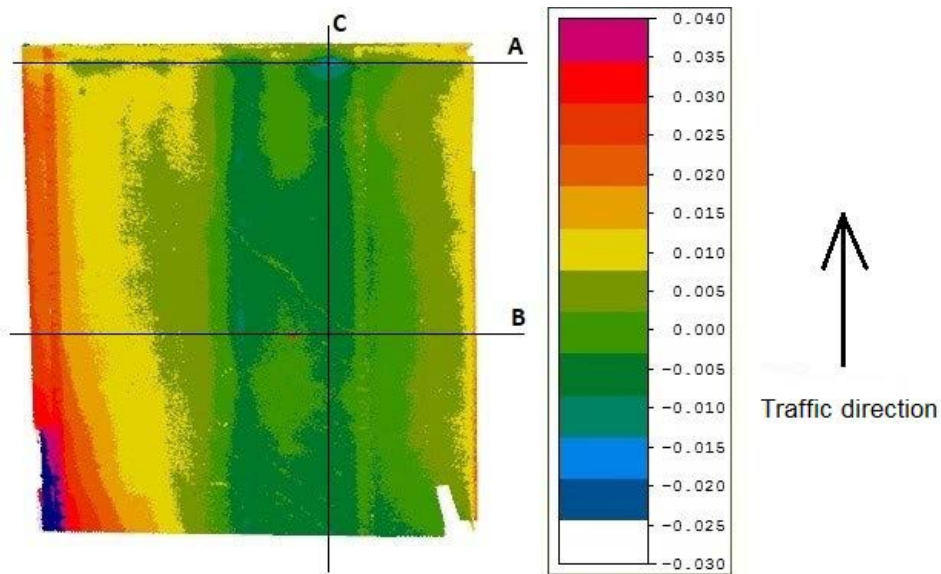
Based on a number of the selected bridge objects, the measurements were performed on the slow lane (most-loaded lane) and on the emergency lane near the bridge joint of the bridge structure. A general view of the location of the scanner positions on the object is shown in Fig. 2. The isometric map of the scanned pavement is shown in Fig. 5. It is clearly visible that the right, more loaded lane is lowered by about 1 cm related to the reference surface. In turn, the edge of the left lane is about 1 cm above the reference position. In the immediate vicinity of the bridge joint, on the right lane zone is lowered by about 0.5 cm- 1.5 cm in relation to the reference position and by 2-3 mm in the left lane.

Figure 5. Isometric map of the scanned pavement surface with marked cross-sections, on the right - the distance scale between the reference surface and the real one.

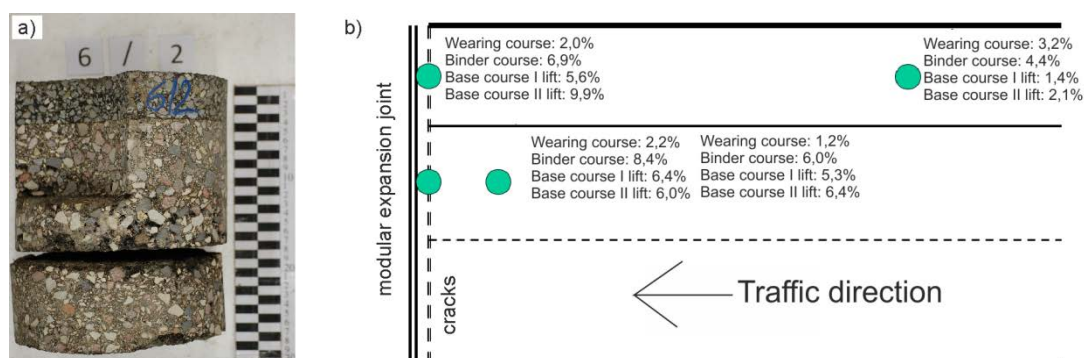
In order to verify the observed zones of inhomogeneous compaction from non-destructive methods, destructive tests were performed (Fig. 7). The cores were used to determine the air void content in the asphalt layers and to determine the range of crack propagation. In addition, information on cores made it possible to determine the thickness of the each layers.

Figure 7. Invasive test results a) core picture b) results of the air voids content in the asphalt layer.

The content of the air voids in the binder course HMAC and two lift layers of the base course from HMAC in samples taken directly at joints, in the vicinity of cracks, was about 2-3 times greater than in the place located about 15 meters from the bridge joint. This would indicate a worse compaction of these layers next to the bridge, compared to the compaction on the regular section. This is confirmed by the appearance of the samples themselves. The samples taken directly at the bridge joint were heterogeneous and porous in some fragments. Tests performed in the laboratory using cores, confirmed the conclusions of non-destructive testing.
