The application of non-destructive methods in the diagnostics of the approach pavement at the bridges

M Miskiewicz, J Lachowicz, P Tysiac, P Jaskula and K Wilde

Faculty of Civil and Environmental Engineering, Gdansk University of Technology, Gdansk, Poland

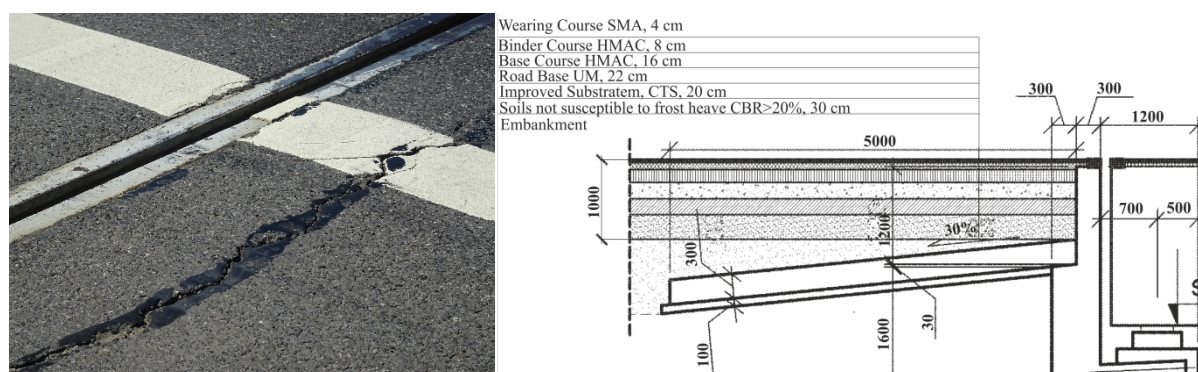
In a relatively short time after the road started operating transverse cracks appeared during the first winter at the majority of expansion joints of modular bridge structures. The cracks occurred 30 cm from the steel profile of the expansion device, at the abutment of the transition plate at the bridgehead. Moreover, the cracks did not appear with bituminous expansion joints. At that time, damage was secured by flooding with a flood mass. It was a provisional only solution. No major actions were taken to remove the cracks from the moment they arose during the measurements based on documentation analysis. During the measurements it was noticed that damage was often accompanied by a visible lack of pavement surface pieces just before the cracking (Fig. 1a). In some circumstances only vertical deformation of the pavement surface appeared without cracks. Lowering the pavement surface usually occurs in the vehicle tracks, also in the areas not subjected to direct impact of the wheels, e.g. in the area of emergency lane or at the inner edges of the wings of abutments.

Figure 1. Analyzed detail, a) approach pavement surface condition b) pavement structure details.

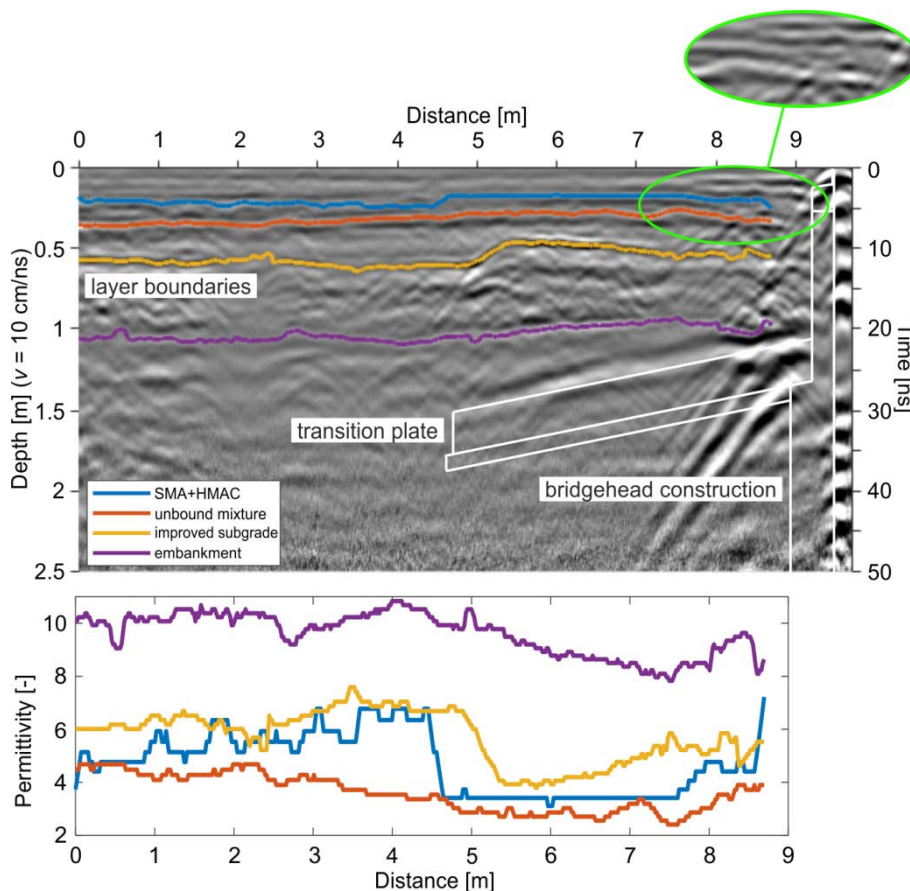
Figure 3. The slow lane (most-loaded lane) longitudinal GPR map.

Anomalies near the bridge joint were observed, i.e.: change of the reflected signal phase, increased reflected signal power and multiple longitudinal reflections (Fig. 3 and Fig. 4a). These anomalies may

Diagnostic tests using the GPR method showed changes in the value of permittivity of individual structural layers of the pavement in a zone around the bridge joint. Detected changes in the dielectric constant in the area of four meters from the bridge joint trigger increased porosity or humidity of the tested medium. Moreover, in case of the elevated humidity, the value of permittivity is higher than the average value due to the value of water permittivity ($\epsilon_r = 81$). However, in the case of increased porosity of the material, the permittivity value is lower than the average due to the value of air permittivity ($\epsilon_r = 1$). In conclusion, the occurrence of inhomogeneous compaction zones in the expansion zone is considered highly probable.

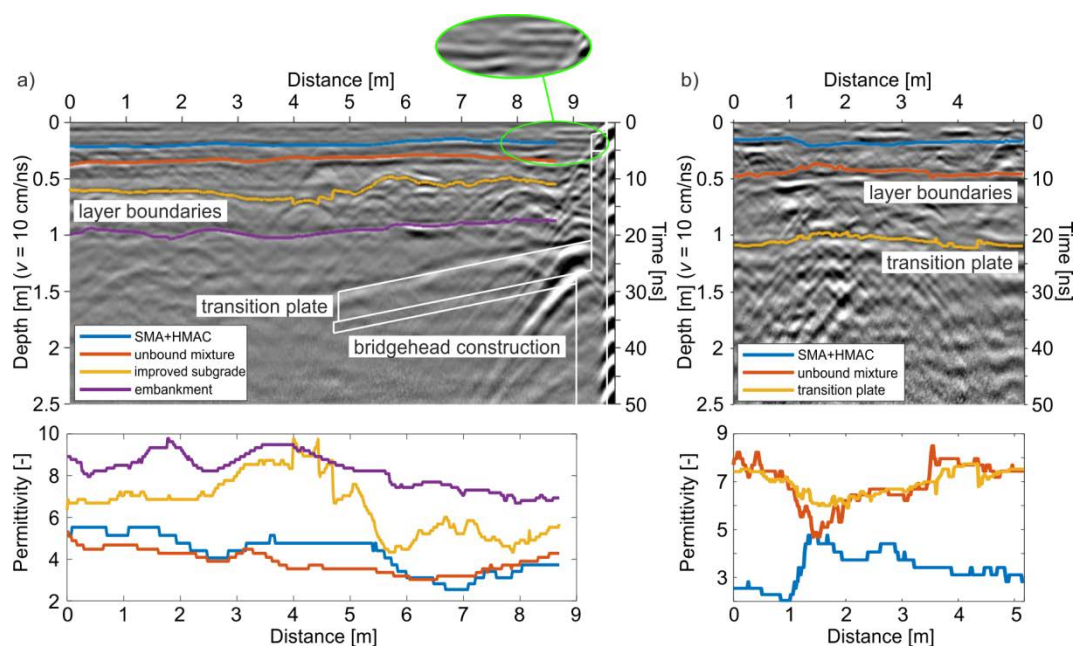
Figure 4. GPR maps a) The emergency lane longitudinal GPR map b) Transversal GPR map of approach pavement at bridge.

indicate structural disturbance, increased humidity or air voids. In order to interpret the observed anomalies correctly, numerical calculations of electromagnetic wave propagation were carried out by means of the finite-difference time-domain method (FDTD). Transverse maps with permittivity diagrams are shown in Fig. 4b. It can be noticed that differences in the dielectric constant occur across the pavement, possibly caused by the low traffic load of the emergency lane.

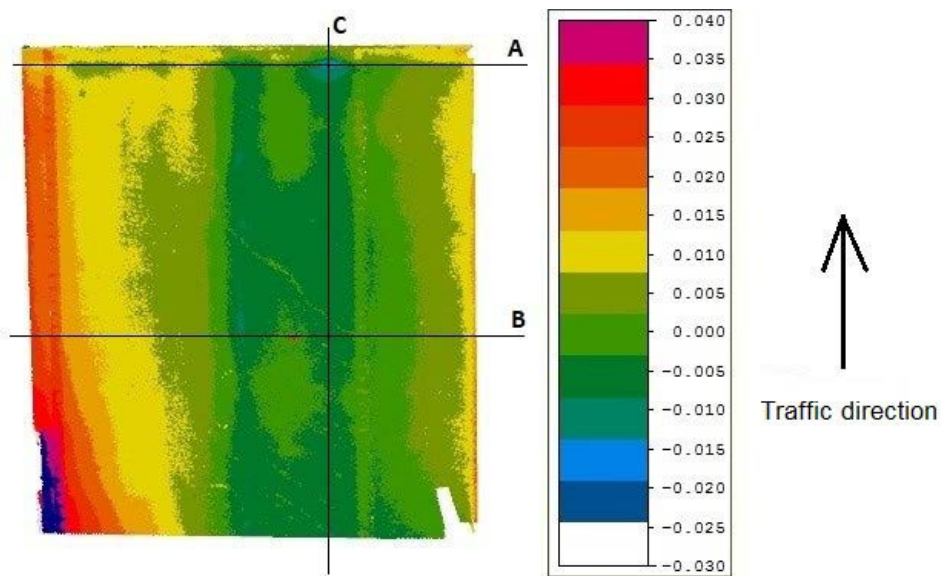
Based on a number of the selected bridge objects, the measurements were performed on the slow lane (most-loaded lane) and on the emergency lane near the bridge joint of the bridge structure. A general view of the location of the scanner positions on the object is shown in Fig. 2. The isometric map of the scanned pavement is shown in Fig. 5. It is clearly visible that the right, more loaded lane is lowered by about 1 cm related to the reference surface. In turn, the edge of the left lane is about 1 cm above the reference position. In the immediate vicinity of the bridge joint, on the right lane zone is lowered by about 0.5 cm- 1.5 cm in relation to the reference position and by 2-3 mm in the left lane.

Figure 5. Isometric map of the scanned pavement surface with marked cross-sections, on the right - the distance scale between the reference surface and the real one.

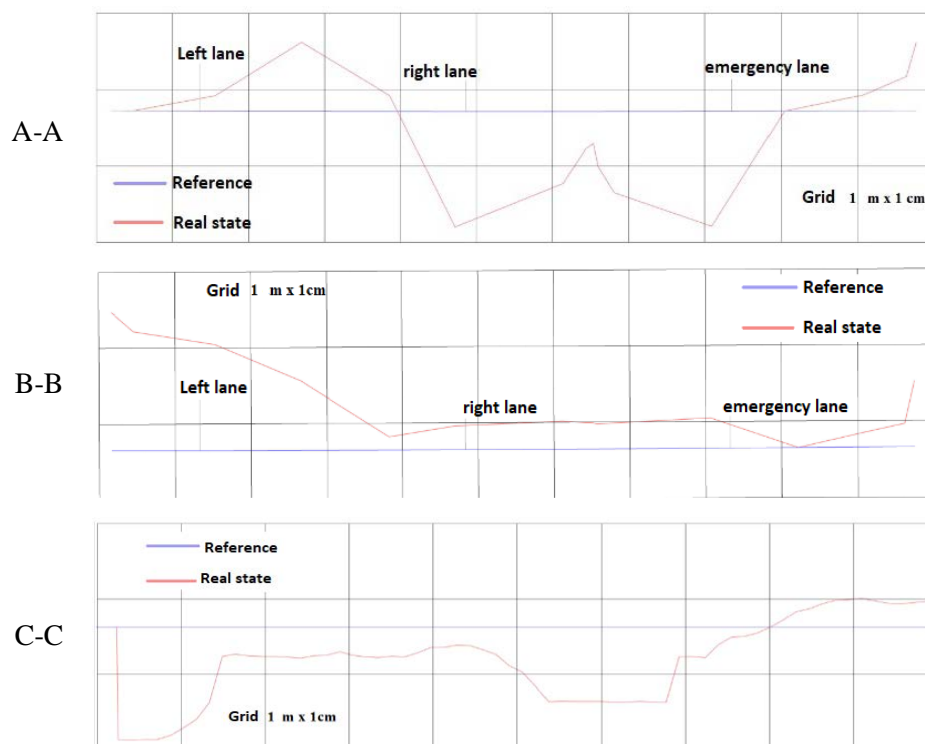
In addition, Fig. 6 shows cross-sections of the surface: across the carriageway in close neighborhood to the bridge joint (A-A), across the road in a section away from the bridge joint by 10m (B-B), along the right edge of the right lane (C-C). As a reference line, the points on expansion joints were taken into account in the case of cross-sections and two points at the edges of the study in the case of longitudinal sections (one on a bridge joint, the other located 10 metres away).

The cross-sections indicate a significant reduction in the right lane of the road in relation to the reference surface. In the lane adjacent to the bridge joint, the measured distance from the reference plane to the real state is on the approximately equal of 1.5 cm. On the fast lane (left lane), elevation of the pavement surface was observed in relation to the reference plane. The elevation value reaches 5 mm. In the cross-section, 10 meters away from the bridge joint, an increase in the area at the edge of the left lane was observed (1.5 cm), without noticeable changes on the right lane. In the longitudinal cross-section case, in the area of a bridge joint lowering the area was observed at the level of 1.5 cm. At a distance of about 10 m from the bridge joint the surface height oscillated near the reference values.

Figure 6. Cross sections of the scanned pavement (scale of 1m along the section x 1 cm after height).

The measurements show that in the close neighborhood of the bridge joint on the slow lane (most-loaded) lane there are significant deformations of the pavement surface. The maximum deformation values of the pavement in comparison to the theoretical reference level were about 1.7 cm. The recorded deformation values of the pavement indicate an uneven settlement of the surface at the entrance to the object and a resulting threshold on the edge of the wall of the outboard bridgehead.

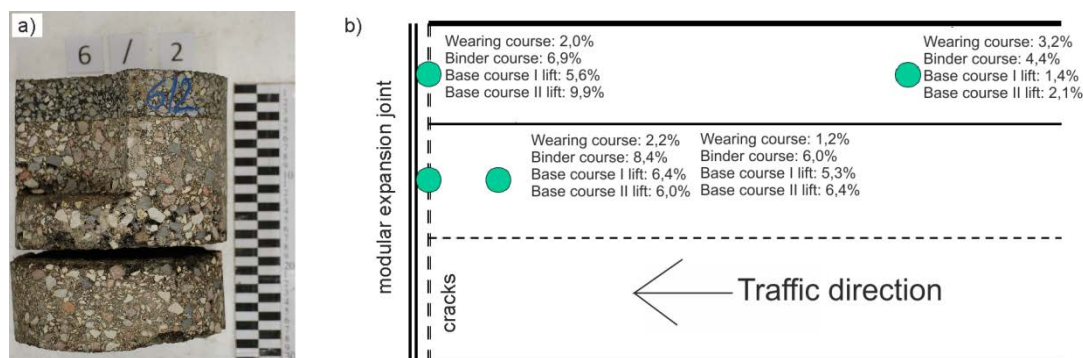
Figure 7. Invasive test results a) core picture b) results of the air voids content in the asphalt layer.

The content of the air voids in the binder course HMAC and two lift layers of the base course from HMAC in samples taken directly at joints, in the vicinity of cracks, was about 2-3 times greater than in the place located about 15 meters from the bridge joint. This would indicate a worse compaction of these layers next to the bridge, compared to the compaction on the regular section. This is confirmed by the appearance of the samples themselves. The samples taken directly at the bridge joint were heterogeneous and porous in some fragments. Tests performed in the laboratory using cores, confirmed the conclusions of non-destructive testing.
